Indian and Northern
Affairs Canada

**Re: Land Use Permit MV2011C0006
Mineral Exploration
Thor Lake, NT**

ENVIRONMENTAL INSPECTION REPORT

Permittee:	Avalon Rare Metals Inc.	Inspection Date – October 6 th , 2011
------------	-------------------------	--

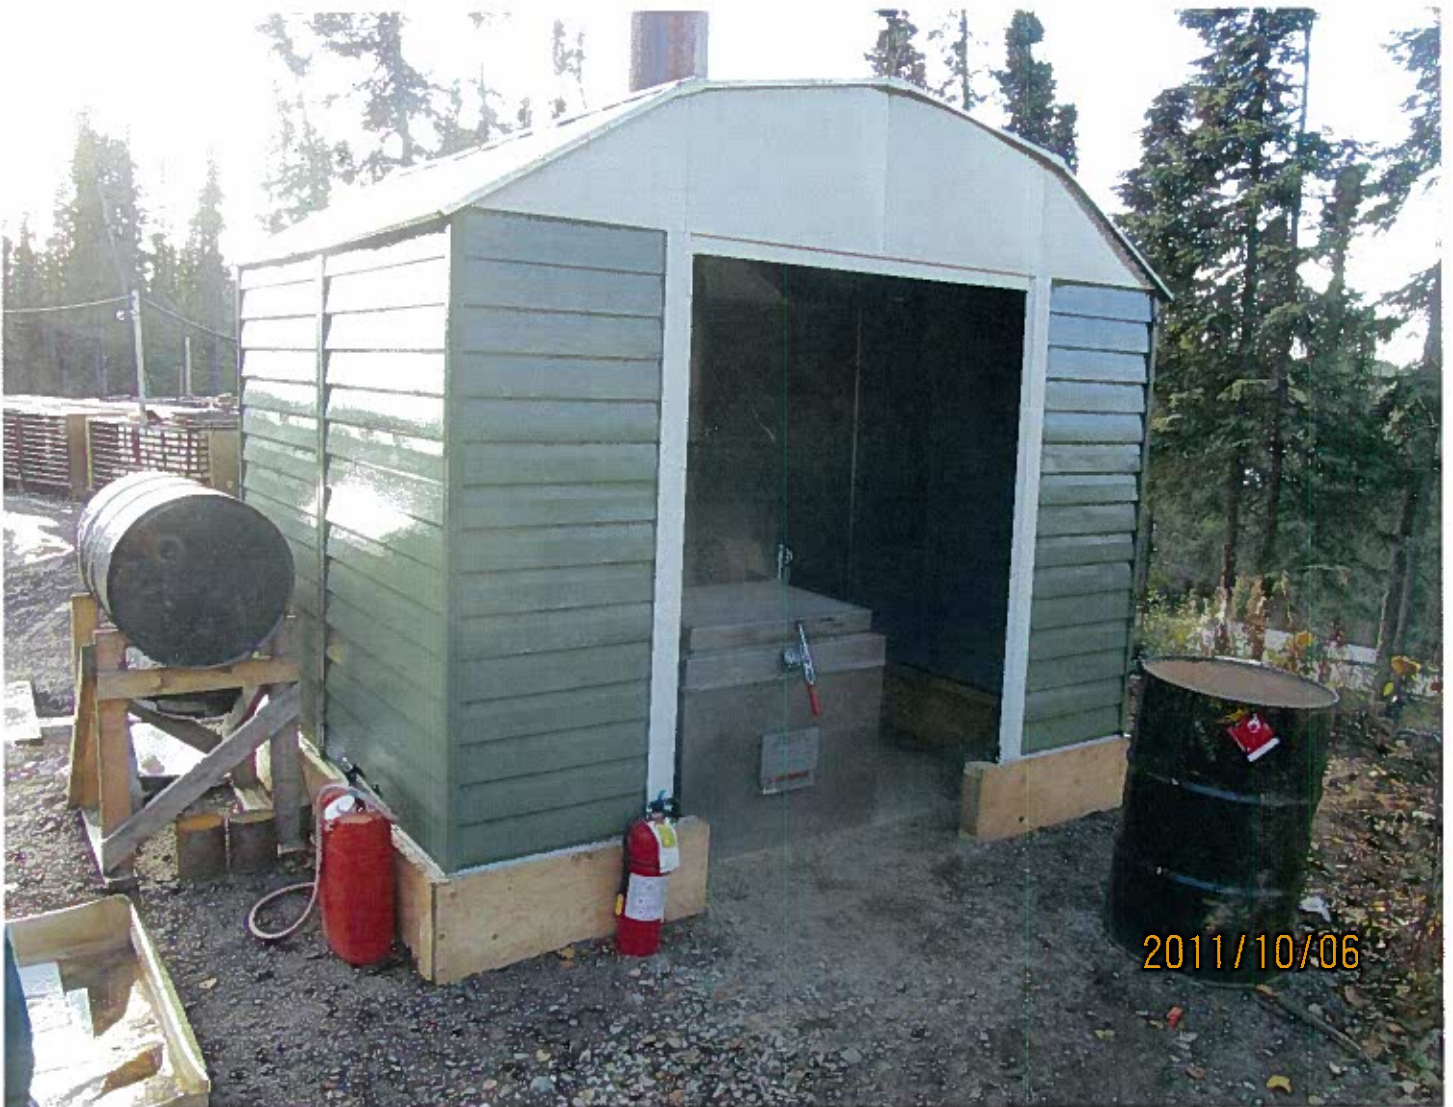
The camp continues to be well managed, and one significant change from the previous inspection is the installation of a new incinerator (Photo #1) for the disposal of combustible garbage. The incinerator installed is an Inciner8 which is equipped with a high temperature secondary burner. In consultation with the Distributor for this unit, the Inspector was informed that it can meet guidelines for the release of dioxins and furans.

Photo #1 - Avalon Rare Metals Inc. - Thor Lake
New incinerator at camp and it has a high temperature secondary burner.

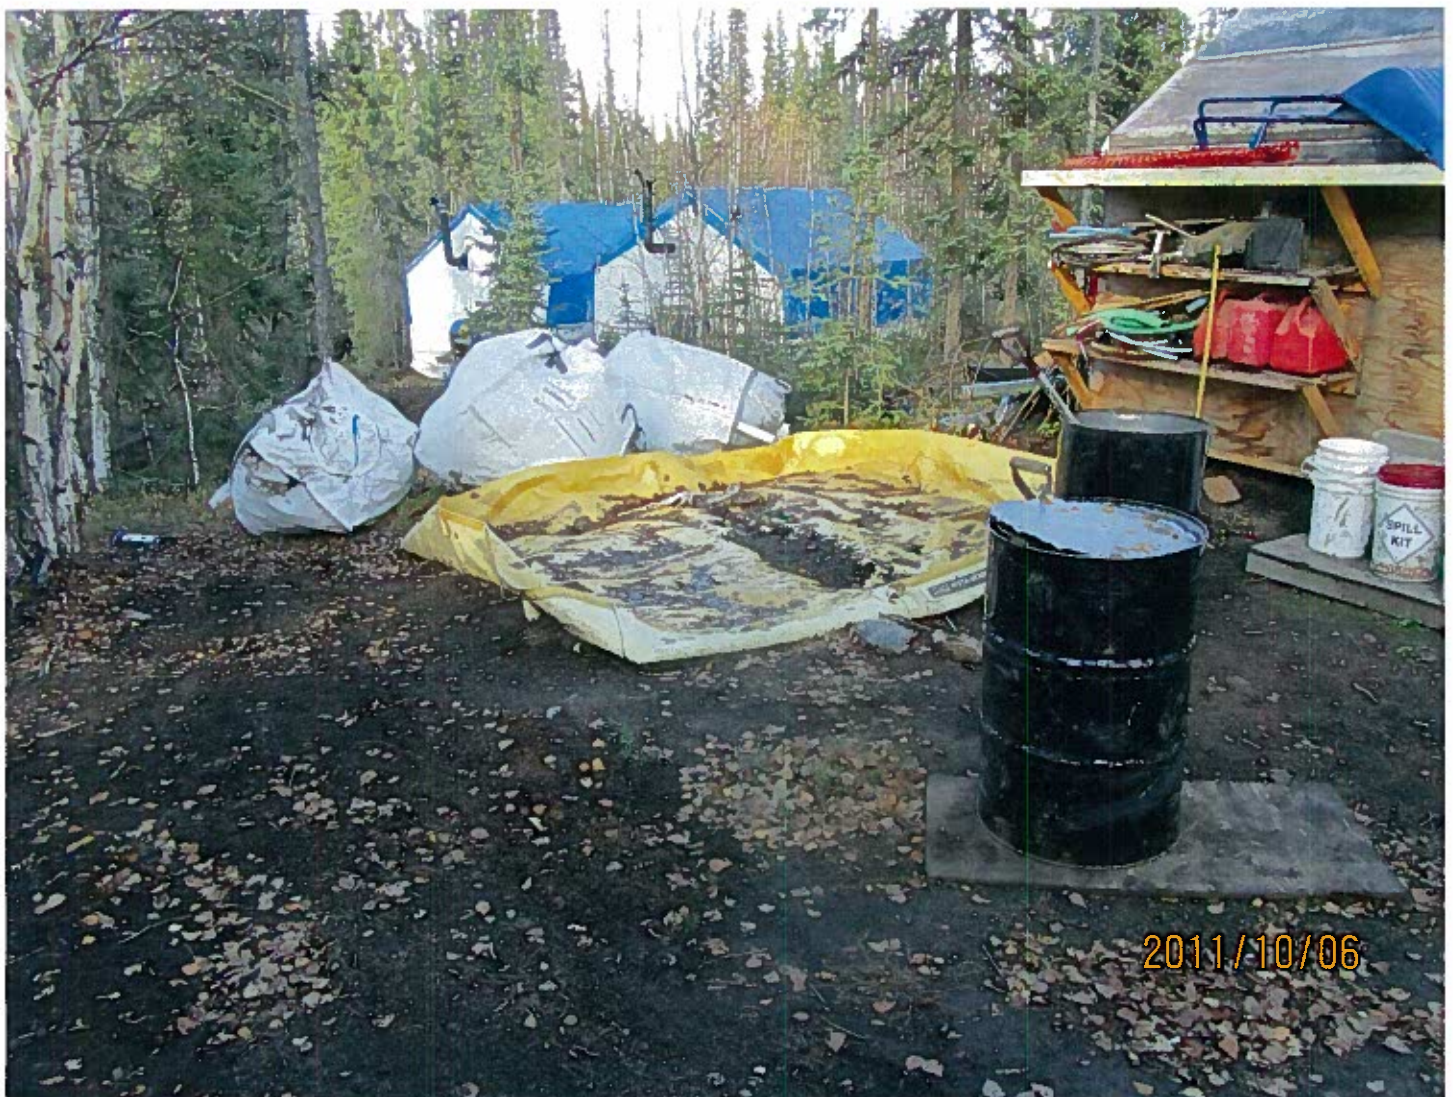
Hydrocarbon impacted soils were being land farmed on site in an instaberm (Photo #2), but with the slow remediation process, the Permittee has now decided to containerize impacted soils and ship them off site for proper disposal. The Inspector has no concerns with this change in impacted soils management, and if land farming is contemplated during future operations, the Permittee must notify the Inspector so that construction of a proper facility can be discussed.

Photo #2 - Avalon Rare Metals Inc. - Thor Lake
Hydrocarbon impacted soils were being land farmed in this instabern. They have since been containerized and shipped off site for disposal.

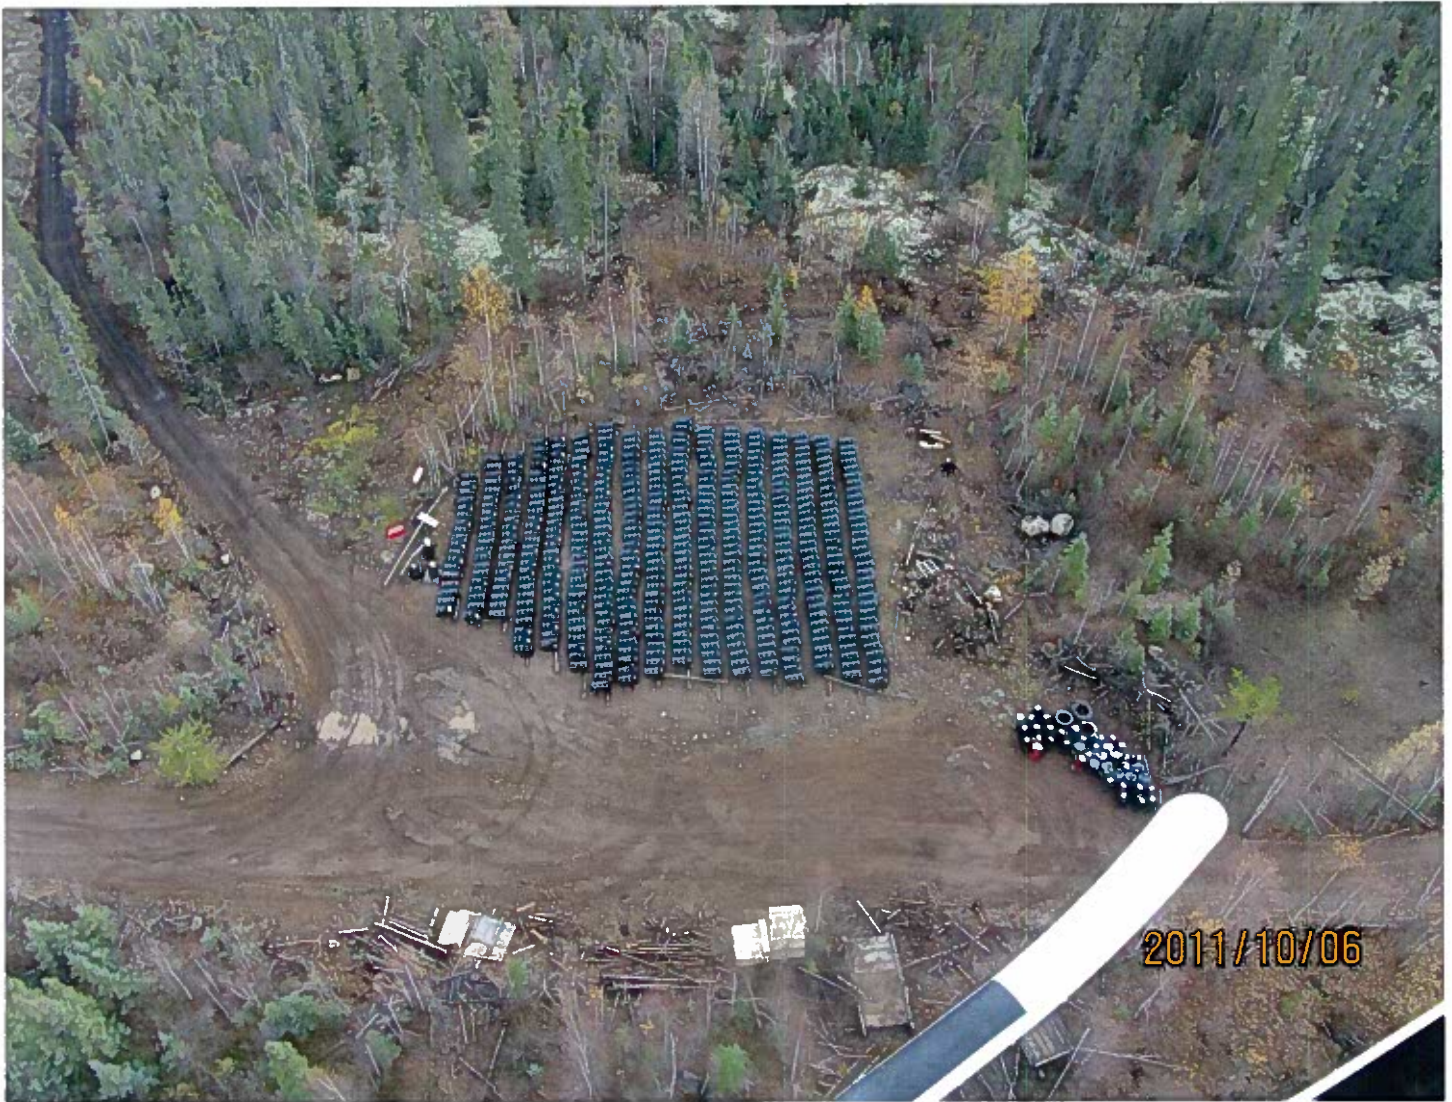
Drummed fuel was recently delivered to the land use area, and fuel caches have been established in strategic locations; near the camp, along the all weather road, and in the area of drilling. As seen in Photo #3 and #4, drums have been positioned in a manner that allows for ease of inspection (walk ways). The Lessee is commended for this diligence, and in discussions with Mr. Randy O'Keefe, the Inspector was informed that routine inspections of the caches is being conducted by the Permittee.

Photo #3 - Avalon Rare Metals Inc. - Thor Lake
One of the fuel caches on site. Inspector was pleased to see walkways and bungs at 3 and 9 o'clock.

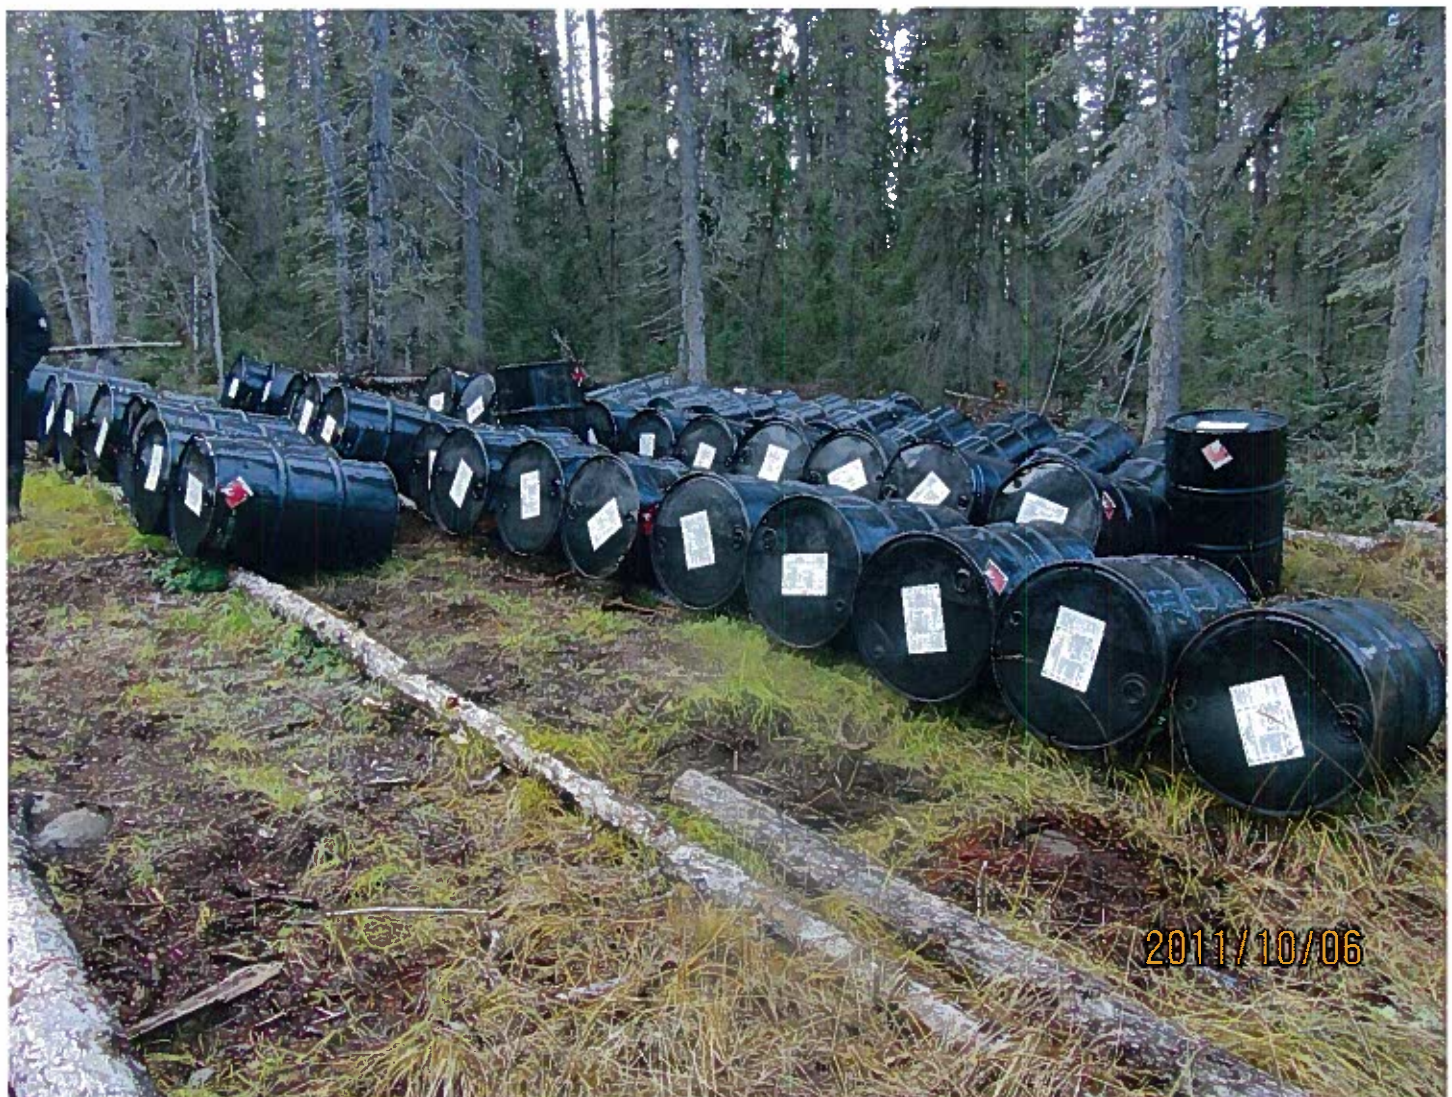
With this diligence, the Permittee has identified (on occasion) faulty bungs or pin hole leaks in a timely manner which has reduced the potential for large volumes of hydrocarbons to escape to the receiving environment. At the fuel cache viewed in Photo #4, the stood up drum at the back of the photo had a leak and although an initial cleanup was immediately conducted, further soil removal to remain compliant with condition #50 must occur as hydrocarbon odors were present in the excavation.

Photo #4 - Avalon Rare Metals Inc. - Thor Lake
Another fuel cache in the area of drilling. The ground in front of the stood up drum to the left has impacted soils that require cleanup.

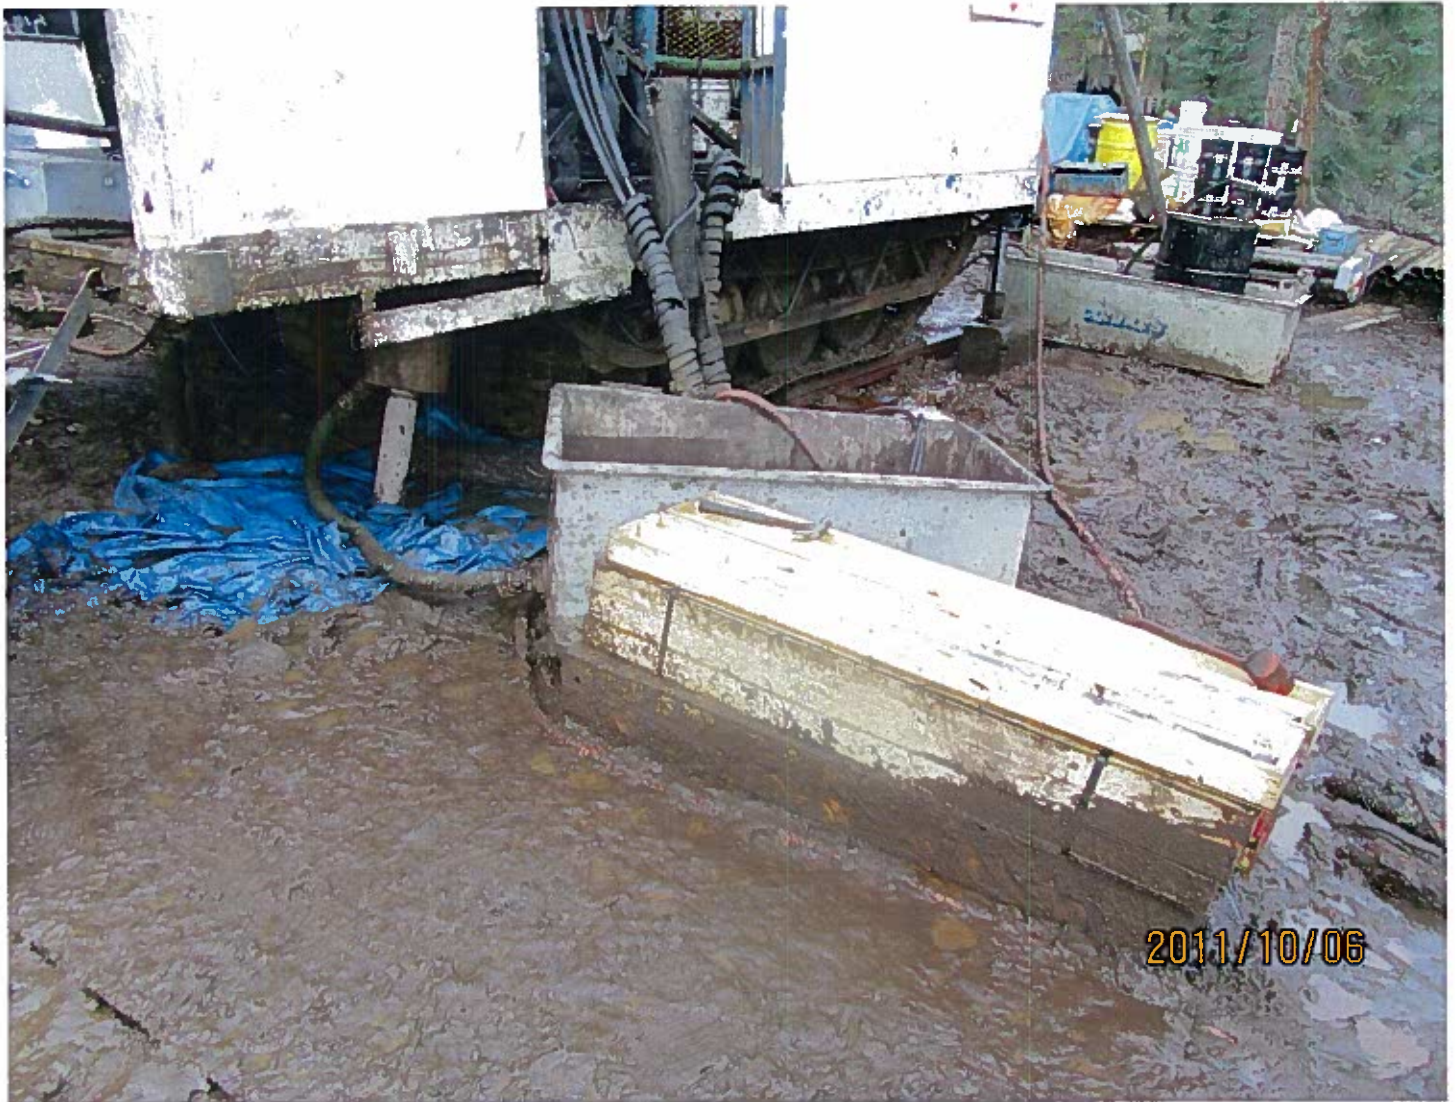
Overall, the Inspector was pleased with the active drills as a casing t-box (photo #5) is being used to direct return water/cuttings away from the drill sites to keep the drill working in the "Dry", secondary containment and absorbent pads are present below all equipment, and cuttings are being directed into a natural depression well away from the nearest watercourse.

Photo #5 - Avalon Rare Metals Inc. - Thor Lake
Tub at the buggy drill for the collection of drill water and cuttings to assist with proper water management.

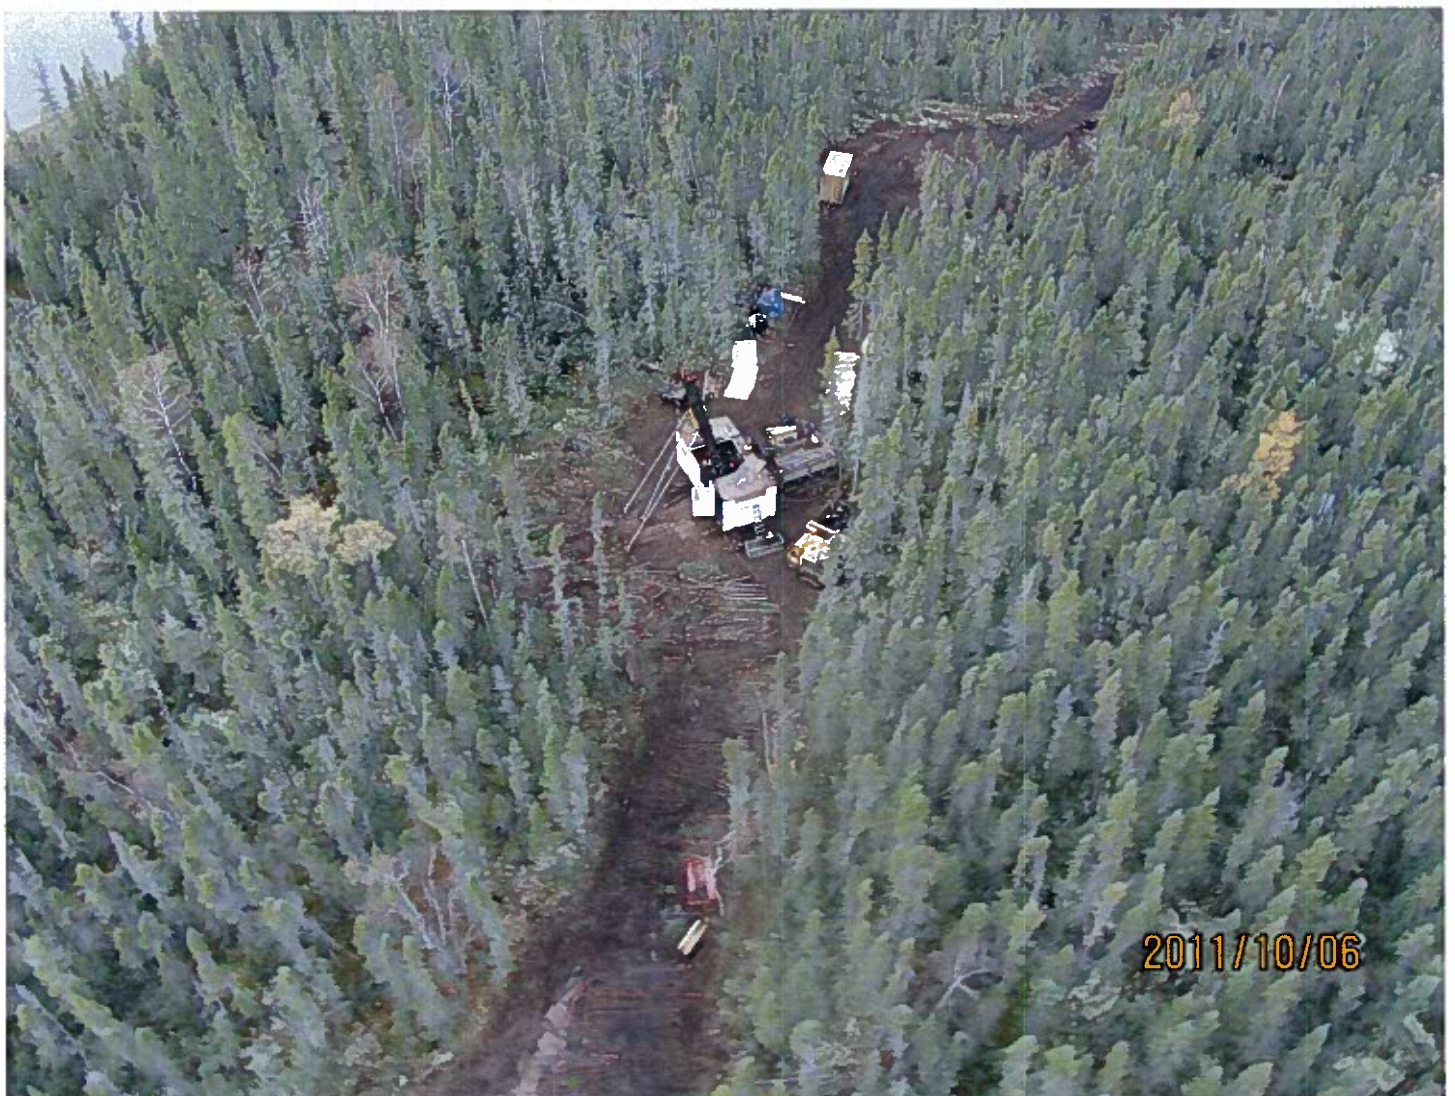
Photo #6 - Avalon Rare Metals Inc. - Thor Lake
Aerial view of the skid drill. No concerns were noted with water management or the corduroying of trails.

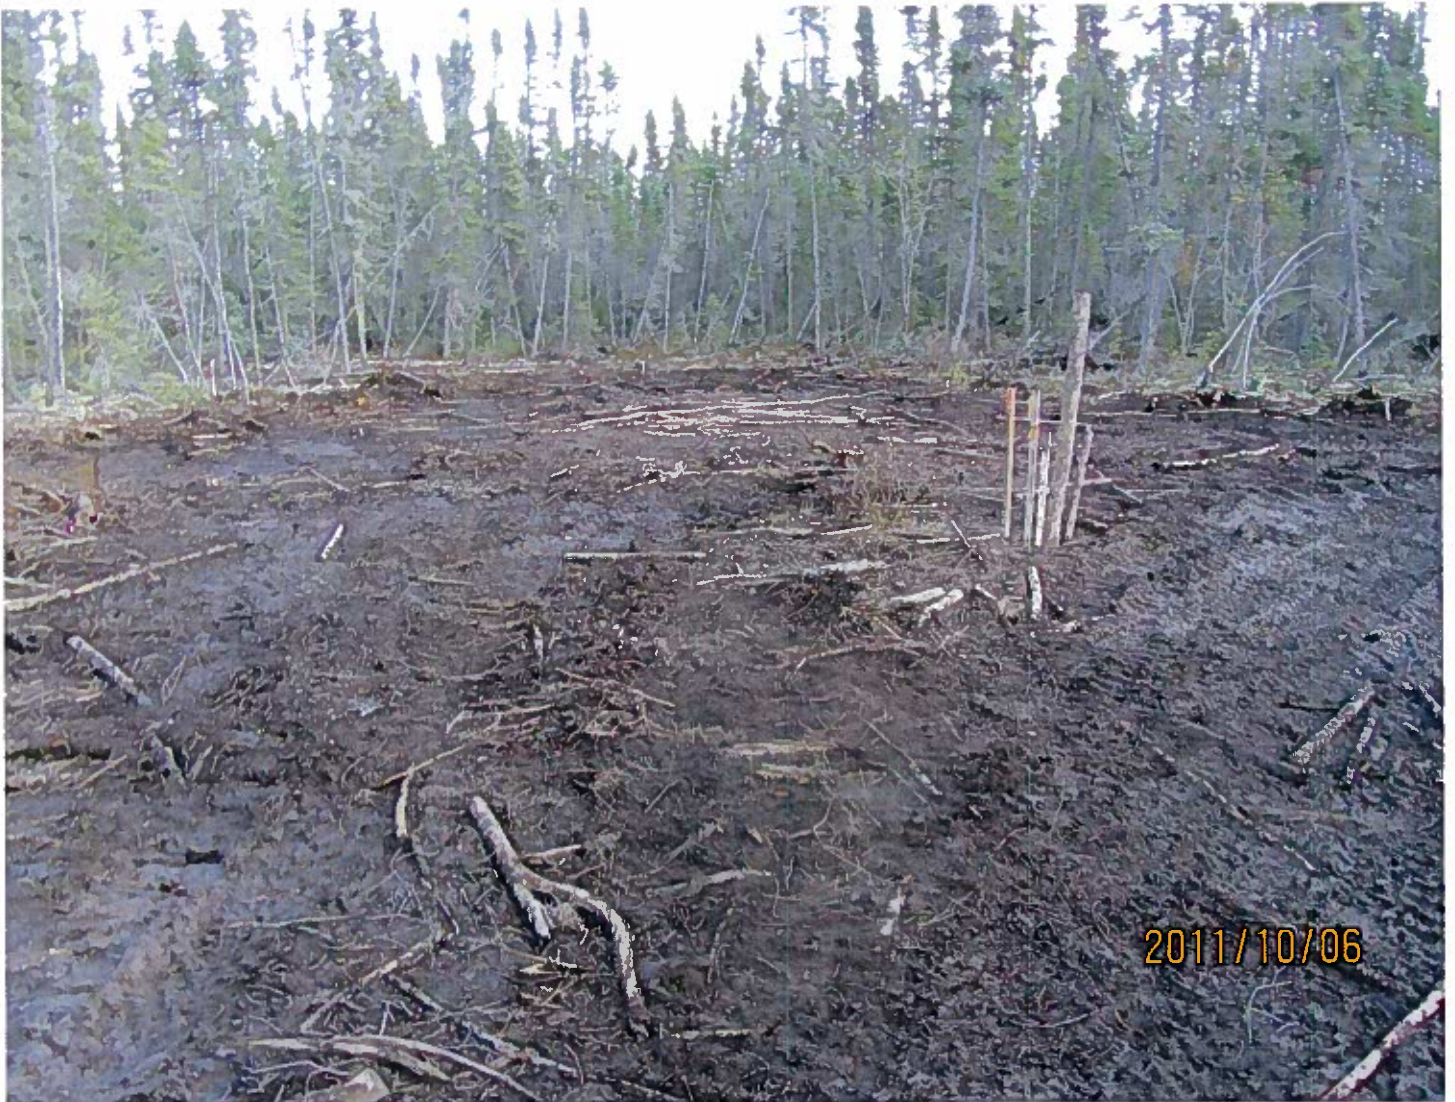
Photo #7 - Avalon Rare Metals Inc. - Thor Lake
Example of a completed drill site that had no concerns noted.

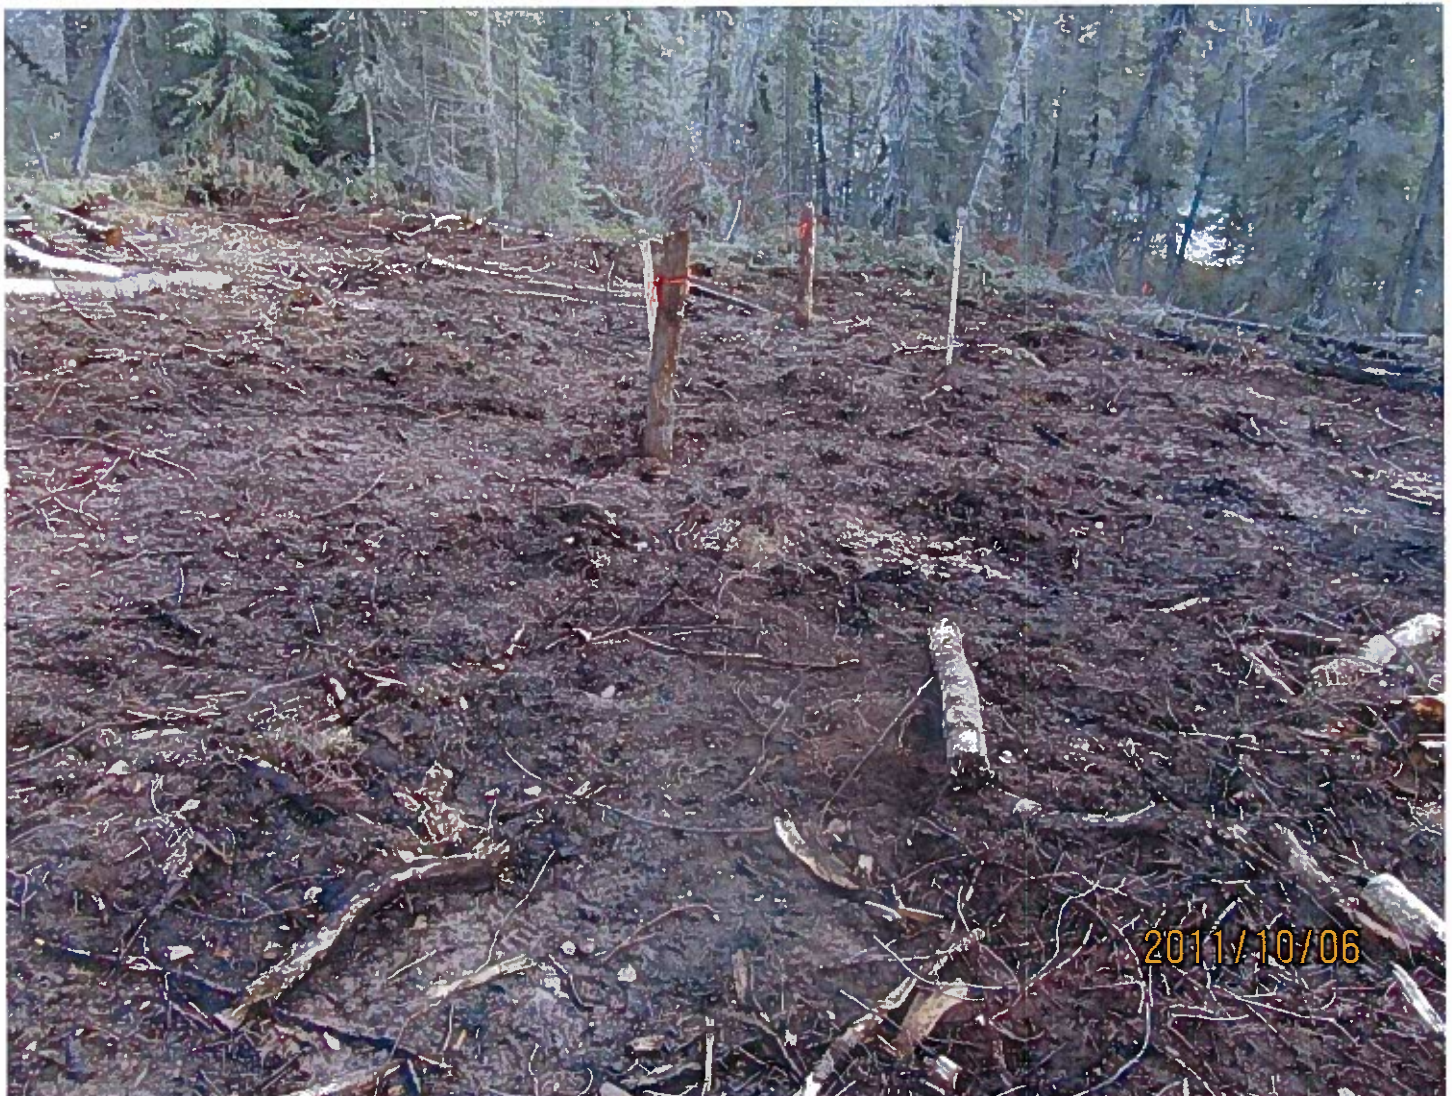
All of the completed drill sites from the summer program were inspected, and photo #7 depicts a typical completed site. Drill mud, rod grease, hydrocarbons, brush disposal, and debris cleanup was satisfactory at the majority of the sites. The only work remaining at one of the completed sites was the need to cut the casing flush with the ground surface to remain compliant with condition #13 of the land use permit (Photo #8).

Photo #8 - Avalon Rare Metals Inc. - Thor Lake
Completed drill site and the stick with flagging at the back of the photo has casing present that must be cut flush with the ground surface.
