**Re: Land Use Permit MV2007C0039
 Mineral Exploration
 Thor Lake, NT**

ENVIRONMENTAL INSPECTION REPORT

Permittee:	Avalon Rare Metals Inc.	Inspection Date – October 7 th , 2010
------------	-------------------------	--

Location(s) Inspected:	Camp, access trails and diamond drill program.
------------------------	--

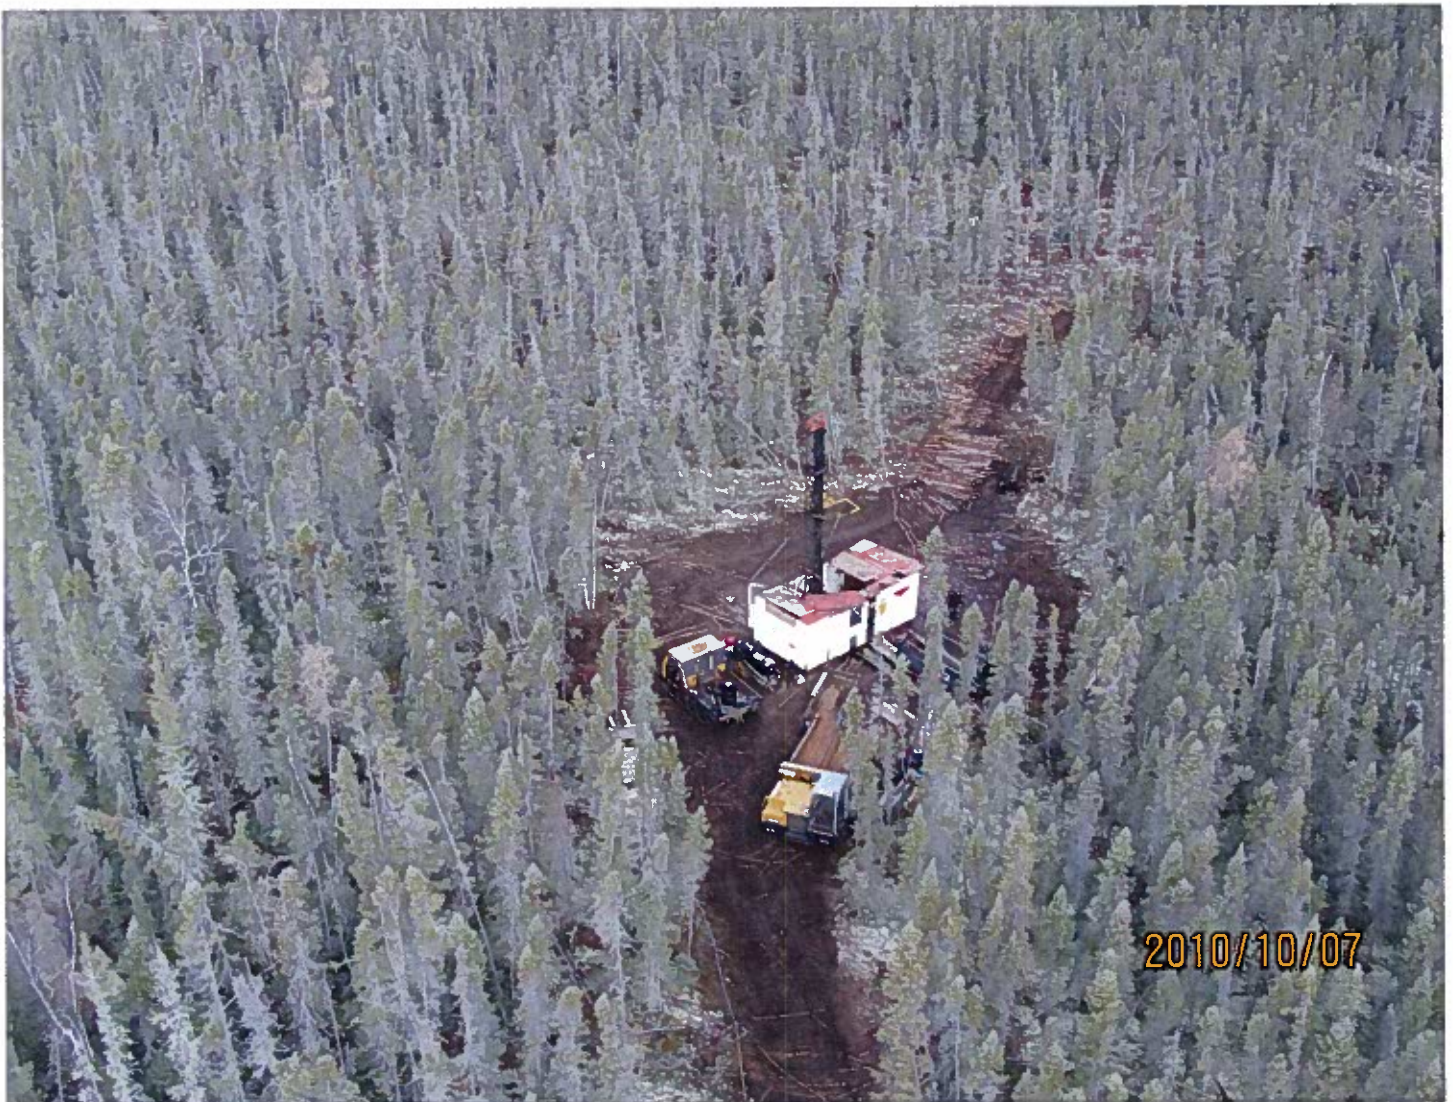
Photo #1 - Aerial view of the skid mounted diamond drill and other permitted equipment being used during this operation.

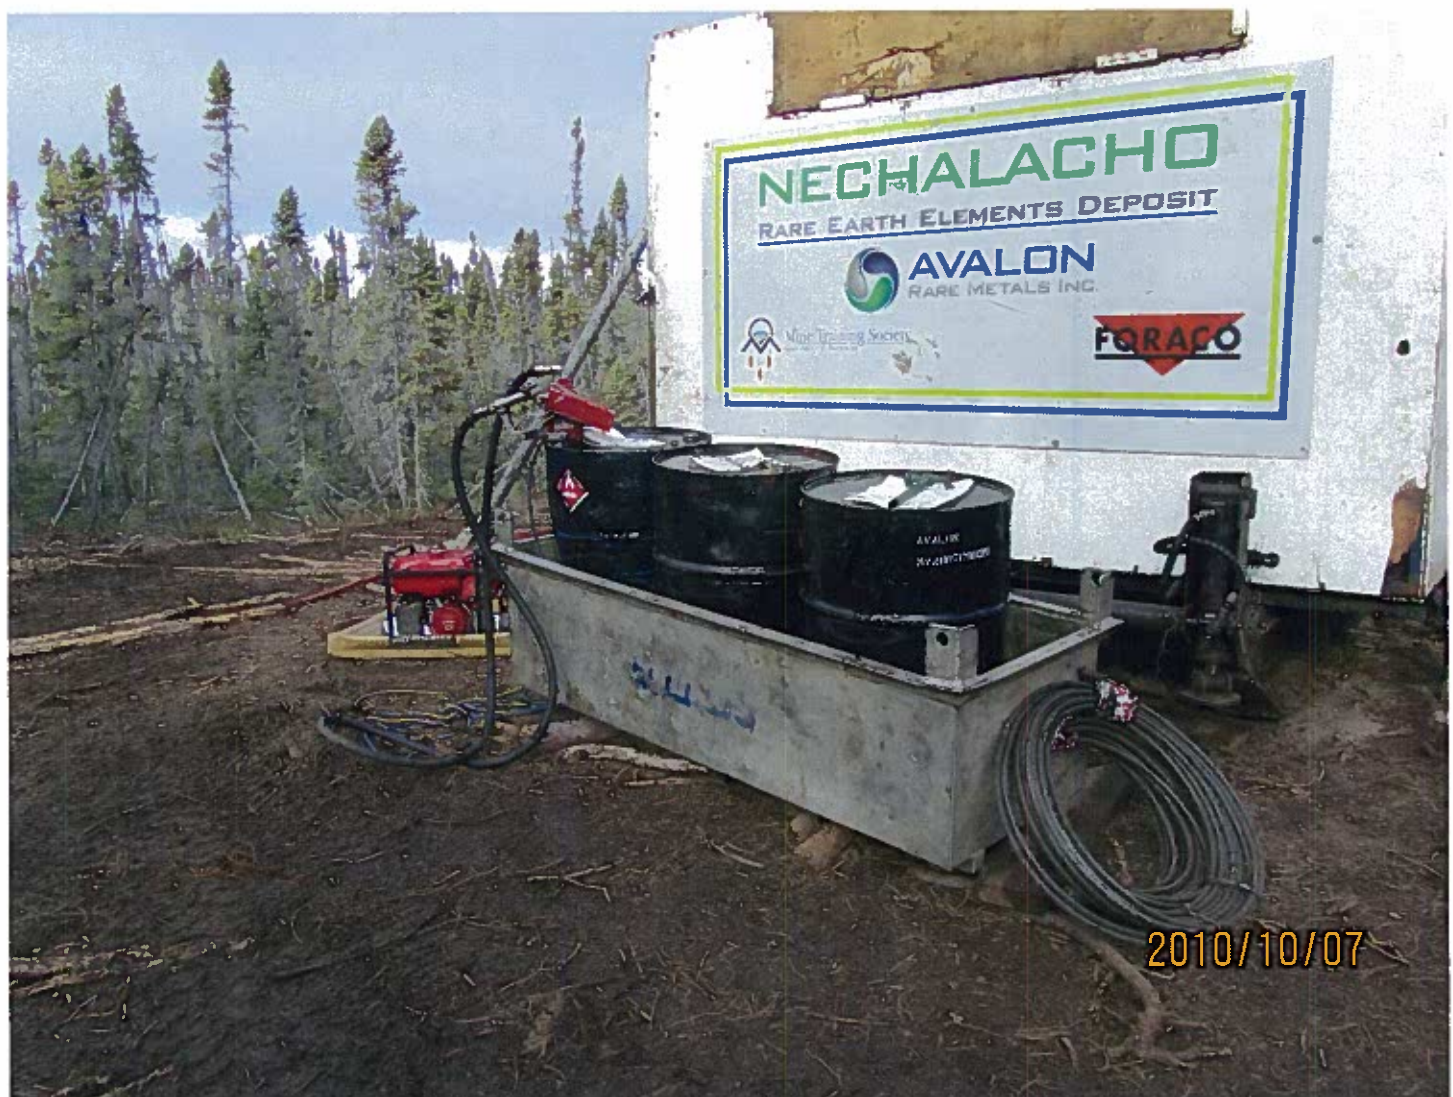
Two Foraco drills were active at the time of the inspection and both appeared to be operating cleanly. The Inspector is pleased to report that adequate secondary containment has been implemented under all fuel containers, pumps and power packs of the drills. Secondary containment structures can be viewed in Photos #2, #4, #5 and #7.

Photo #2 - Adequate secondary containment has been implemented on active drums at the skid mounted drill.

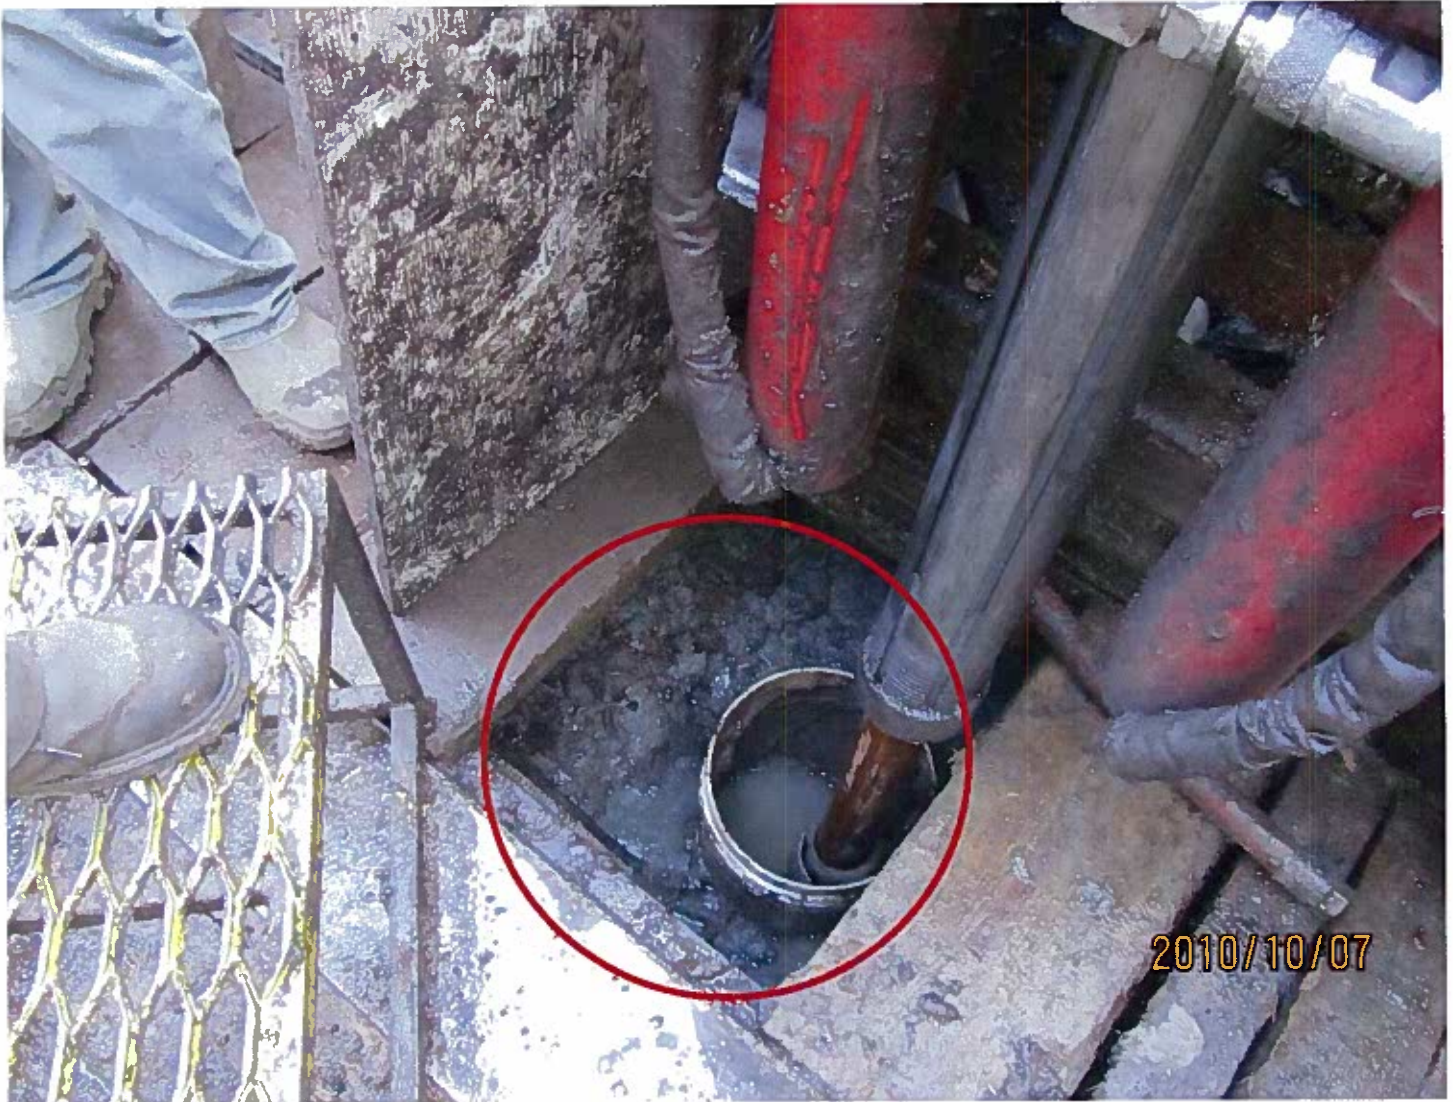
Cuttings and water management at the drills is of utmost importance due to ground conditions (permafrost) and the Inspector is pleased to report that at all completed and active drill sites, Foraco personnel appear to have managed this aspect of the drill program quite well. Returns are being collected in a sump (Photo #3 and #6) and pumped well away from the drill pad to allow for dispersal in the adjacent forest.

Photo #3 - A sump has been excavated below the casing at the skid mounted drill to collect drill cuttings and water to allow for proper disposal away from the drill pad.

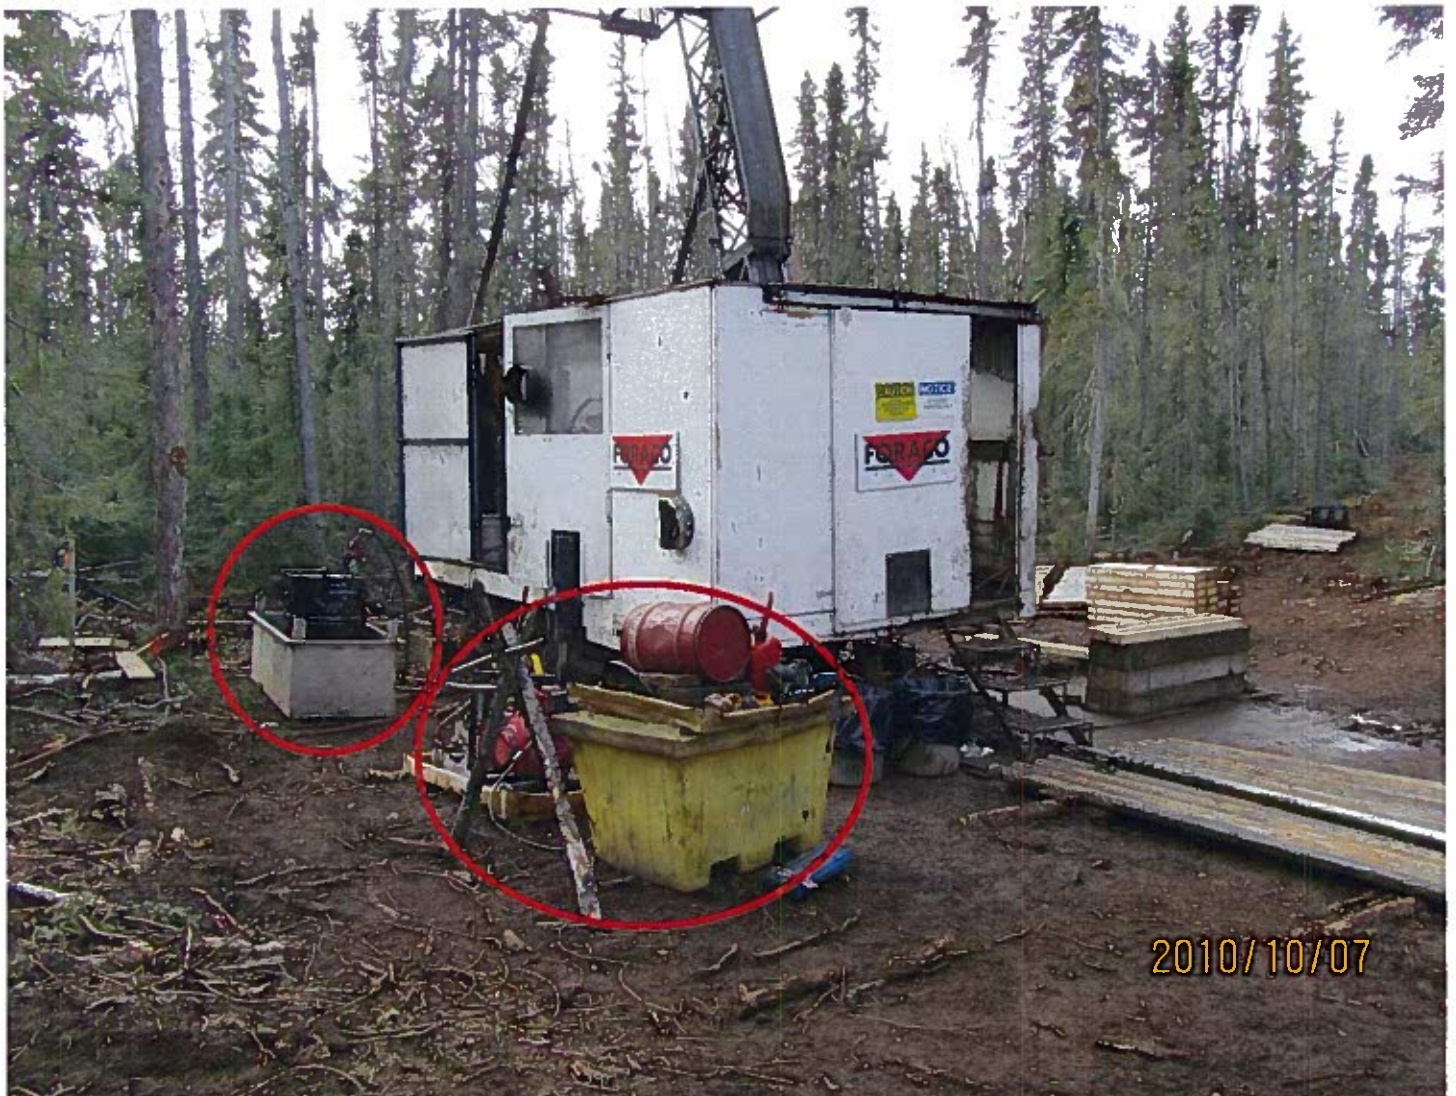
Photo #4 - Overview of the buggy drill setup. Adequate secondary containment has been implemented on all active fuel containers and the water pump at this drill site (circled).

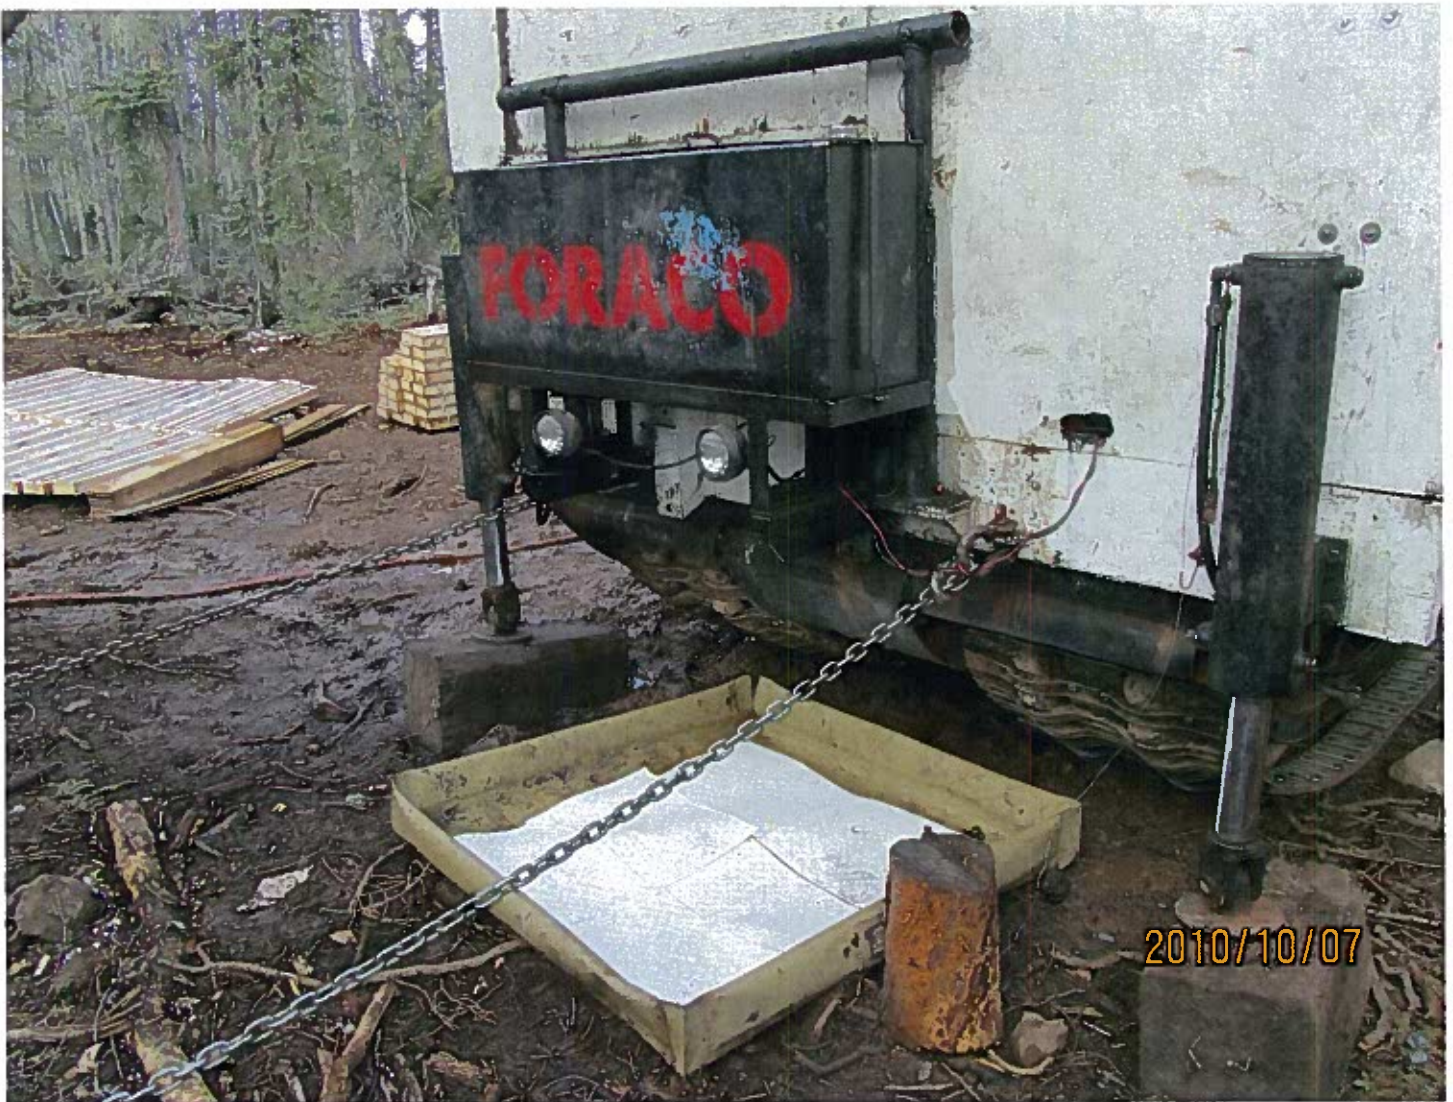
Photo #5 - Leaks/weepers from the fuel tank on the buggy drill has been a concern during previous inspections and the Inspector is pleased to report there were no concerns with it during this inspection and adequate secondary containment has been implemented.

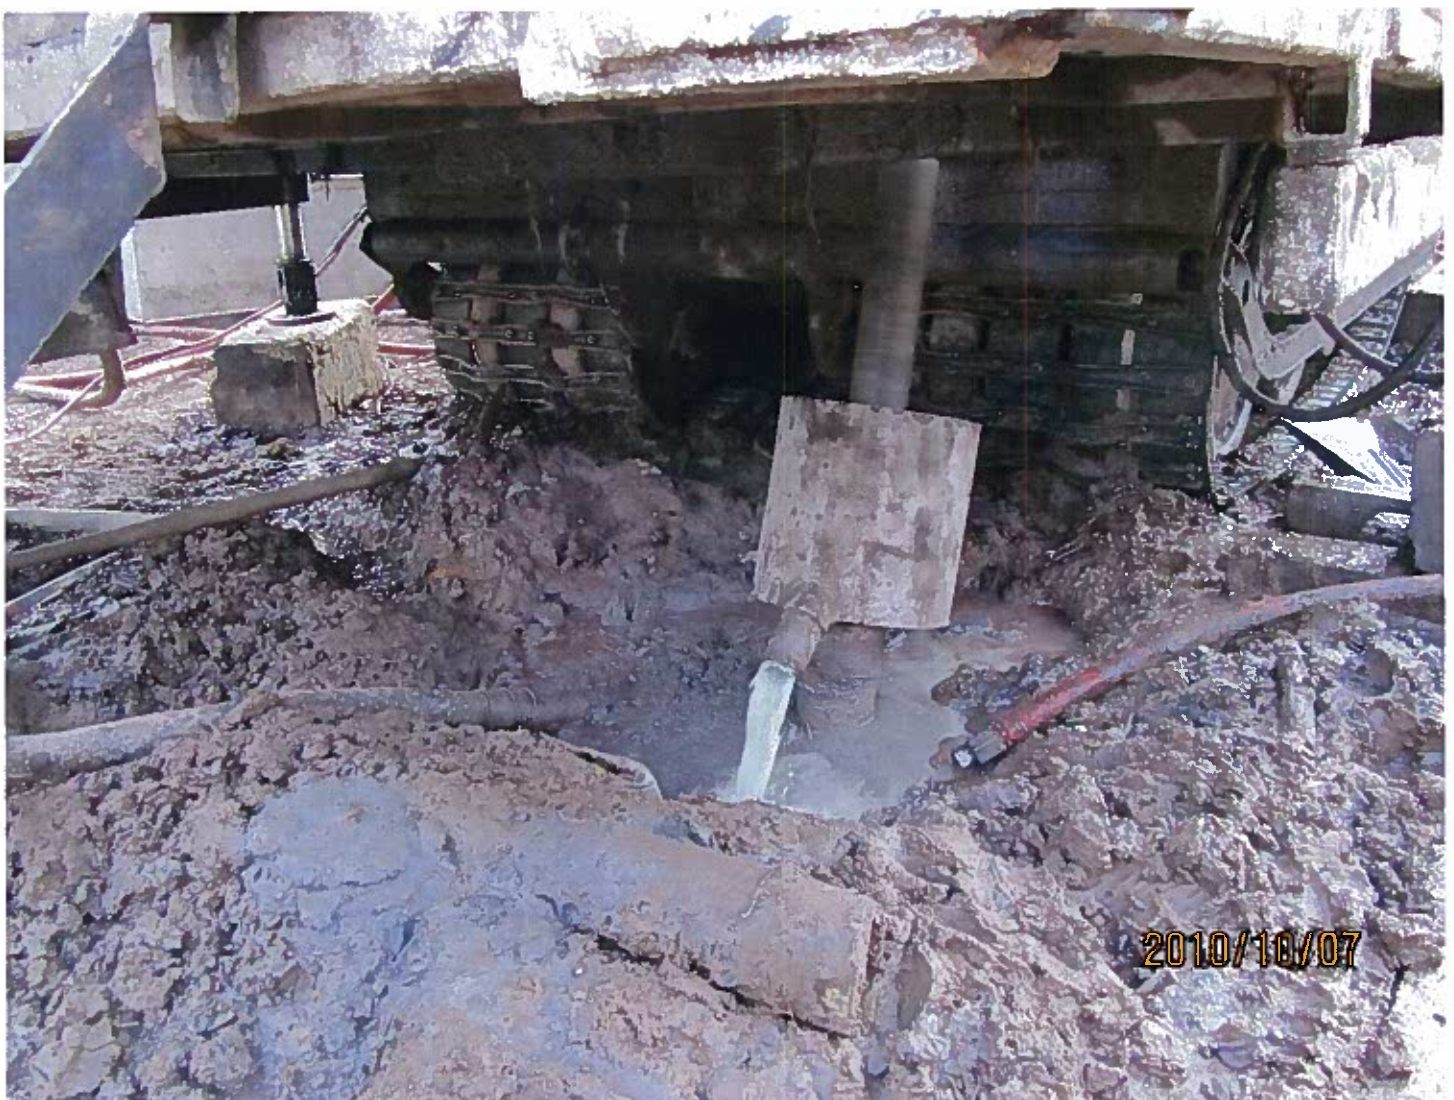
Photo #6 - Sump to collect drill water and cuttings has been excavated below the casing on the buggy drill. Proper disposal is occurring at this drill.

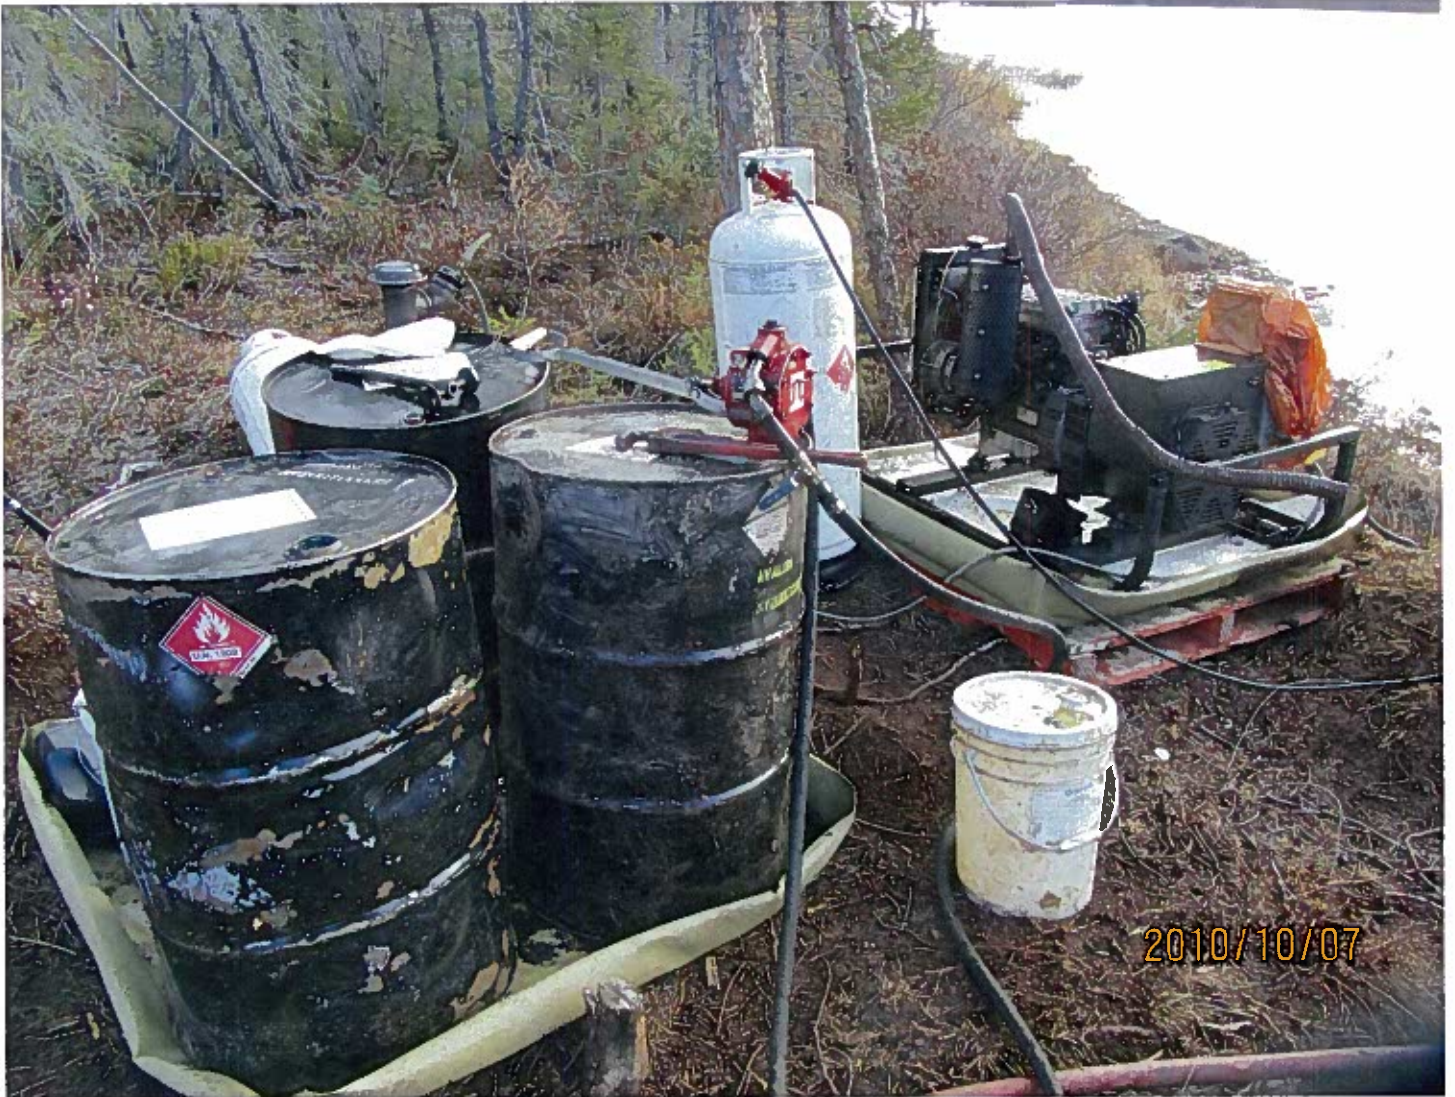
One potential concern noted that the Permittee must stay on top of is the maintenance of the secondary containment structure below the water pump (Photo #7). A leak from the fuel filter was observed and the hydrocarbon absorbent mat was saturated and in need of replacement. There was also some water noted in this containment structure, and to prevent overtopping, water must be mopped of hydrocarbons and removed.

Photo #7 - Water pump and associated fuel by the shoreline of Long Lake. Secondary containment below the fuel drums and water pump was satisfactory, but the Permittee must ensure that they are maintained to prevent them from filling up with water and over topping.

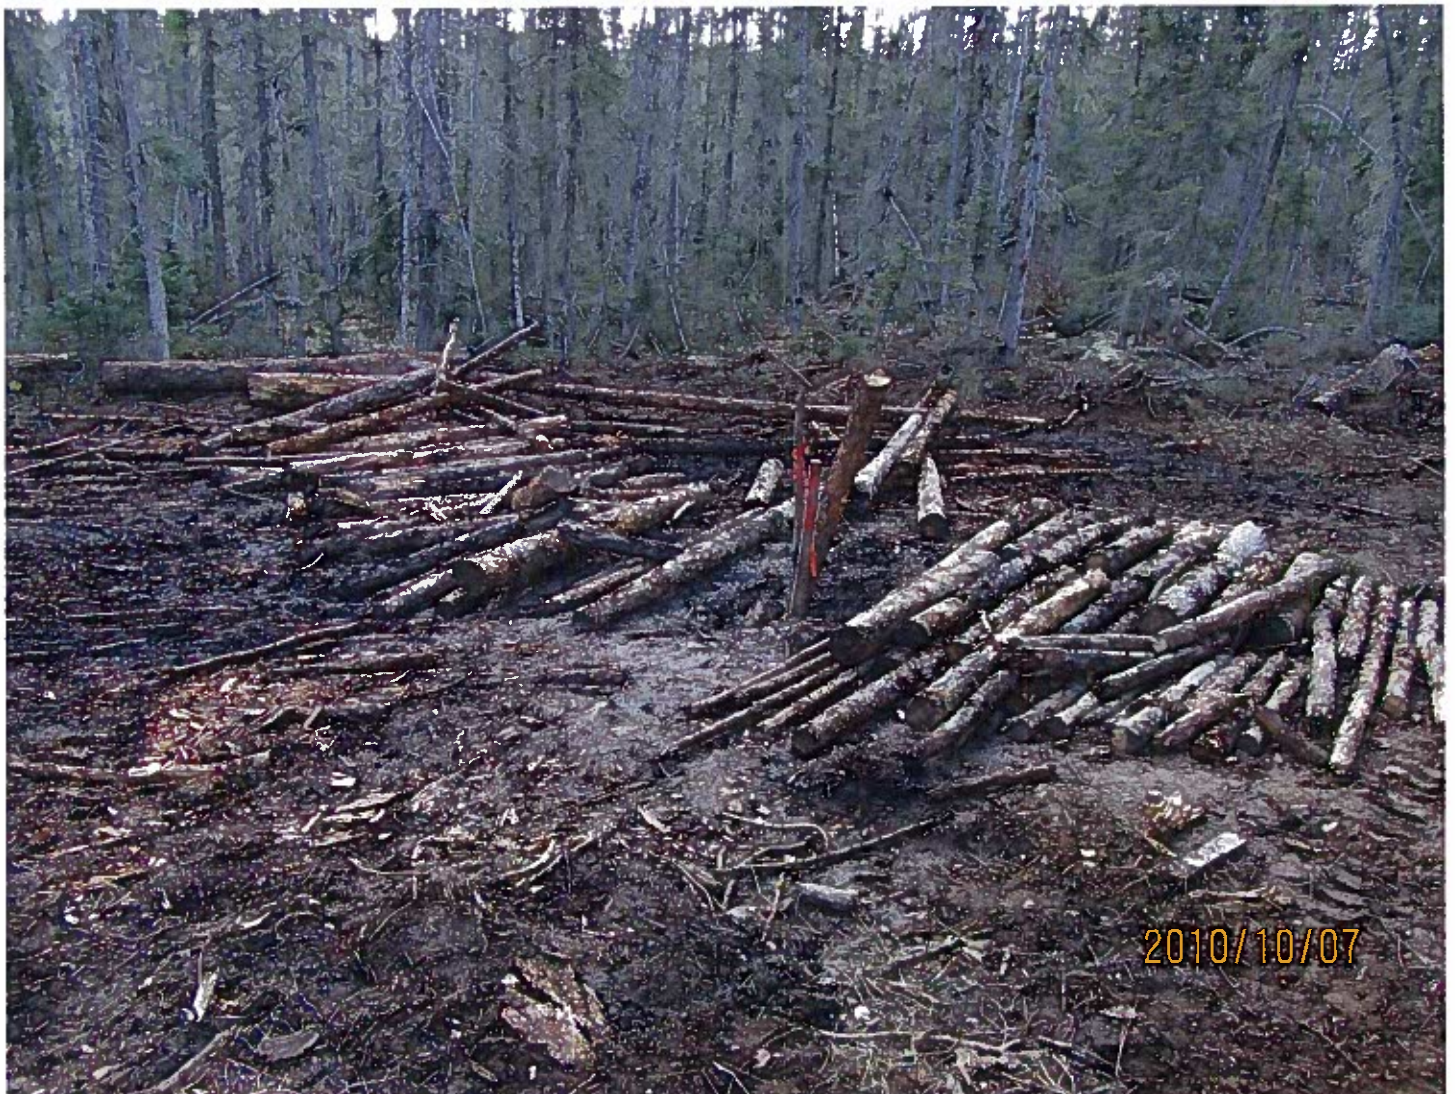
Photo #8 - Buggy drill just pulled off this target and tree disposal appeared to be the only restoration work required at this site.

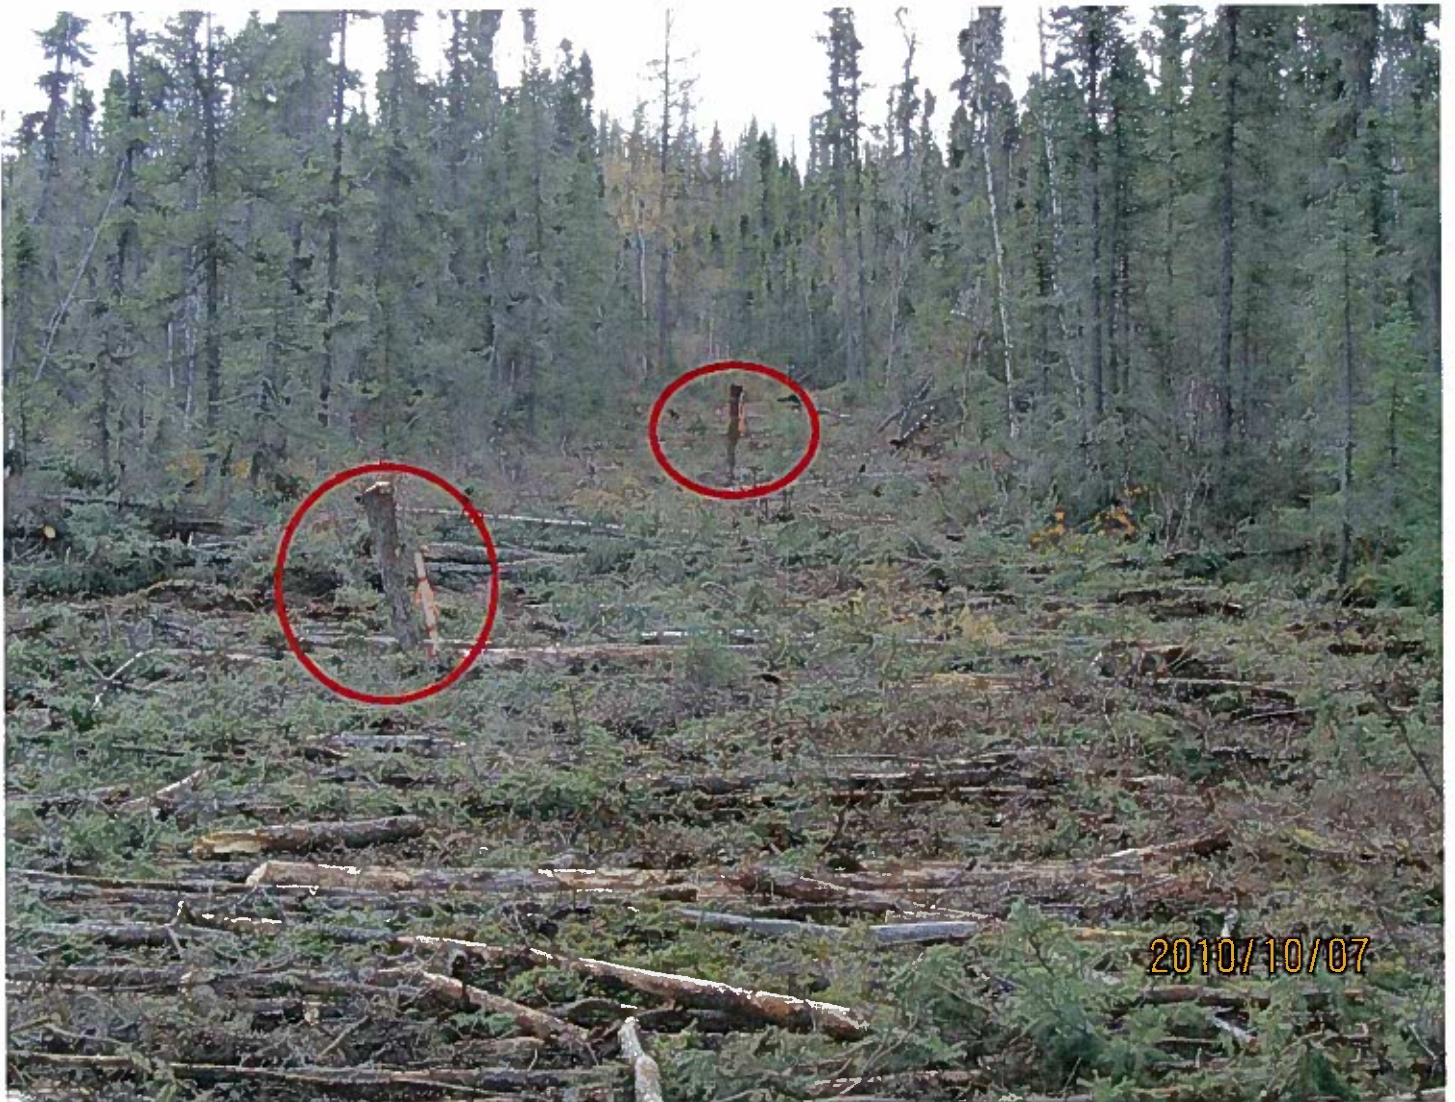
All of the completed drill sites from the summer program were inspected and the Inspector was impressed with the Permittee's diligence to ensure a thorough cleanup of all sites was conducted. No rod grease, fuel spills or drill muds were noted at any of the sites and Photos #9 and #10 are examples of a few sites where adherence to the operating conditions annexed to the permit have been maintained.

During the previous inspection, trail width was noted as a concern and the Permittee was instructed by the Inspector to keep the trail width to a minimum to remain compliant with condition #10 of the permit. As viewed in Photo #9, the width of trails has been reduced to only what is required to safely move the drills and the Inspector appreciates the Permittee's cooperation.

Photo #9 - Two completed drill sites (circled) and access trail are viewed in this photo. The Inspector was pleased with the reduction in clearing that occurred along this access trail, as trail width was a concern noted during the previous inspection.

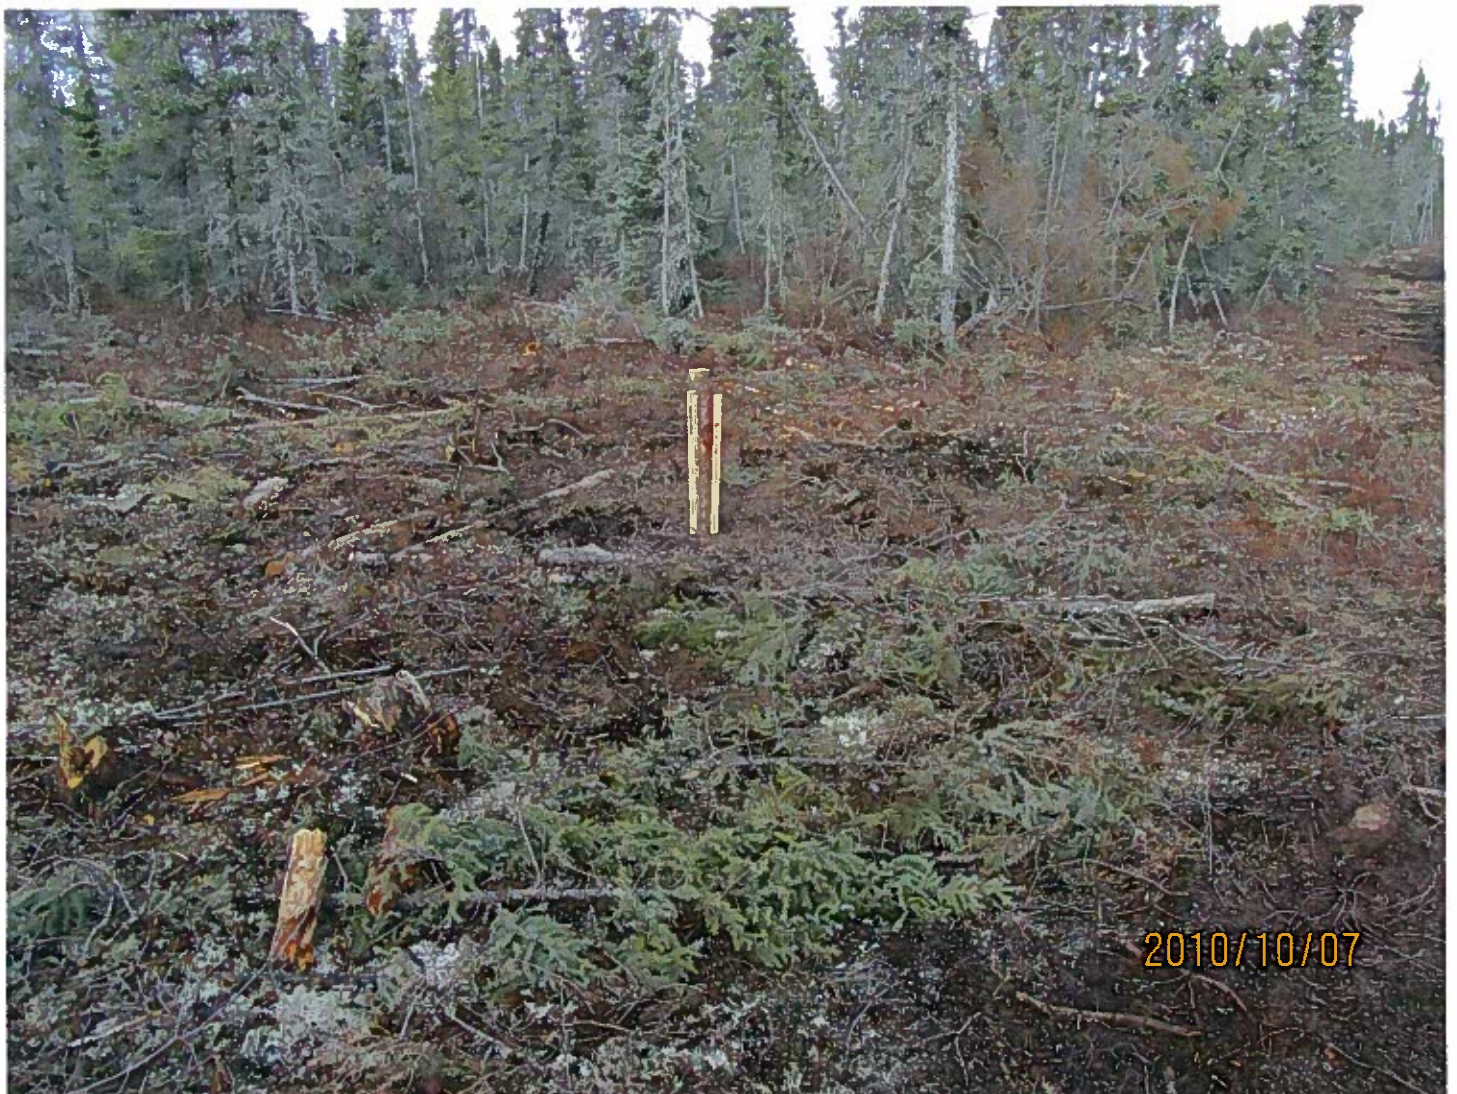
Photo #10 - Completed drill site and the stake in the centre of the photo marks the hole collar. The majority of the completed drill sites were drilled and cleaned up with full adherence to the operating conditions annexed to the land use permit.

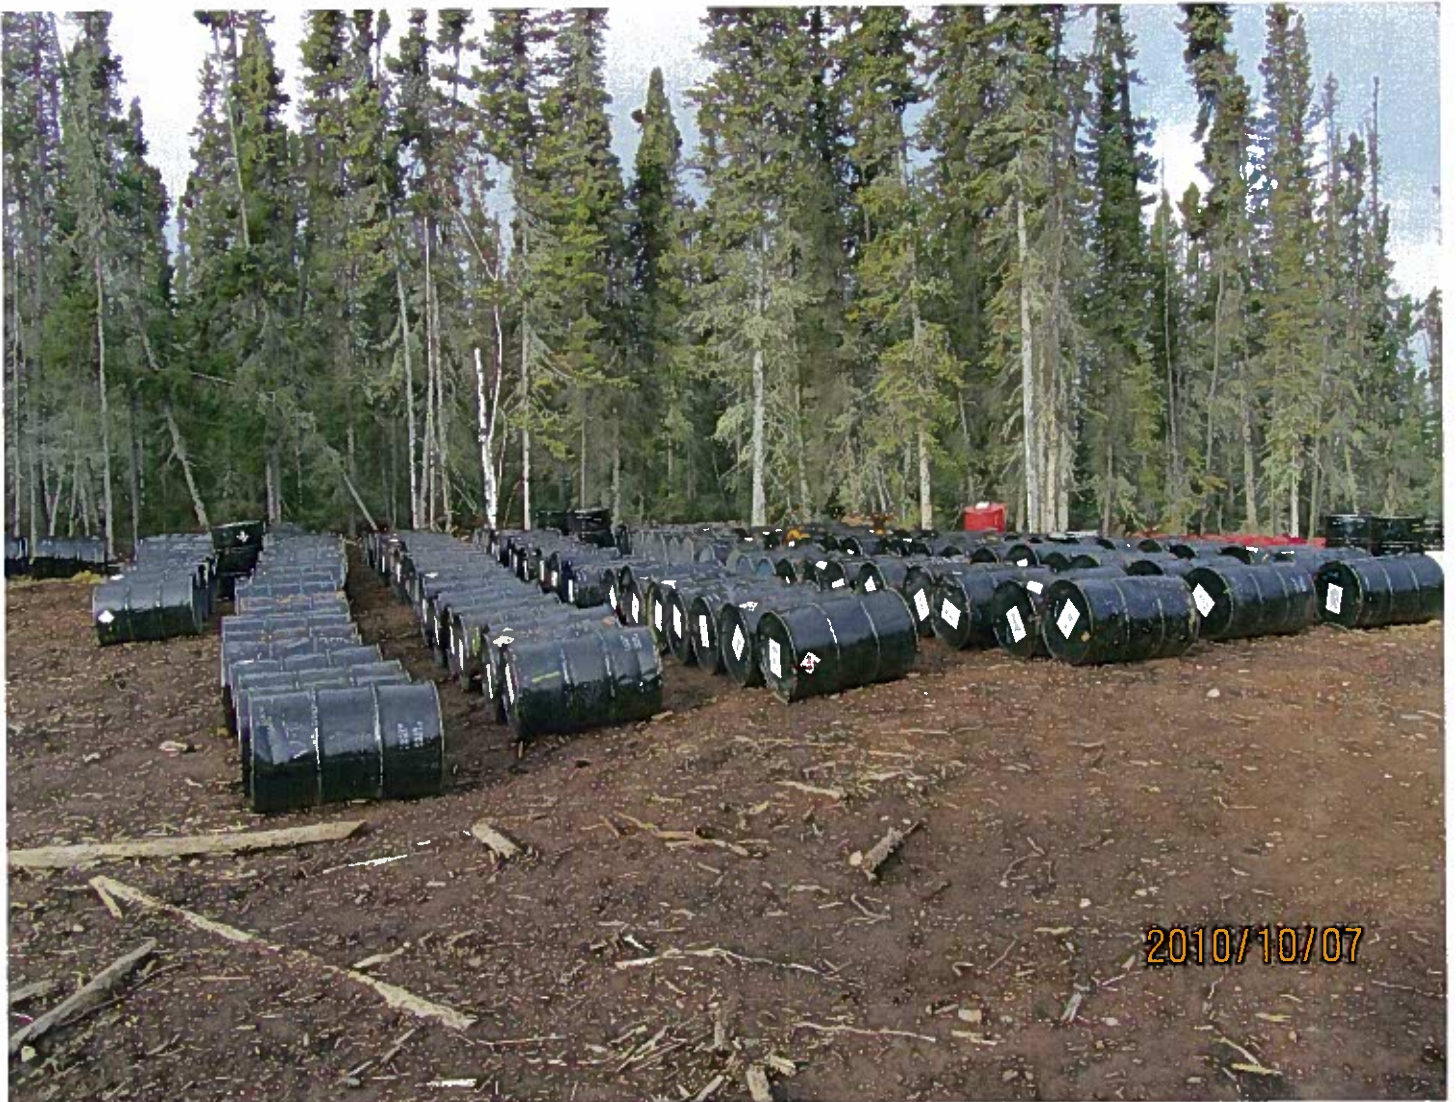
Two fuel caches south of Thor lake were inspected, and as seen in Photo #11 and #12 they have been established in a manner which will reduce the likelihood of a large fuel spill from occurring by maintaining walkways between the rows of drums, and positioning the bungs of the drums at 3 and 9 o'clock. Another good practice implemented by the Permittee at one of the inspected caches (photo #12) is slightly elevating the tops of the drums on logs.

Photo #11 - Fuel cache on the south side of Thor Lake. The Inspector appreciates the Permittee's diligence with maintaining walkways between the drums for ease of inspection, and placing the bungs at 3 and 9 o'clock.

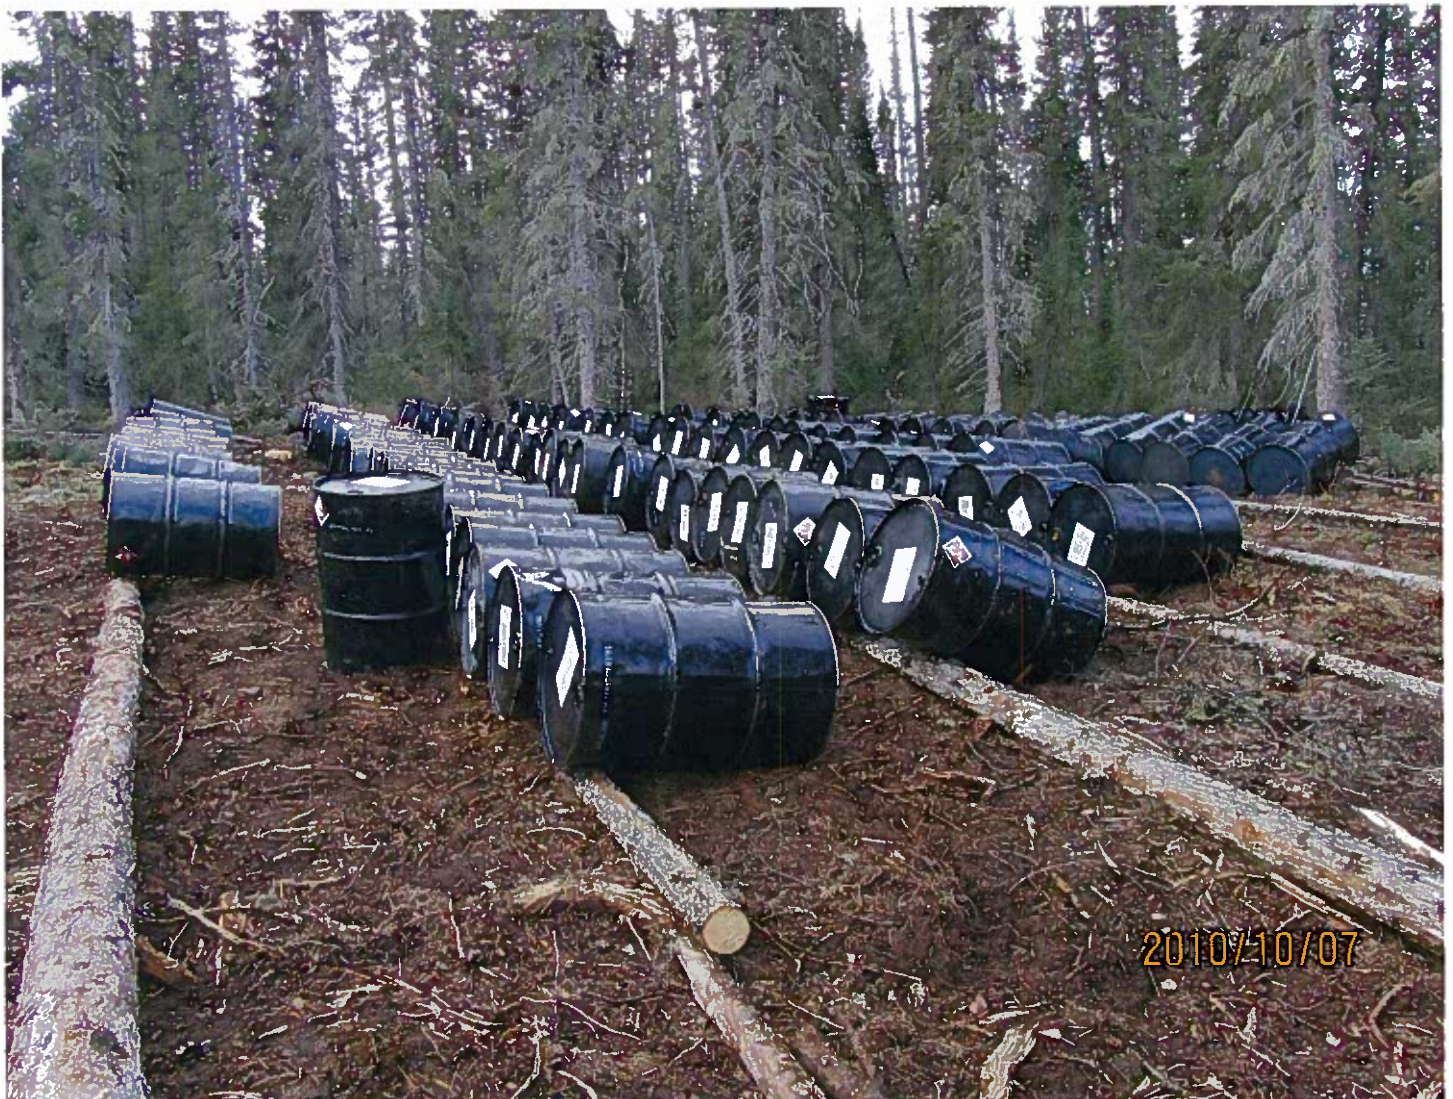
Photo #12 - Another well established fuel cache, and another good practice implemented by the Permittee. Drums have been slightly elevated by placing the top of the drums on logs.
