**Re: Land Use Permit MV2007C0039
Mineral Exploration
Thor Lake, NT**

ENVIRONMENTAL INSPECTION REPORT

Permittee:	Avalon Rare Metals Inc.	Inspection Date – March 17 th , 2011
------------	-------------------------	---

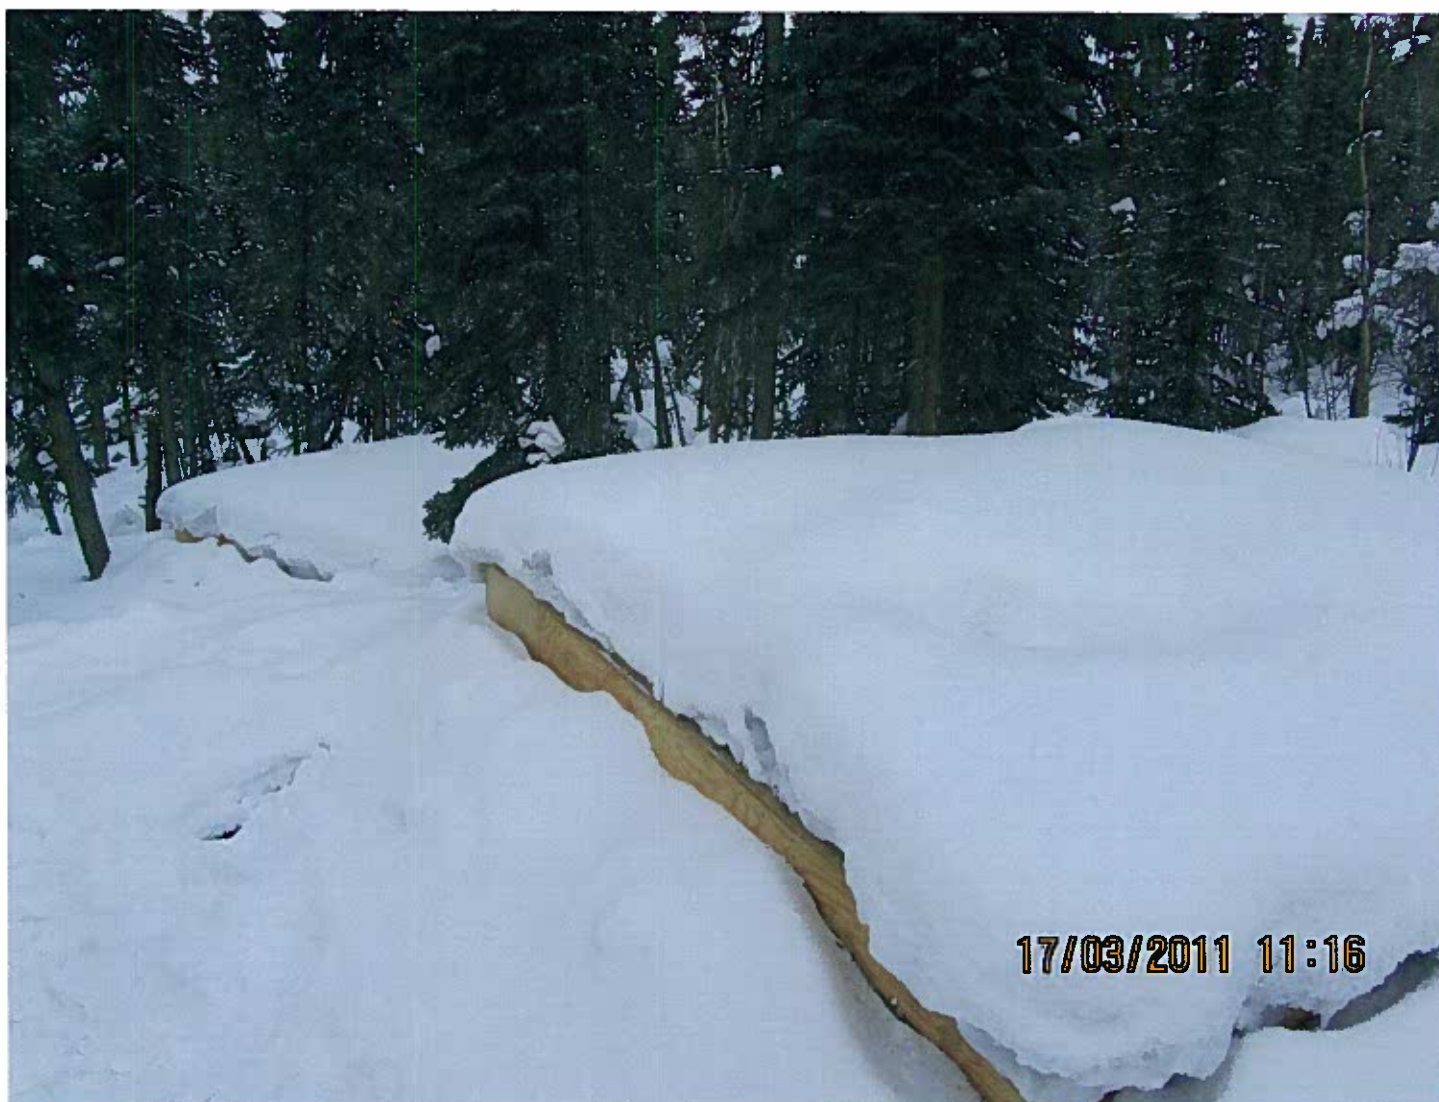
The grey water sump has been modified. The original sump now flows to a secondary sump through PVC piping to allow for ample time to percolate through the surrounding soils. Both the primary and secondary sumps are covered with plywood.

MV2007C0039 - Avalon Rare Metals Inc. - Mineral Exploration - Thor Lake, NT.
Grey water sump has been expanded and covered.

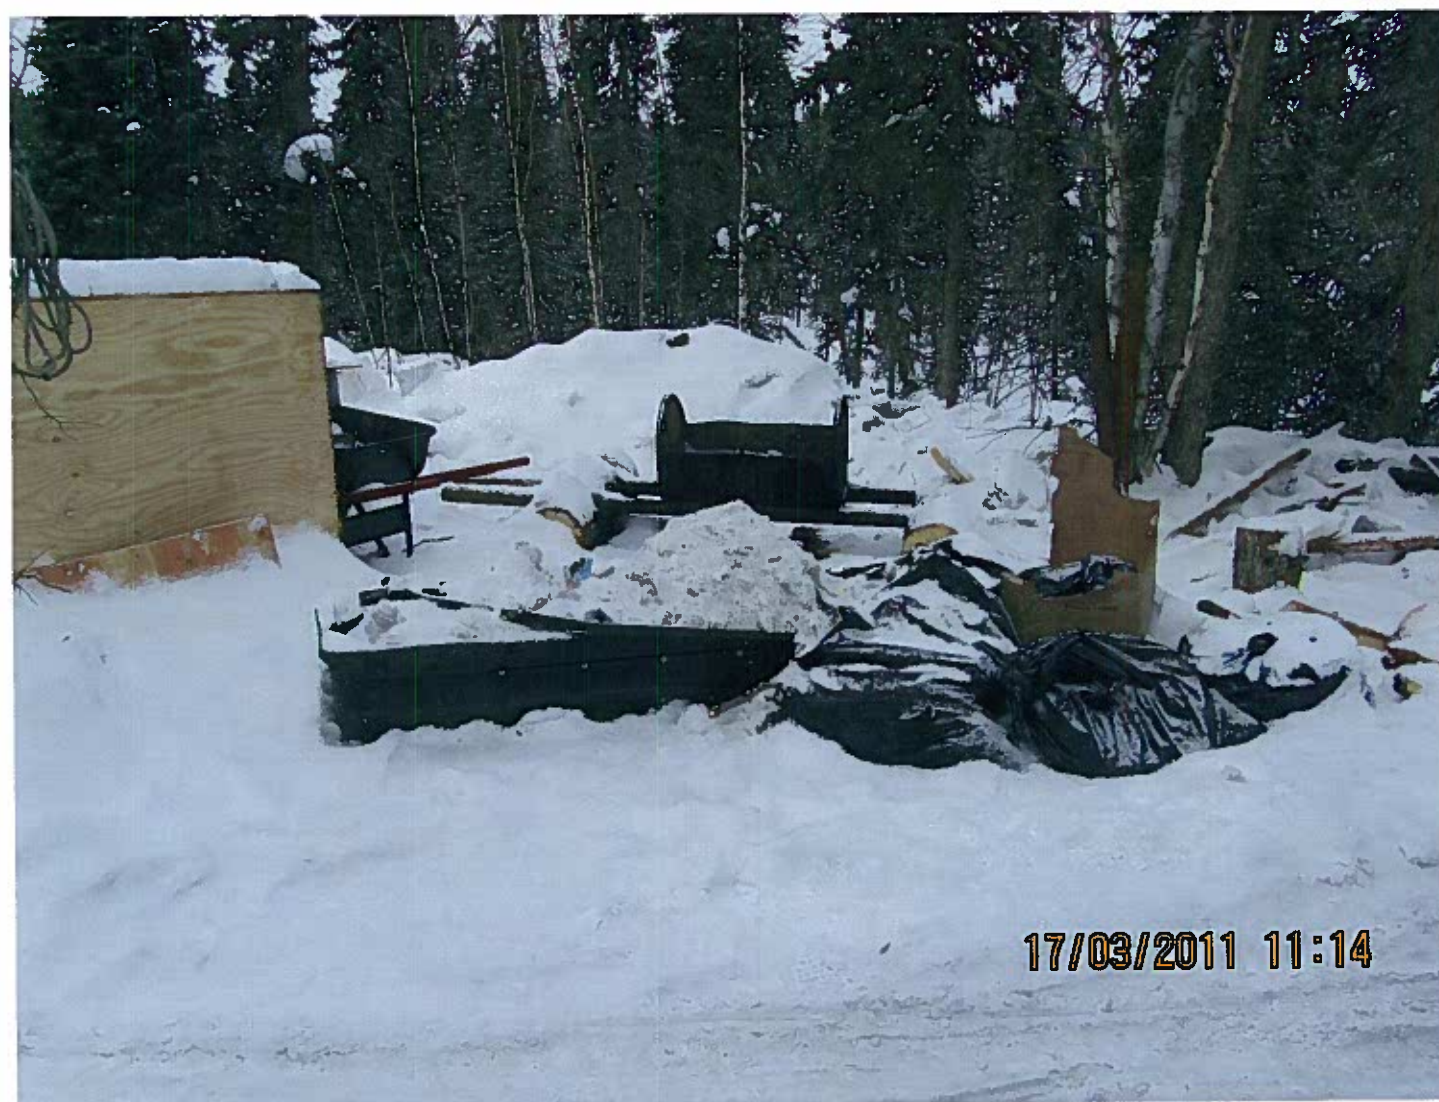
When small spills occur during the drilling operation, any hydrocarbon impacted snow and ice is collected and brought back to the camp location where it is processed. The ice and snow is melted in an empty drum and any hydrocarbons are mopped

off of the surface using absorbent pads. The remaining water is then discharged overland. Inspectors are pleased to see this practice being employed on site. During future operations on site, the Permittee may wish to explore alternative methods that can be employed to achieve the same goal. Please keep Inspectors apprised if any changes to the existing system are made.

MV2007C0039 - Avalon Rare Metals Inc. - Mineral Exploration - Thor Lake, NT.
Hydrocarbon impacted snow and ice from minor spills is being collected, thawed and treated on site.

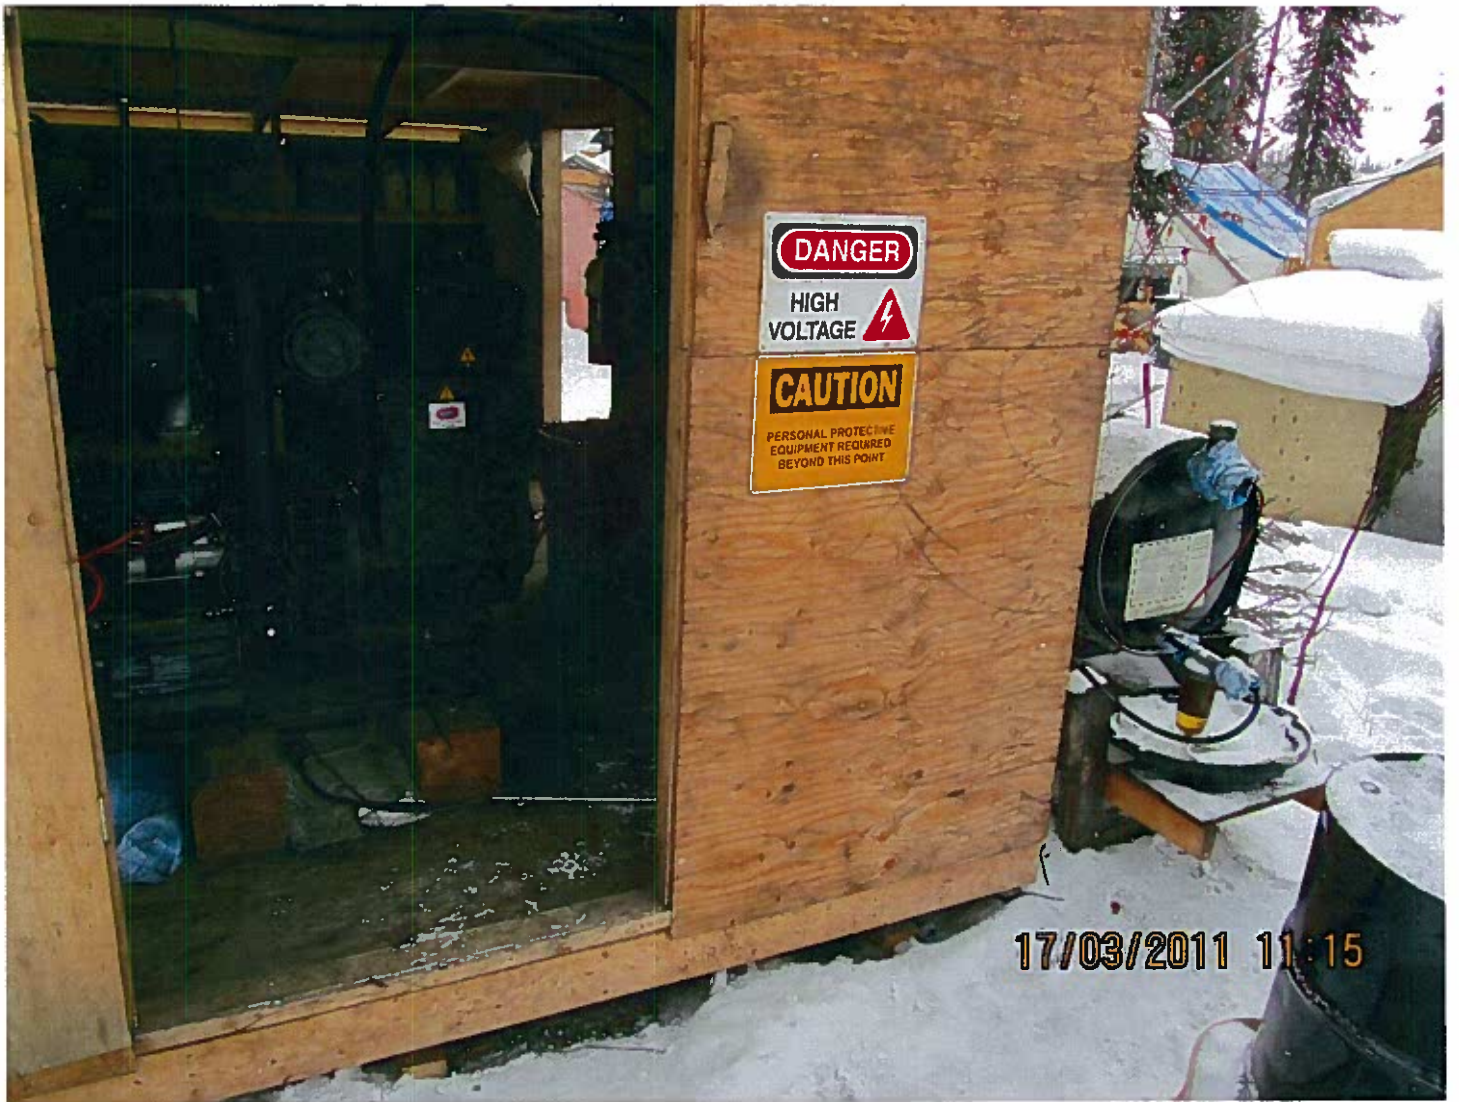
MV2007C0039 - Avalon Rare Metals Inc. - Mineral Exploration - Thor Lake, NT.
Generator at the camp has been lined with absorbents to capture potential leaks or drips.

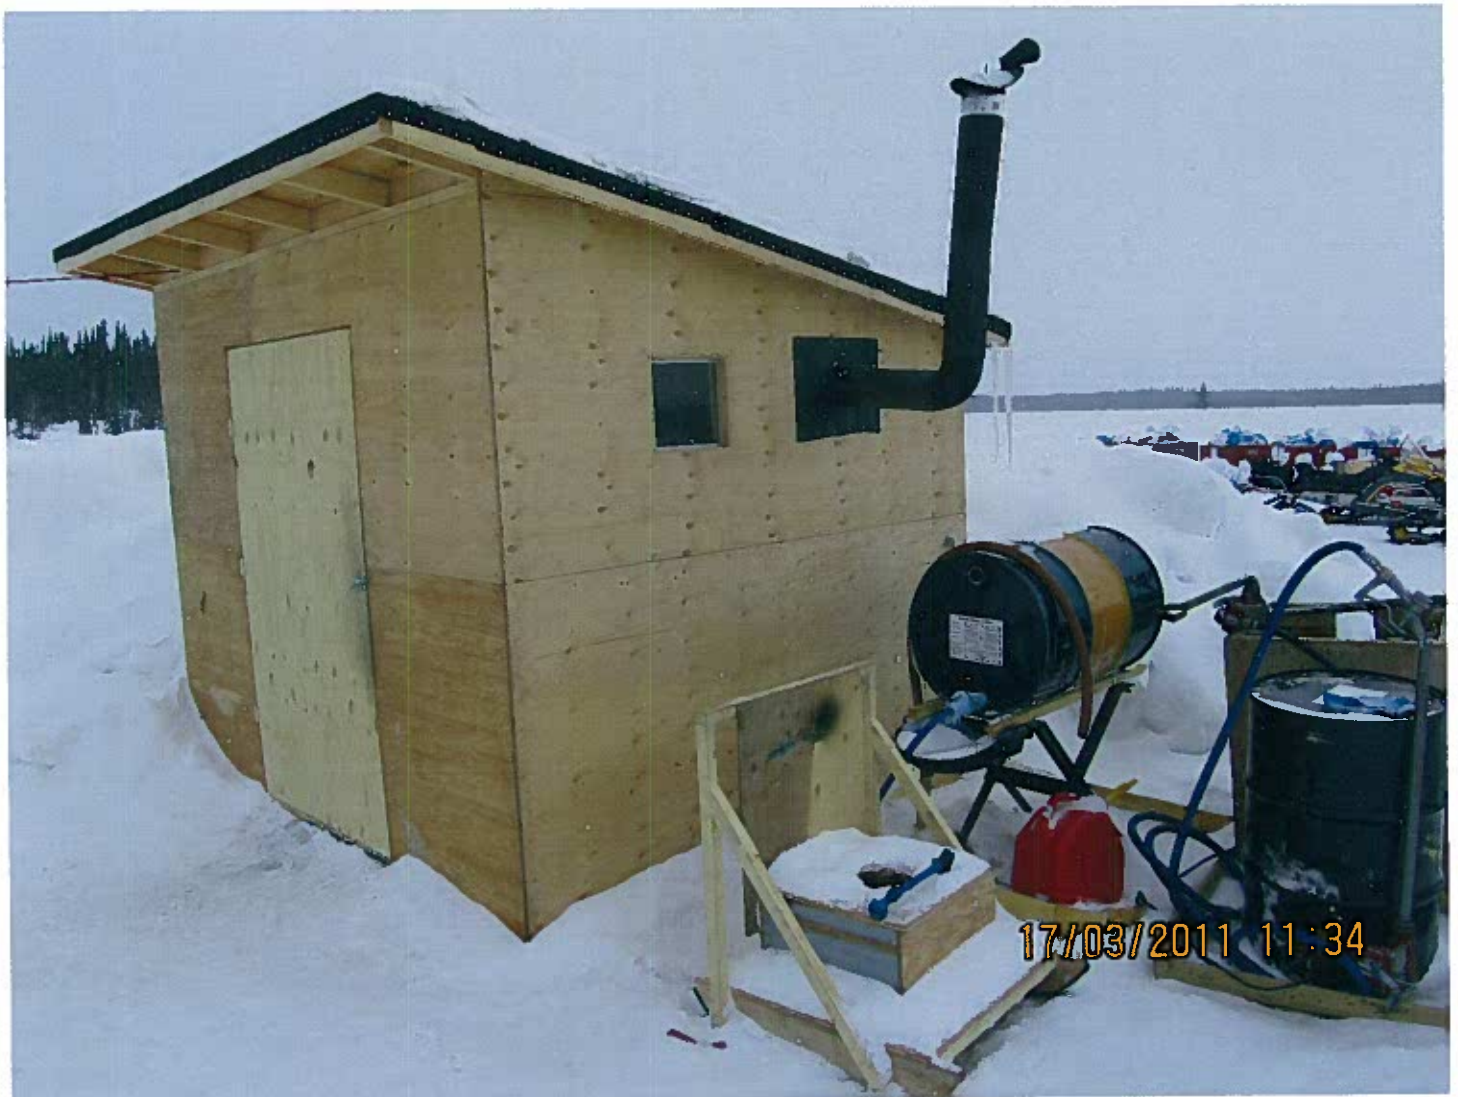
A heated shed has been built adjacent to the camp to store water pumps and water lines and prevent them from freezing. The shed is heated using an oil stove and the fuel is stored within secondary containment. No concerns were noted at this location.

MV2007C0039 - Avalon Rare Metals Inc. - Mineral Exploration - Thor Lake, NT.
Pump shack has been constructed to house water pumps and hoses. Fuel for the shack is within secondary containment.

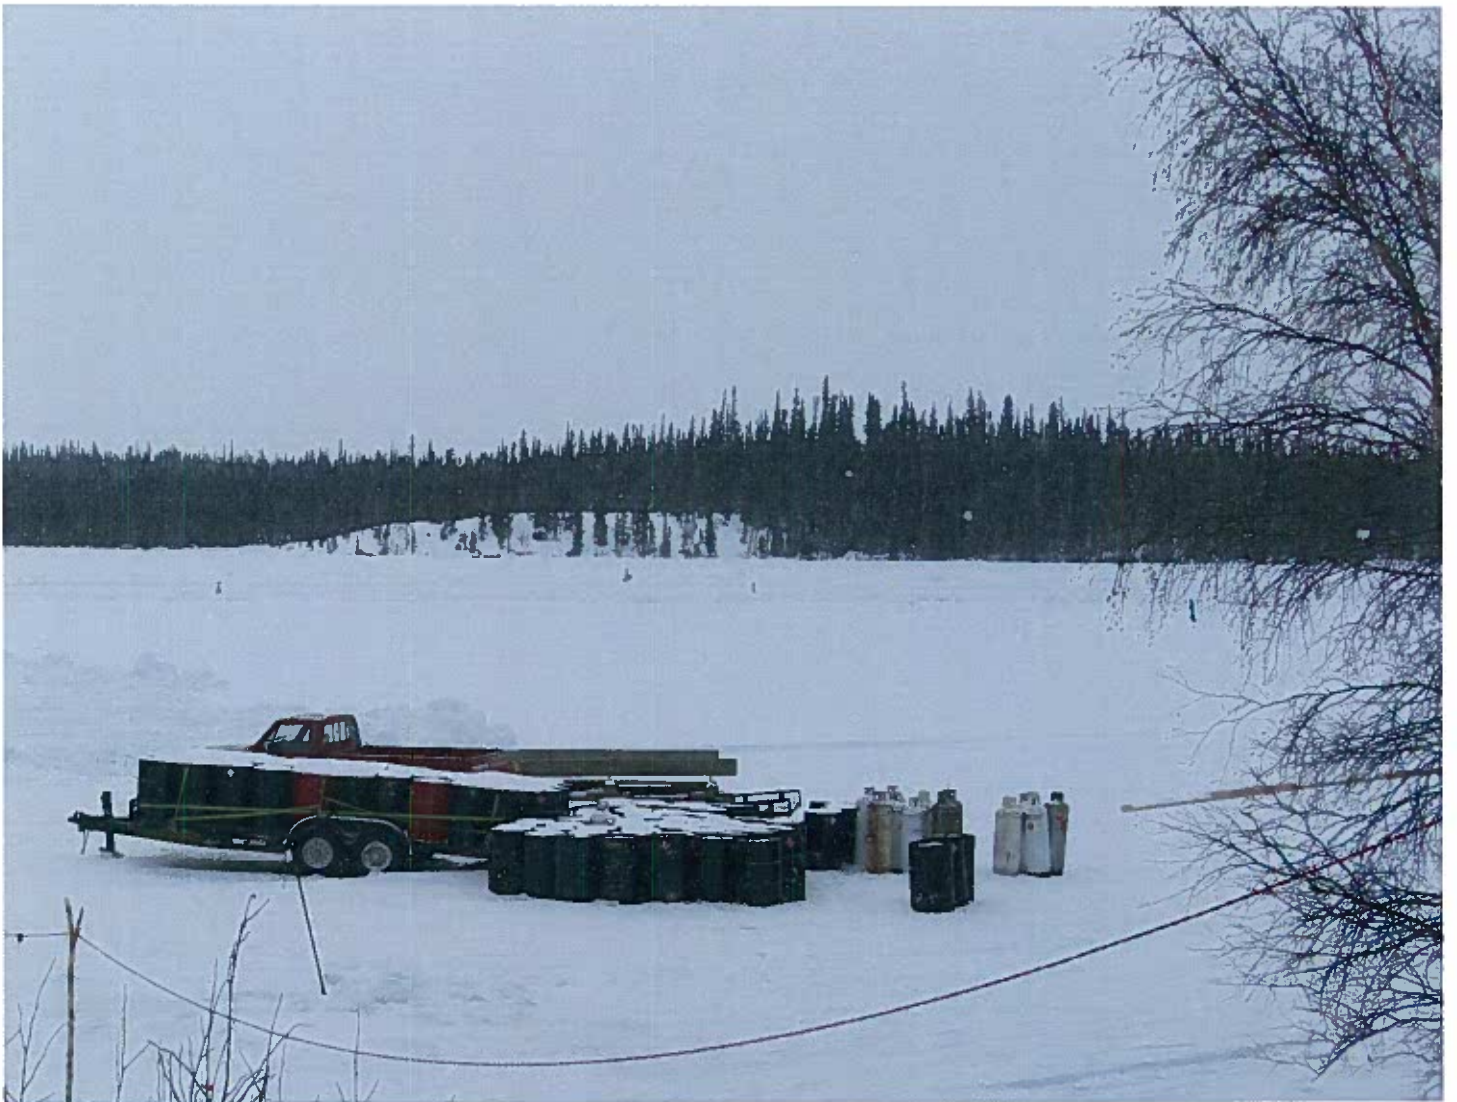
Empty drums were being staged adjacent the airstrip for removal from site and proper disposal. Avalon is preparing for this seasons fuel delivery. Fuel will be transported to site using the ice based airstrip on Thor Lake.

MV2007C0039 - Avalon Rare Metals Inc. - Mineral Exploration - Thor Lake, NT.
Empty drums are being staged for removal from site adjacent to the airstrip.

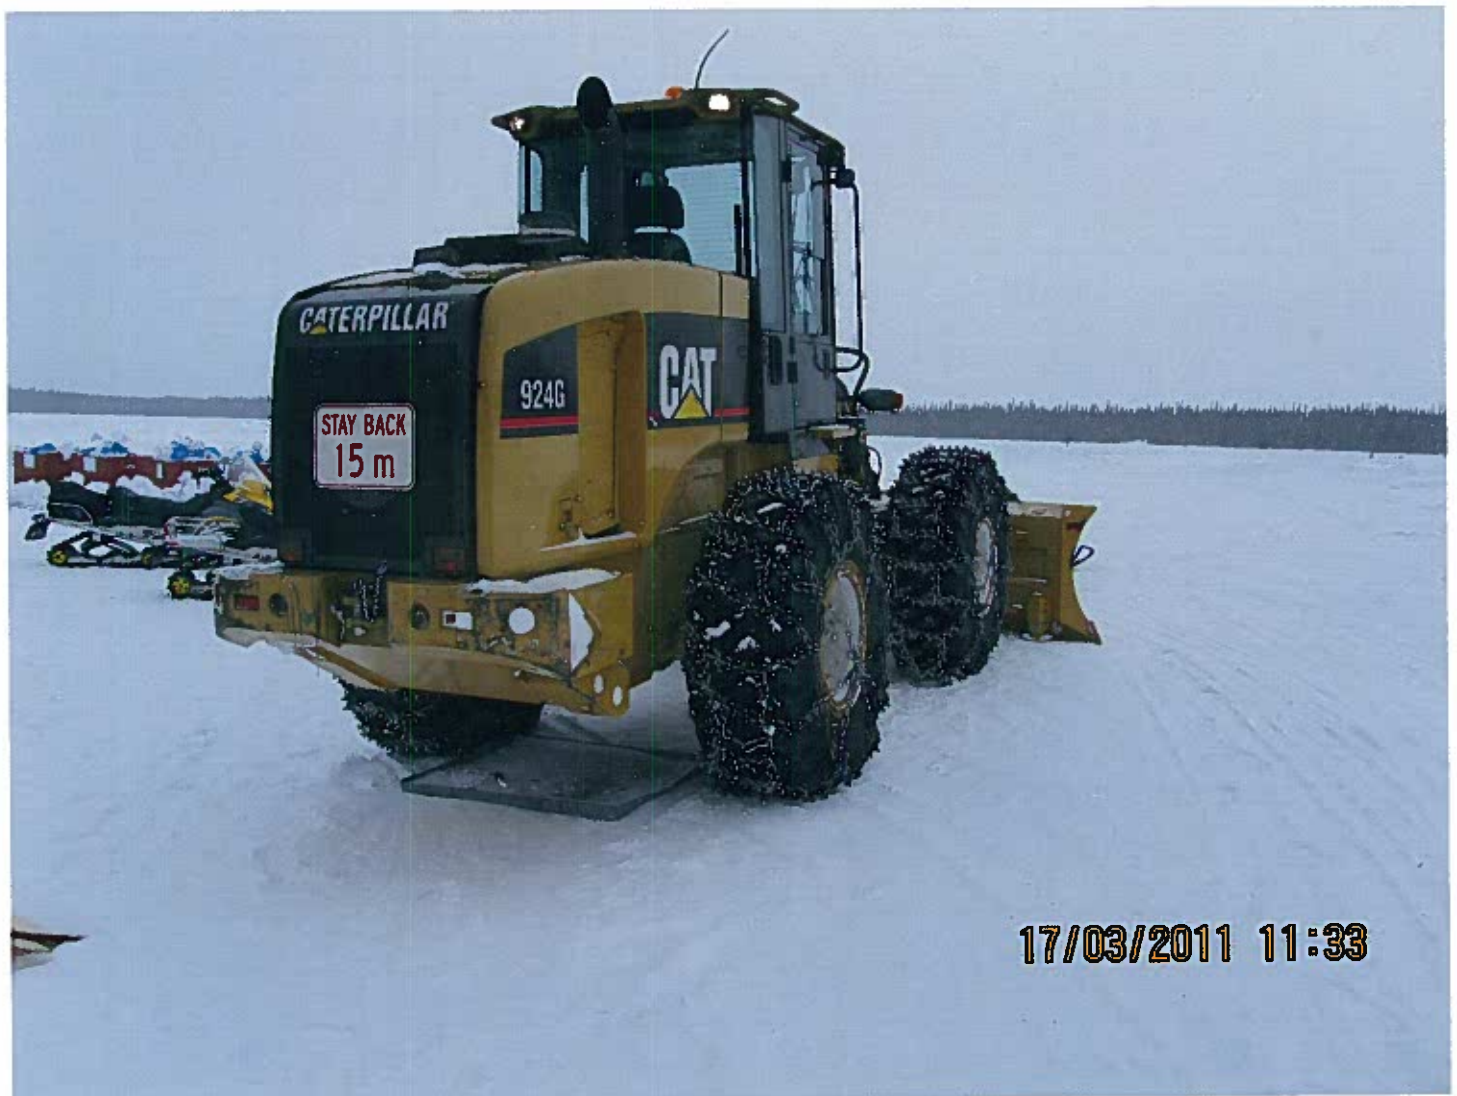
During the inspection, several pieces of parked equipment were inspected. Each vehicle had been parked over a drip tray to capture potential leaks. The Inspector was pleased to see this practice.

MV2007C0039 - Avalon Rare Metals Inc. - Mineral Exploration - Thor Lake, NT.
Drip trays have been placed under equipment on site.

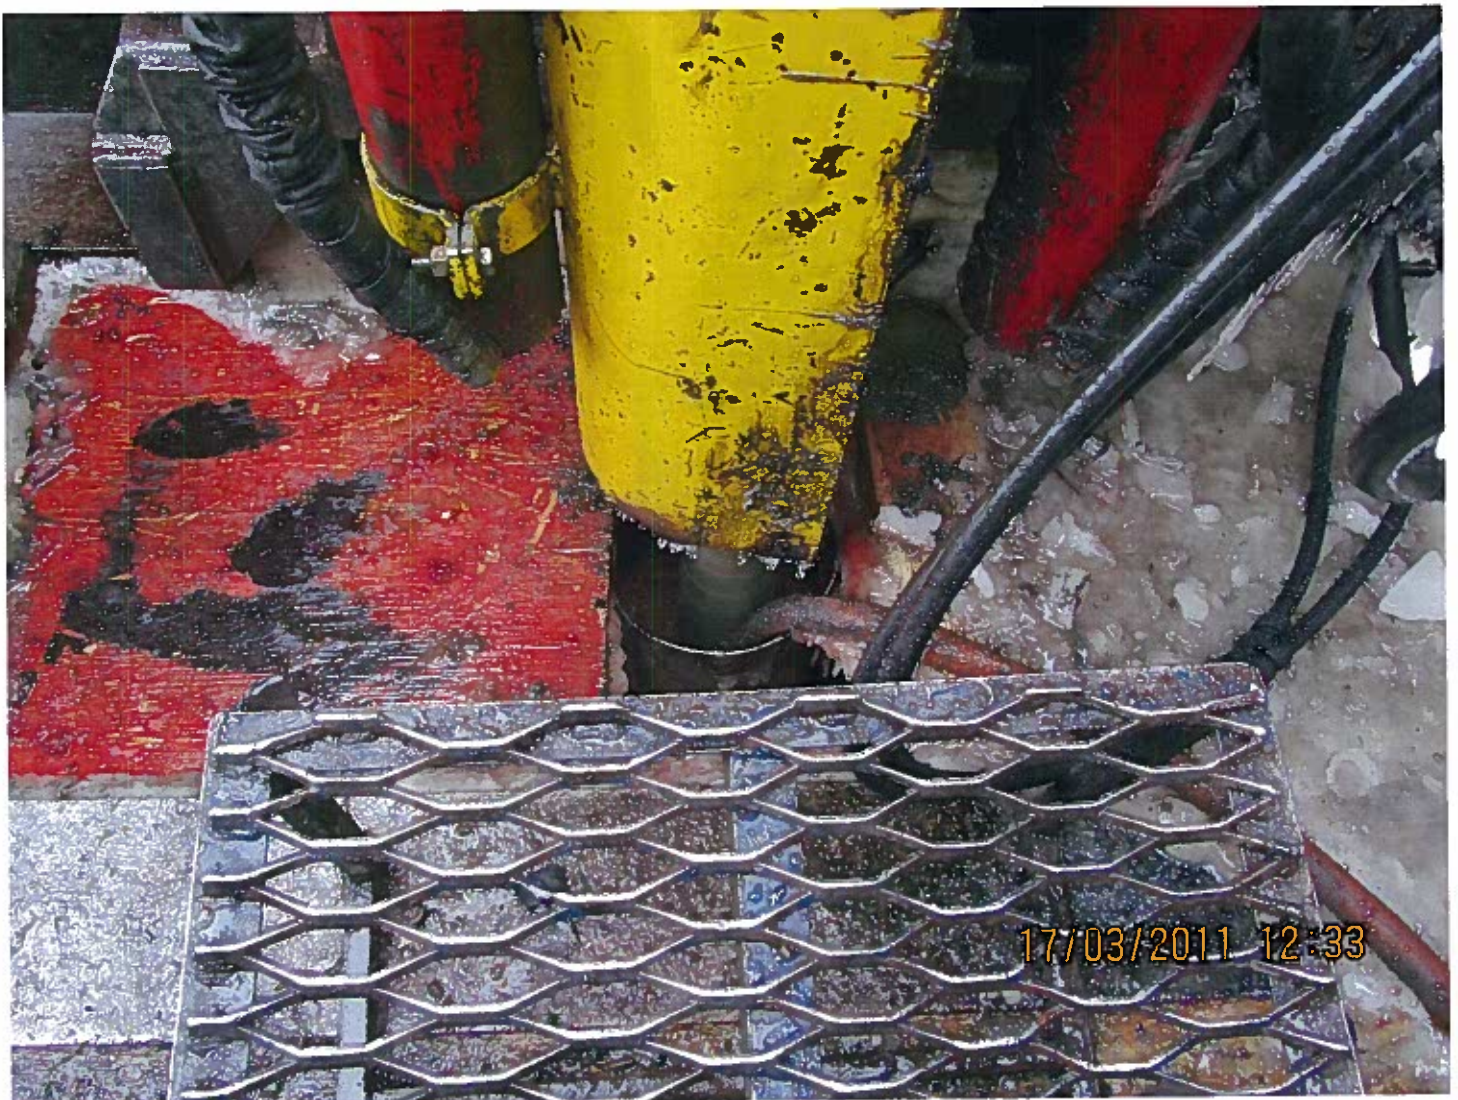
Cuttings disposal at both of the drills was satisfactory. Cuttings were being collected at the collar and redirected to land based disposal locations well away from any water body. Once drillers are finished at any particular hole they conduct the initial cleanup, removing timbers and other debris from the drill site. Avalon staff members then wait for the hole to freeze up and use a dozer and loader to scrape any remaining cuttings that may be frozen in the ice. The ice and snow from the final cleanup is also being deposited on land away from both Long and Thor Lakes. Several of the completed drill sites were inspected and no concerns were identified.

MV2007C0039 - Avalon Rare Metals Inc. - Mineral Exploration - Thor Lake, NT.
Cuttings at both active drills were being contained and redirected to land based locations.

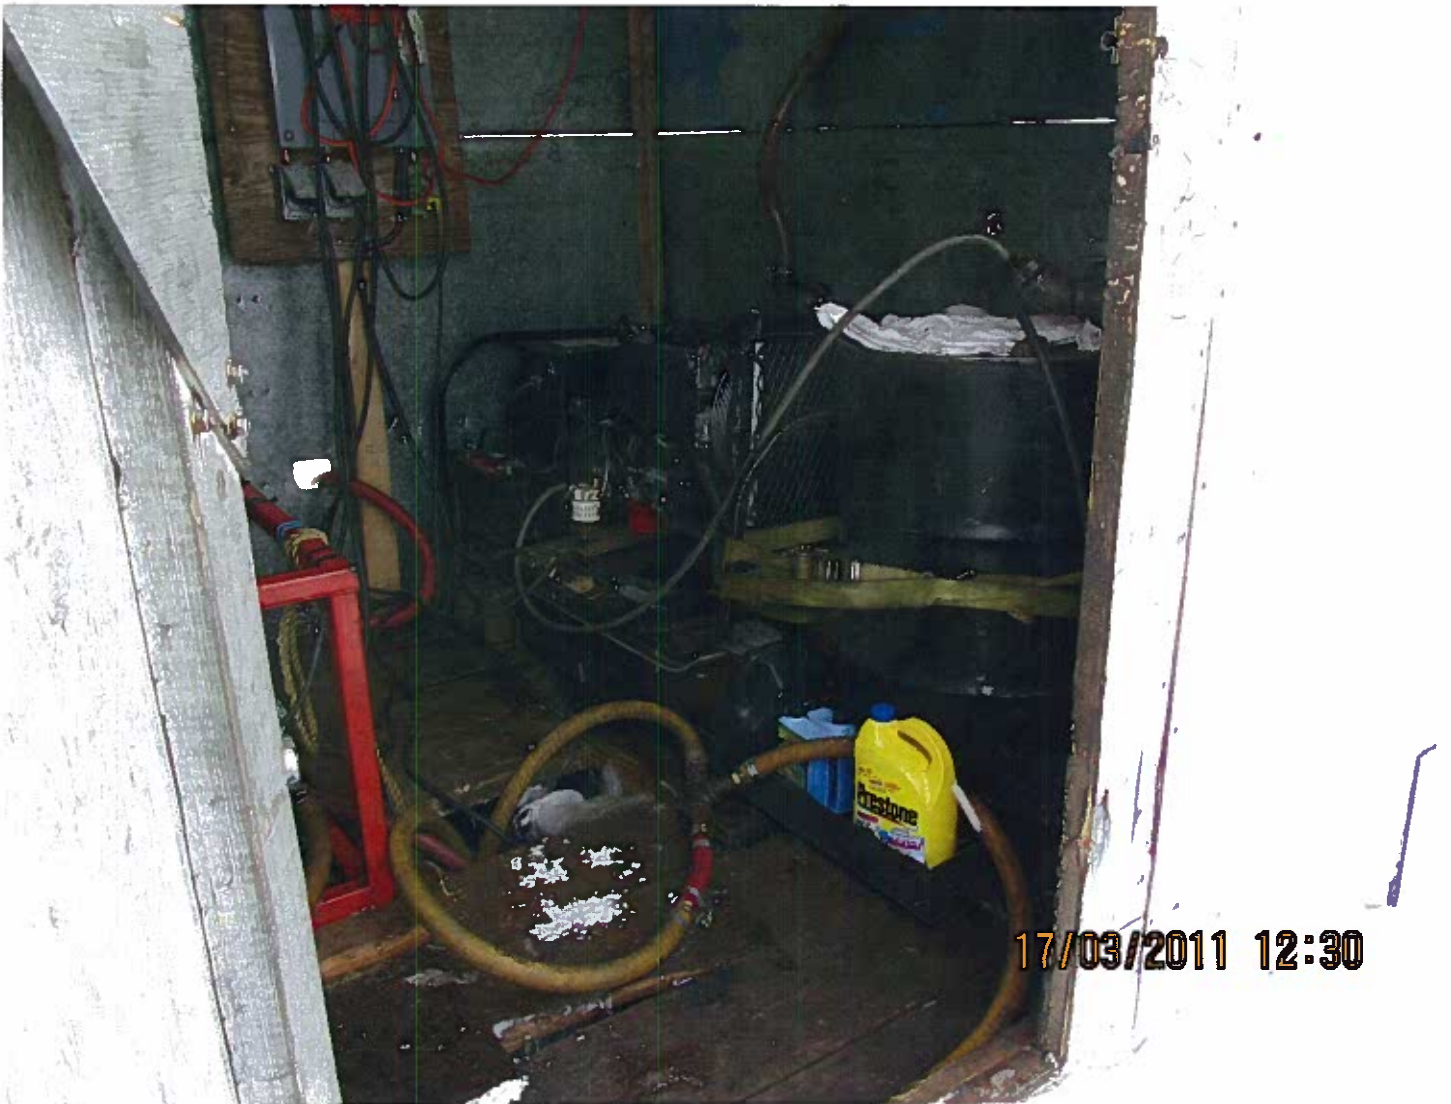
MV2007C0039 - Avalon Rare Metals Inc. - Mineral Exploration - Thor Lake, NT.
Fuel at the pump shack is contained and absorbents were present under the pump.

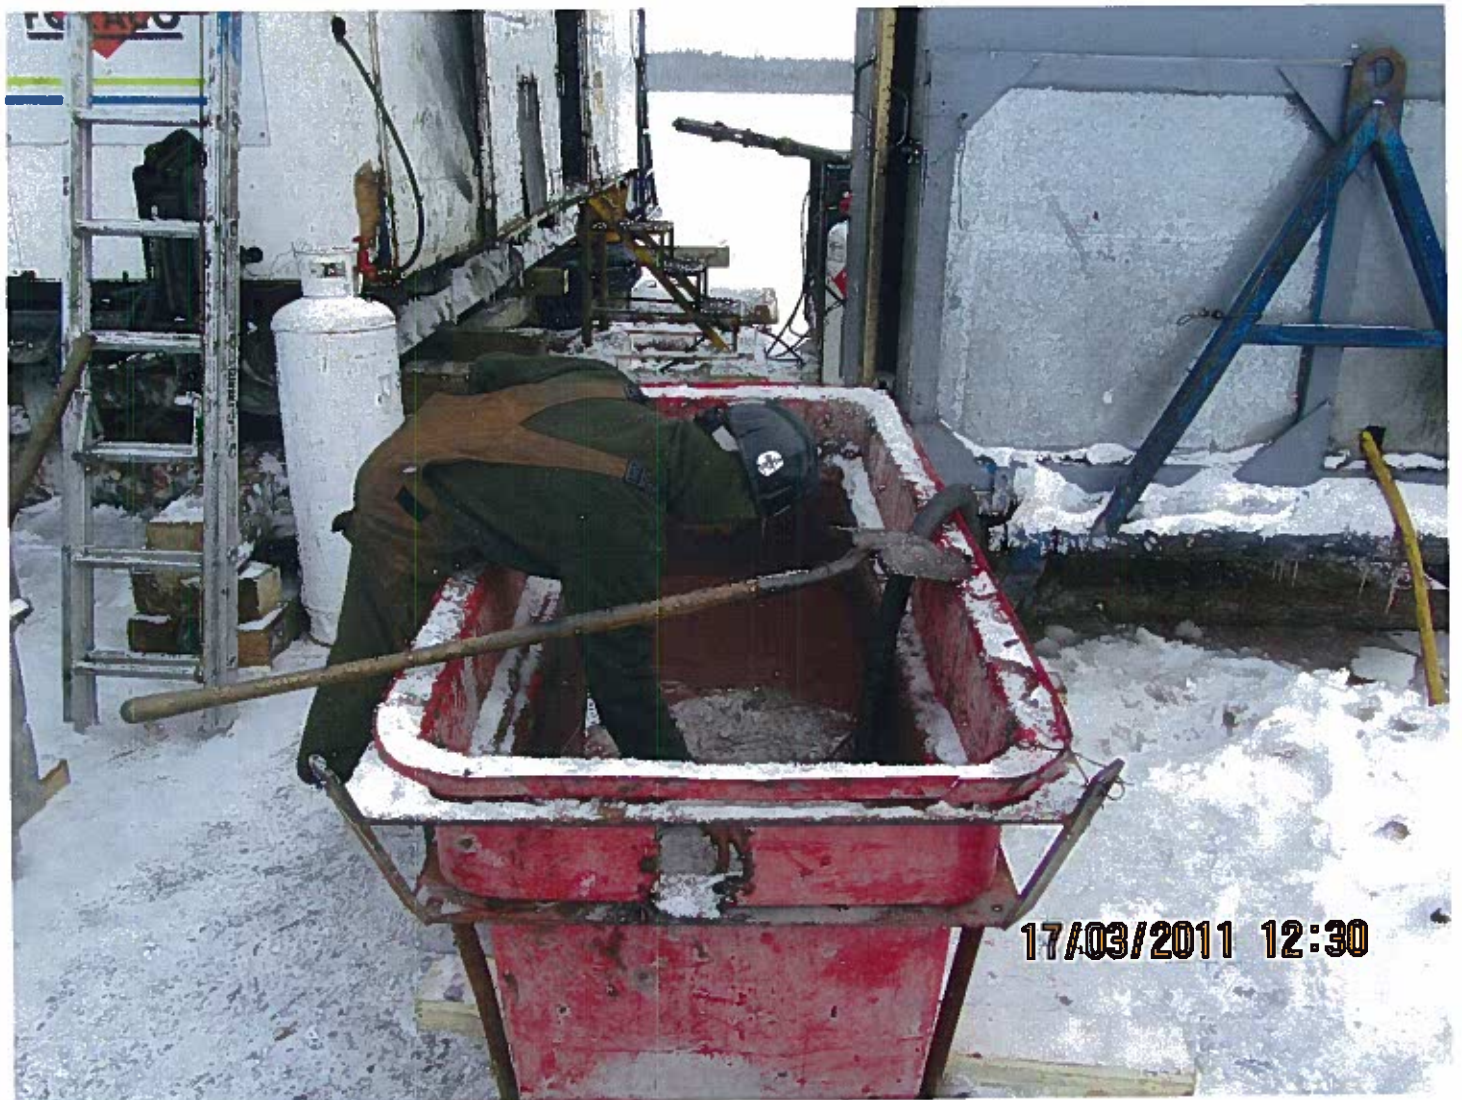
The only other concern identified was with the accumulation of rod grease from the drilling process on the water surface of the mud tank at Drill #2. Inspectors notified the Permittee and the drill crew of this concern and absorbent pads were used to mop up excess rod grease immediately. This practice must continue throughout the drill program to ensure that rod grease is not being pumped with the cuttings to the land based disposal locations. Your copy of the Environmental Inspection Report is enclosed and should be self explanatory.

The only other concern with the drilling was the presence of rod grease on the water in the mud tub at Drill #2. It became apparent upon inspection that rod grease from the drilling process was collecting on the surface of the recycled water in the red tub at the drill. Inspectors notified the Permittee and the drill crew of this concern and absorbent pads were used to mop up excess rod grease immediately. This practice must continue throughout the drill program to ensure that rod grease is not being pumped with the cuttings to the land based disposal locations.

MV2007C0039 - Avalon Rare Metals Inc. - Mineral Exploration - Thor Lake, NT.
Rod grease was present on the water surface of this mud tank. Grease was mopped up for disposal.

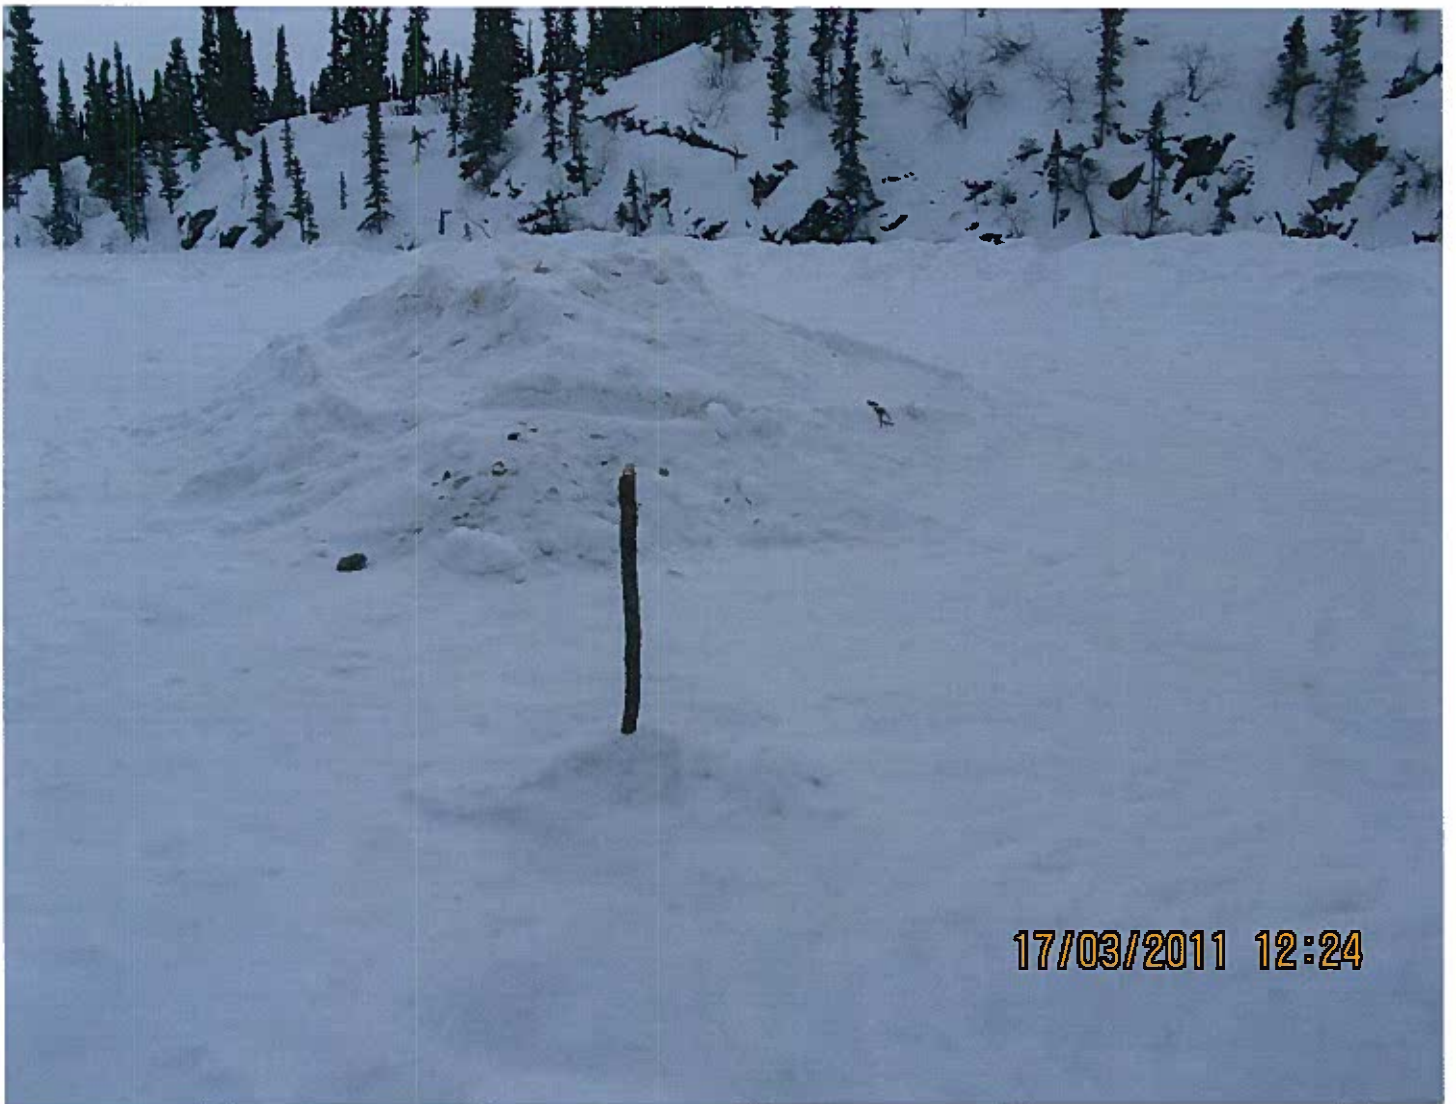
MV2007C0039 - Avalon Rare Metals Inc. - Mineral Exploration - Thor Lake, NT.
Completed drill site on Long Lake. Pile of snow with some residual cuttings that will be transported to a land based disposal location.

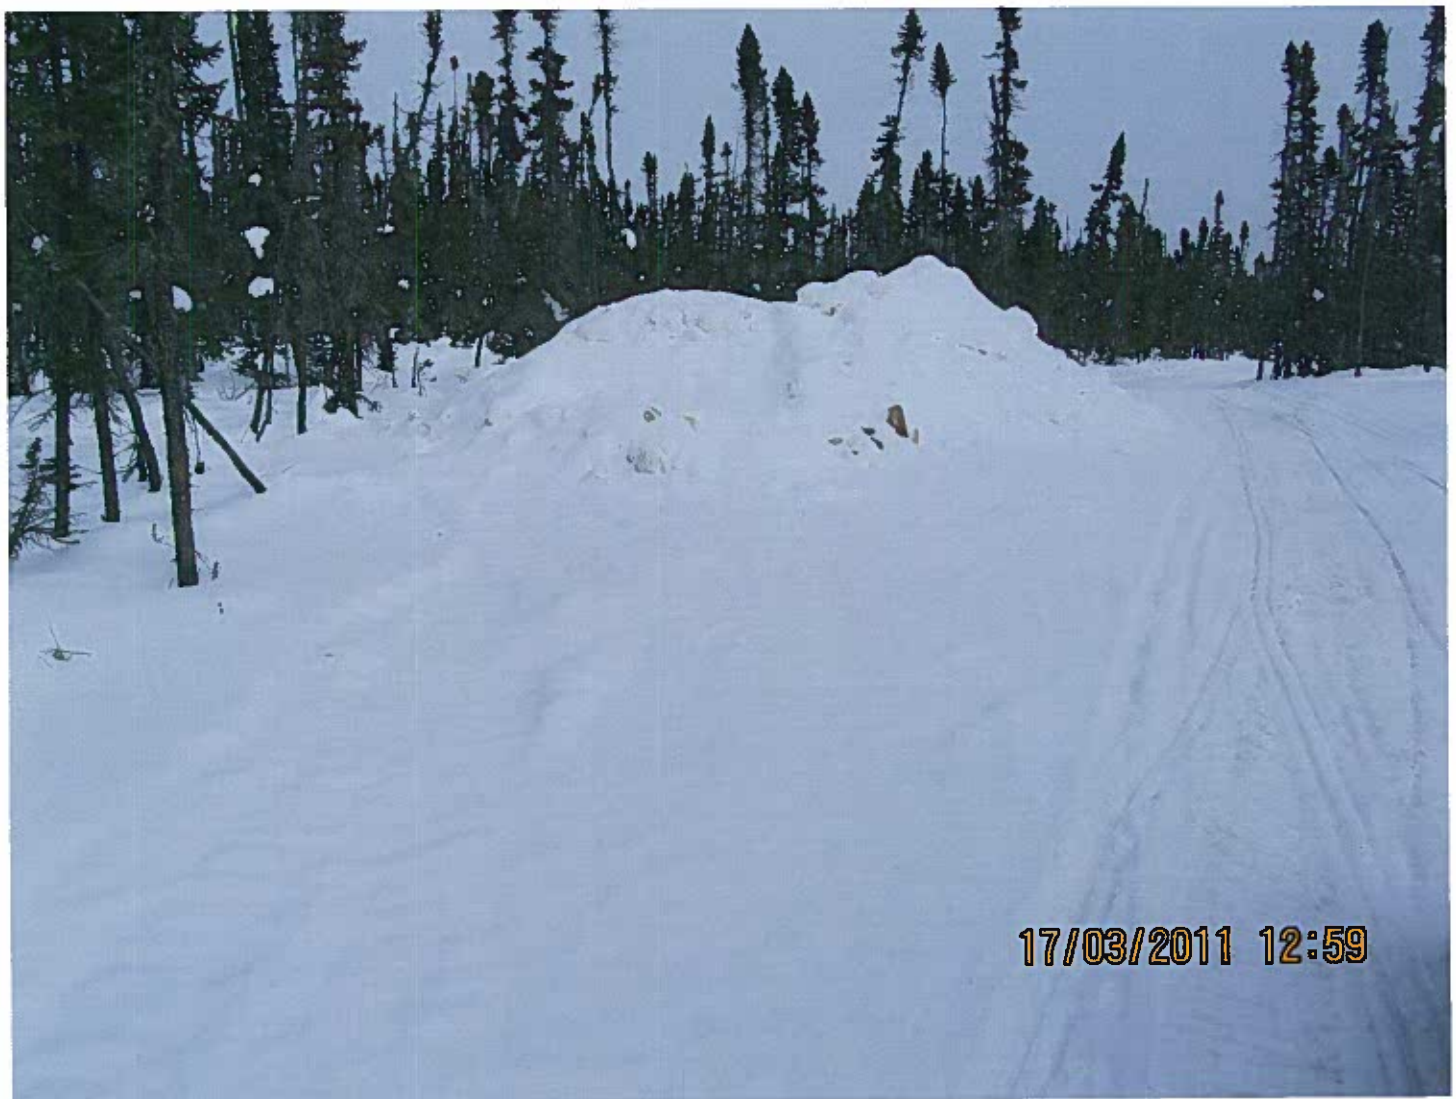
MV2007C0039 - Avalon Rare Metals Inc. - Mineral Exploration - Thor Lake, NT.
Land based disposal location for snow and ice containing cuttings.

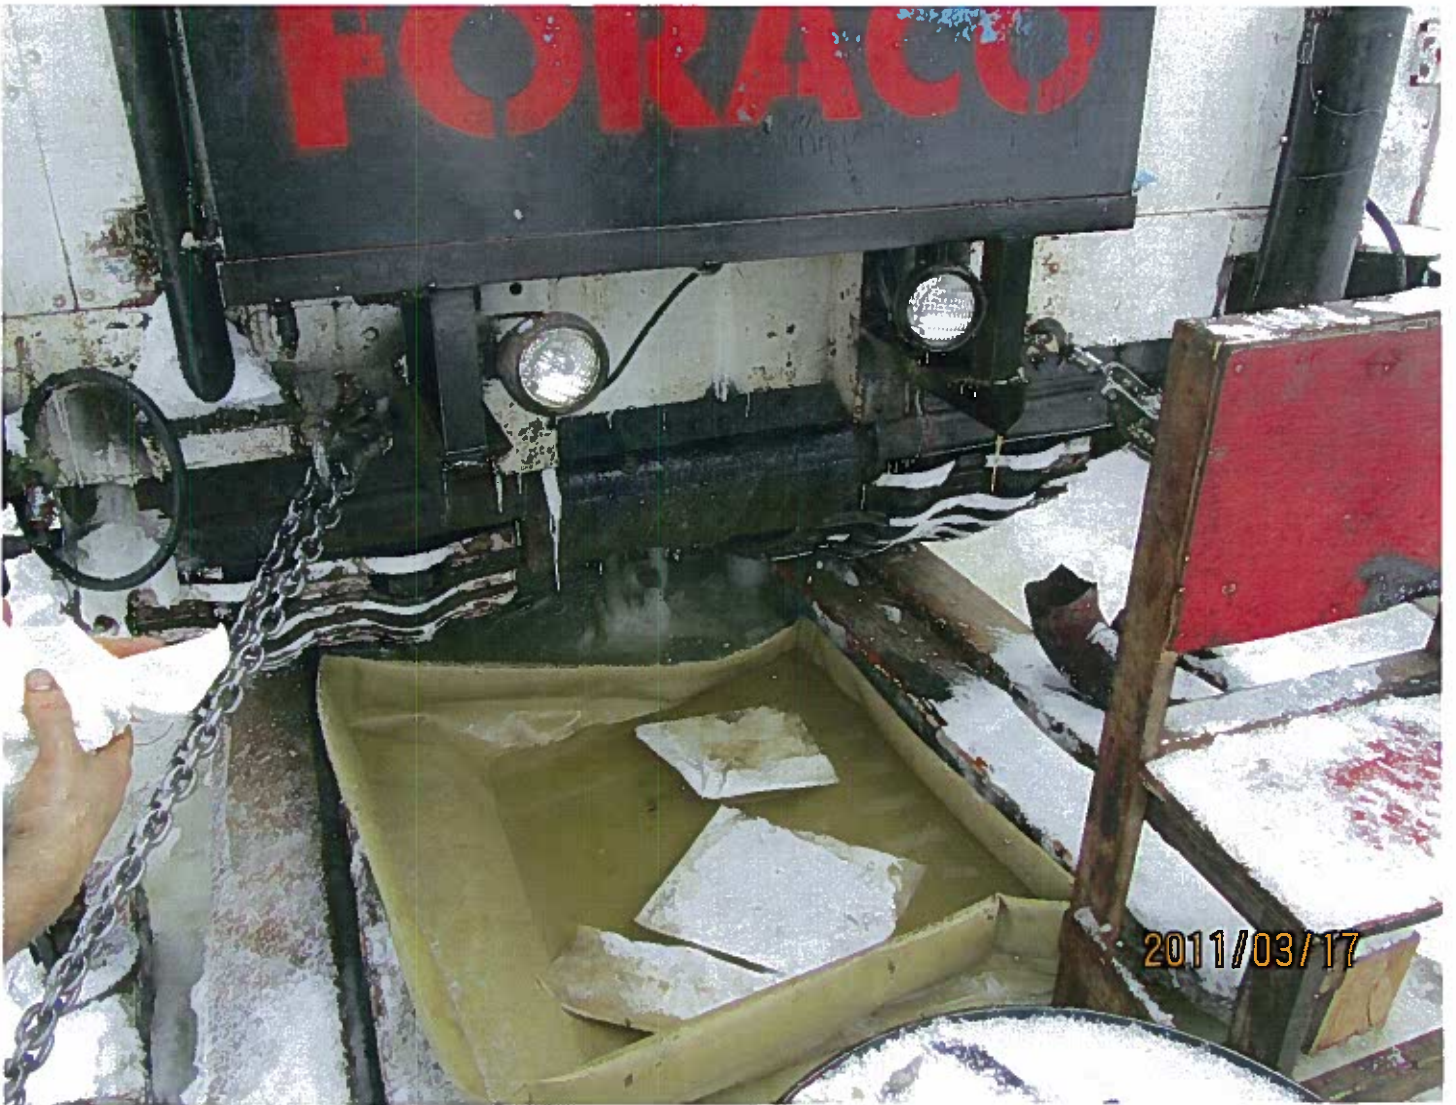
The saddle tank on the Drill #1 was leaking from a fitting on the underside of the tank. This concern has been raised in the past and fuel handling at this particular tank is unacceptable. Inspectors require a more permanent solution to be implemented on site in order to maintain compliance with Condition #47 of the permit. Inspectors have already been informed by Avalon staff that a suitable alternative will be implemented.

Fuel handling at the drills was satisfactory with the exception of the saddle tank on Drill #1. This tank appeared to be leaking from a fitting under the tank. There was a secondary containment berm under the tank but some diesel contamination was present out side the containment structure. Drillers were made aware of the problem immediately and responded to Inspectors concerns. The driller tightened the problem fitting, mopped up any hydrocarbons on the surface of the water within the secondary containment unit, and began chipping and scraping contaminated snow and ice for collection and proper disposal.

This concern has been raised in the past and fuel handling at this particular tank is unacceptable. Inspectors require a permanent solution to be implemented on site in order to maintain compliance with Condition #47 of the permit, which states:

“The Permittee shall not allow petroleum products to spread to surrounding lands or into water bodies”.

MV2007C0039 - Avalon Rare Metals Inc. - Mineral Exploration - Thor Lake, NT.
Diesel contamination under the saddle tank on the buggy drill. Secondary containment was present but some impacted ice was identified.

The Permittee has informed Inspectors that the drill contractor will be sending in a double walled tidy tank to replace the problem tank and that this tank will only be used during transport of the drill from target to target. All fueling during drilling will occur within secondary containment from drums contained within a metal sloop or from a double walled tank. This appears to be a suitable alternative and should significantly reduce the potential for spills to occur from this saddle tank.

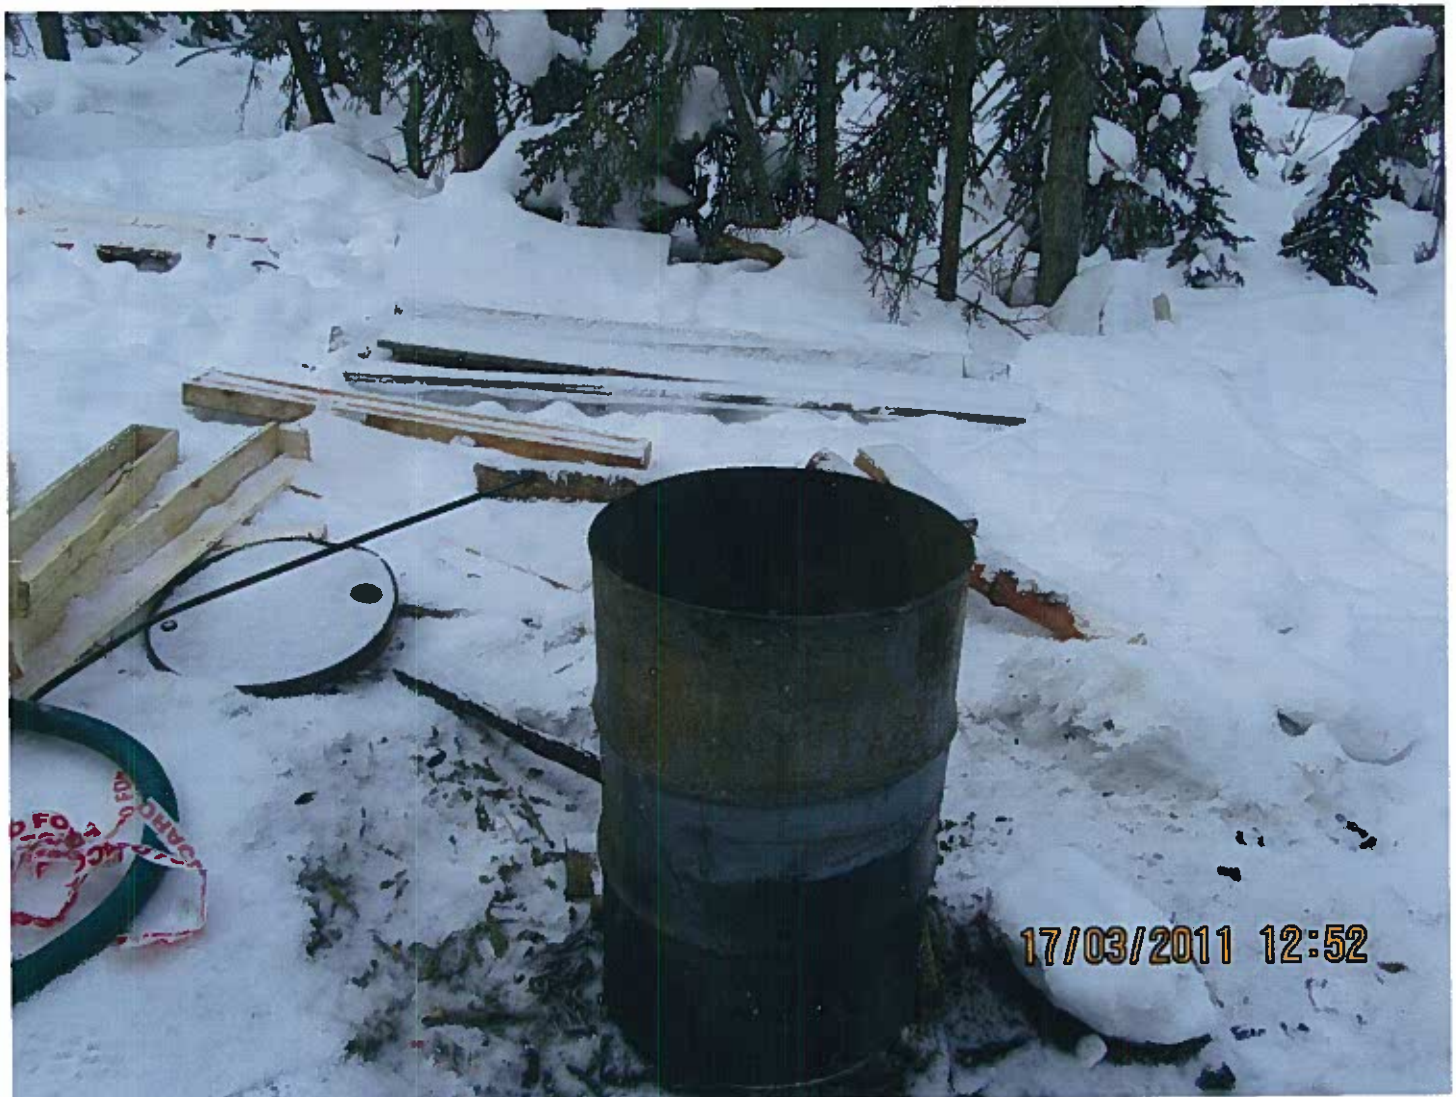
MV2007C0039 - Avalon Rare Metals Inc. - Mineral Exploration - Thor Lake, NT.
Combustible waste is being burned at the drillers lay down. Ash must be removed for proper disposal.
