**Re: Land Use Permit MV2007C0039
Mineral Exploration
Thor Lake, NT**

ENVIRONMENTAL INSPECTION REPORT

Permittee:	Avalon Rare Metals Inc.	Inspection Date – March 17 th , 2011
------------	-------------------------	---

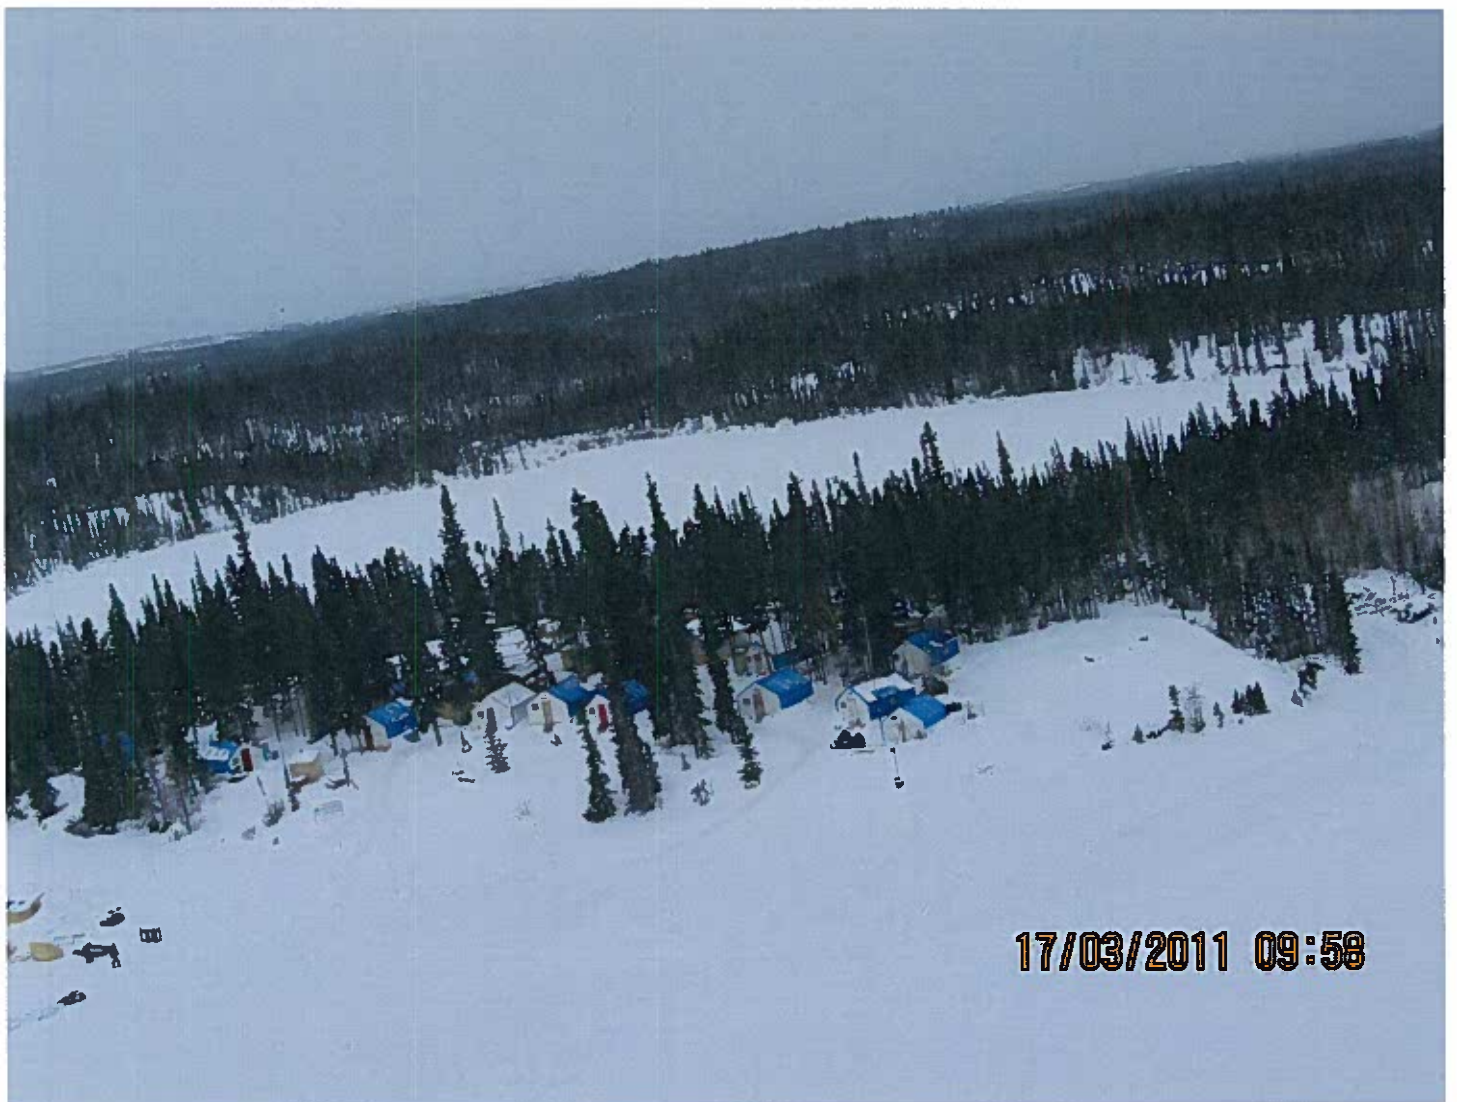
The camp was inspected and no major concerns were identified. Garbage is being burned regularly, the grey water sump has been expanded and covered, and all of the fuel active fuel drums have wrapped fittings and secondary containment.

MV2007C0039 - Avalon Rare Metals Inc. - Mineral Exploration - Thor Lake, NT.
Aerial view of Avolon's camp at Thor Lake.

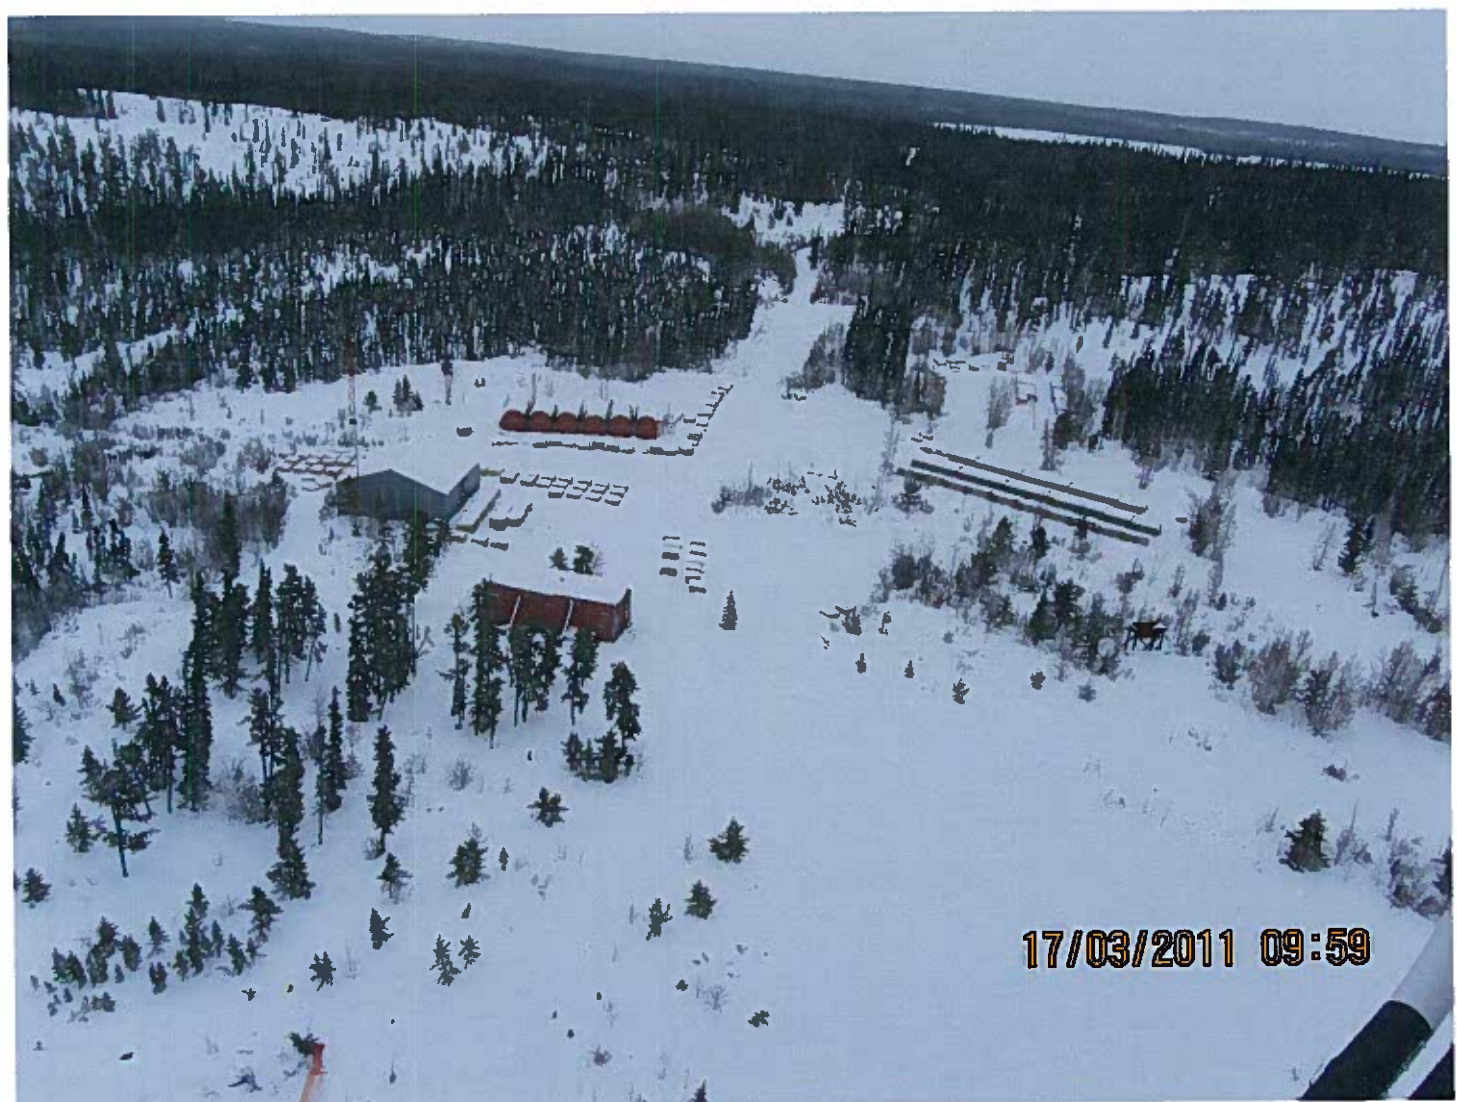
MV2007C0039 - Avalon Rare Metals Inc. - Mineral Exploration - Thor Lake, NT.
Aerial view of the old Highwood site. Site is primarily being used for core storage presently.

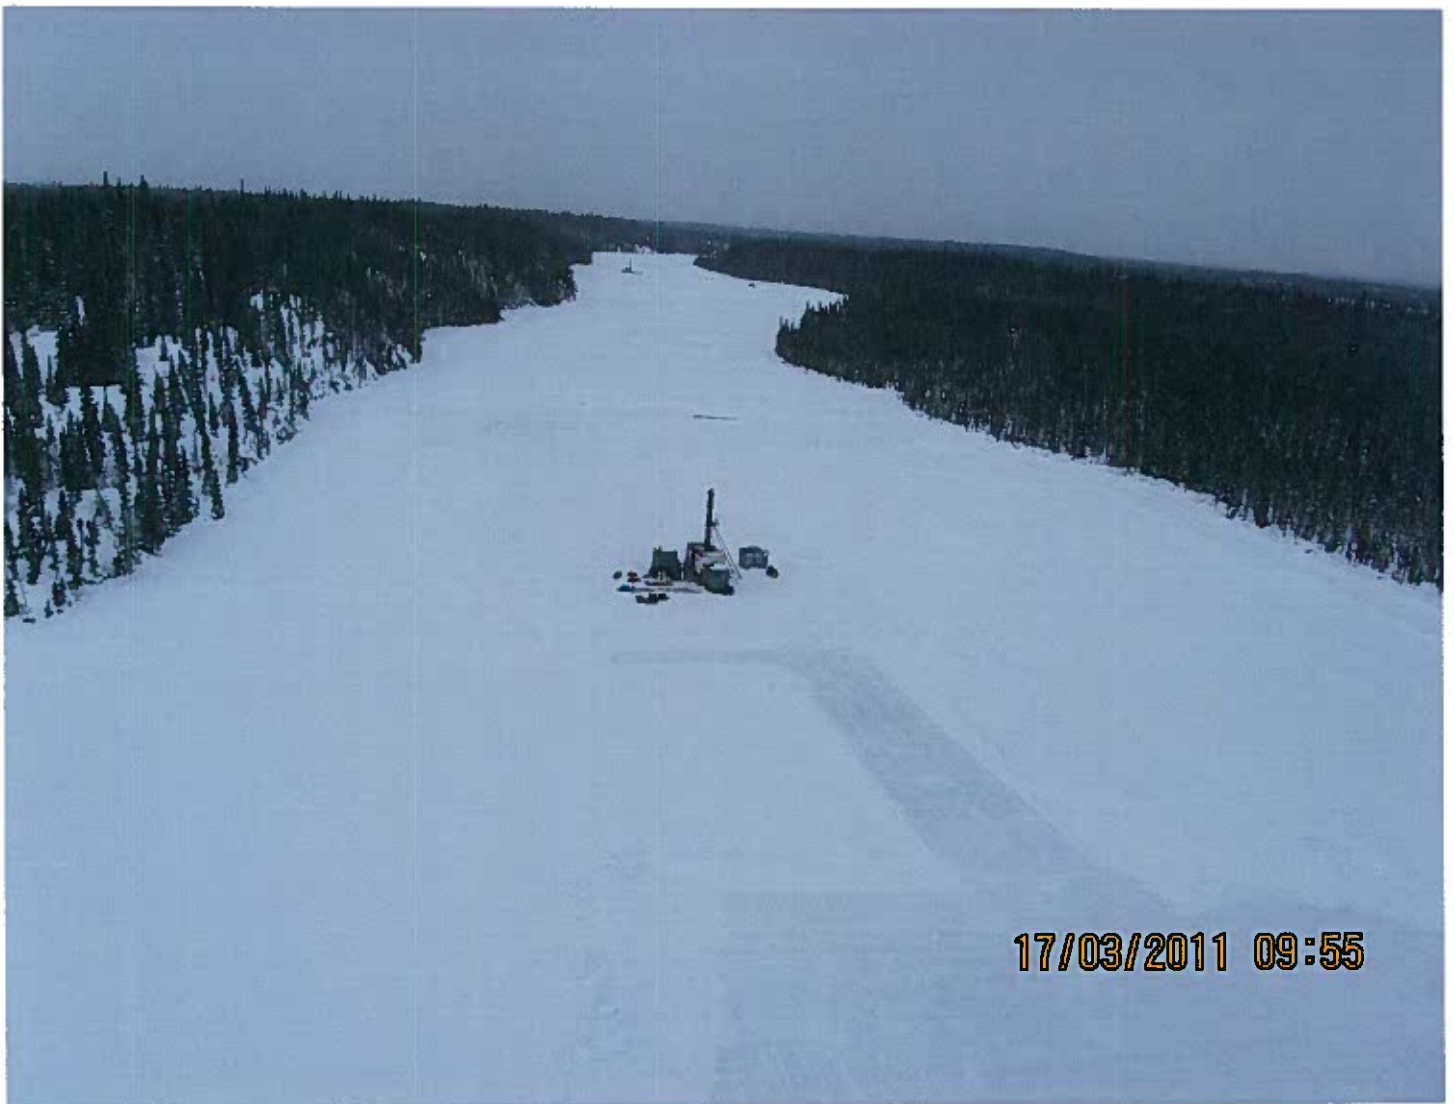
MV2007C0039 - Avalon Rare Metals Inc. - Mineral Exploration - Thor Lake, NT.
Aerial view of the two active drills on Long Lake.
