**Re: Land Use Permit MV2010G0001
Airstrip Construction
Thor Lake, NT**

ENVIRONMENTAL INSPECTION REPORT

Permittee:	Avalon Rare Metals Inc.	Inspection Date – June 22 nd , 2010
------------	-------------------------	--

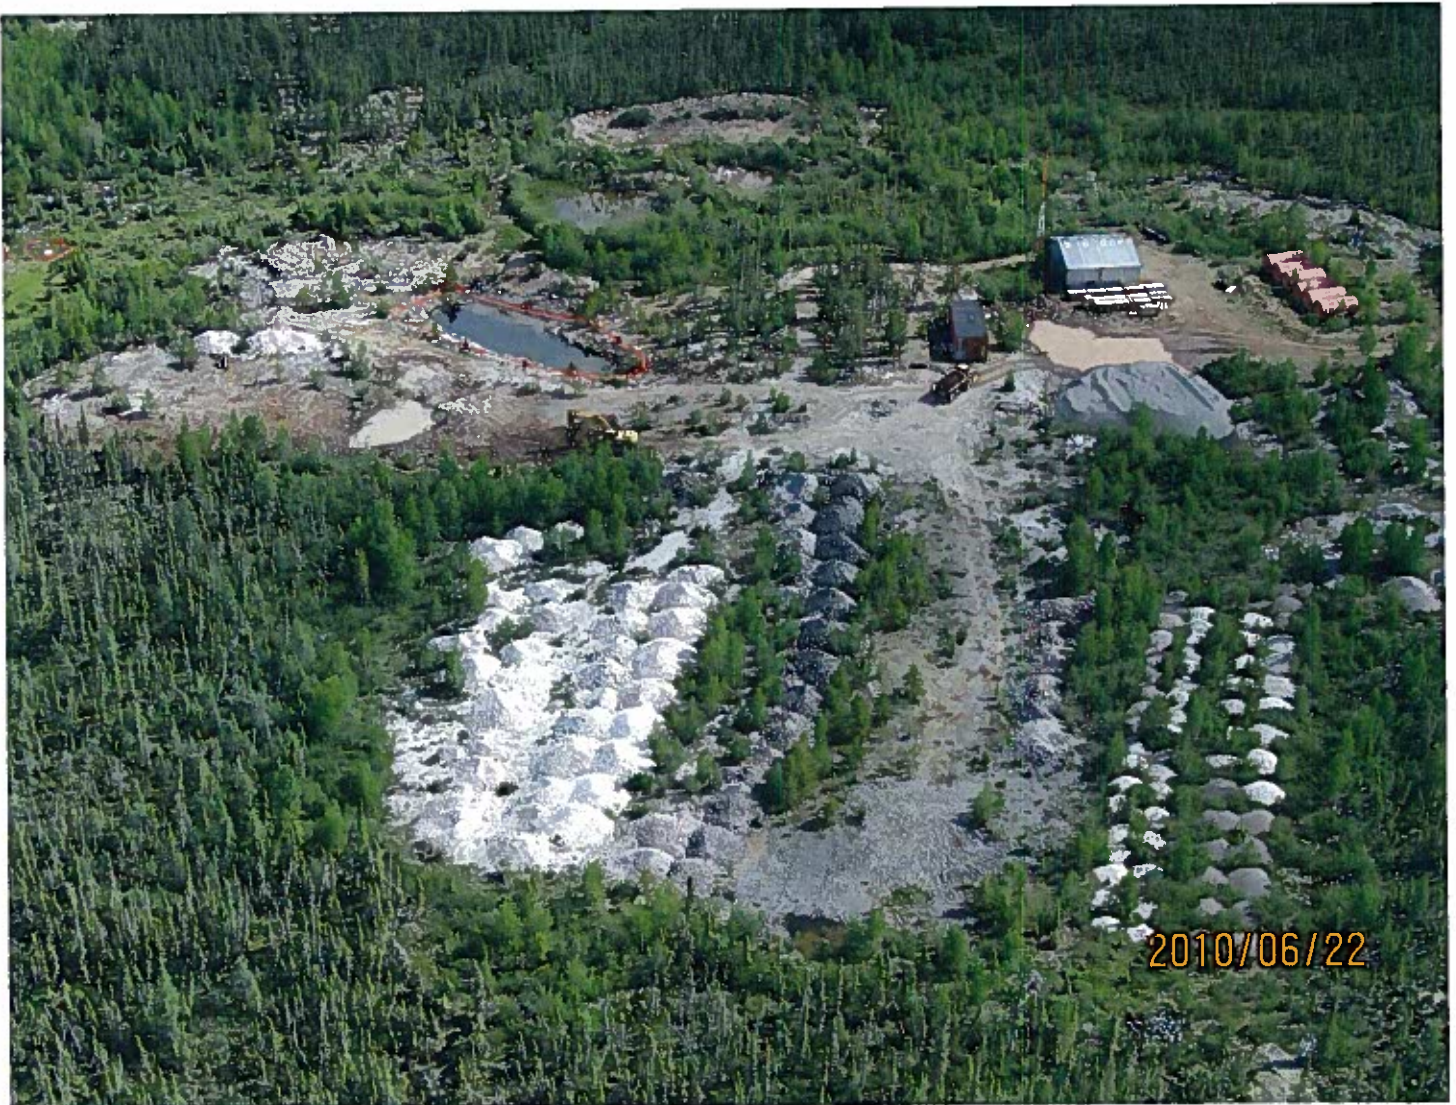
MV2010G0001 - Avalon Rare Metals Inc. - Thor Lake
Aerial view of the T-zone of the land use area.

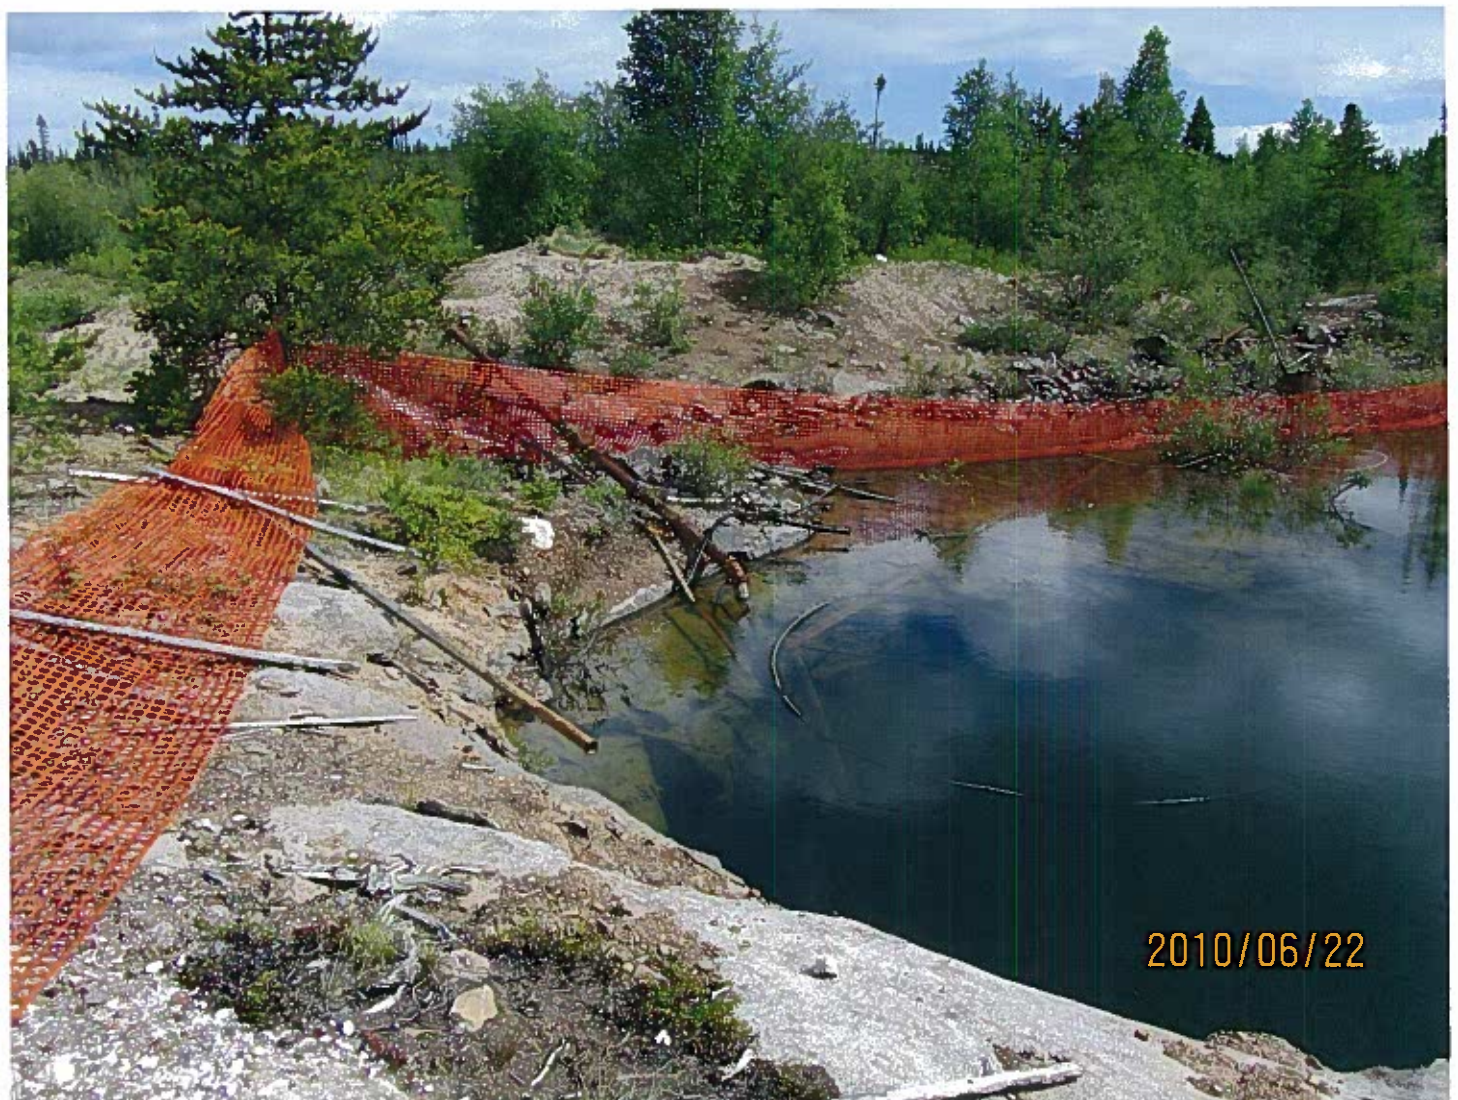
MV2010G0001 - Avalon Rare Metals Inc. - Thor Lake
Waste materials at the T-Zone will be collected for off site disposal while personnel are actively working in the area.

The Permittee is also committed to undertaking further restoration of the T-Zone while equipment is present on site and this includes the de-commissioning of the settling ponds, collection of steel piping, and removal of any other miscellaneous items that no longer serve a purpose on site.

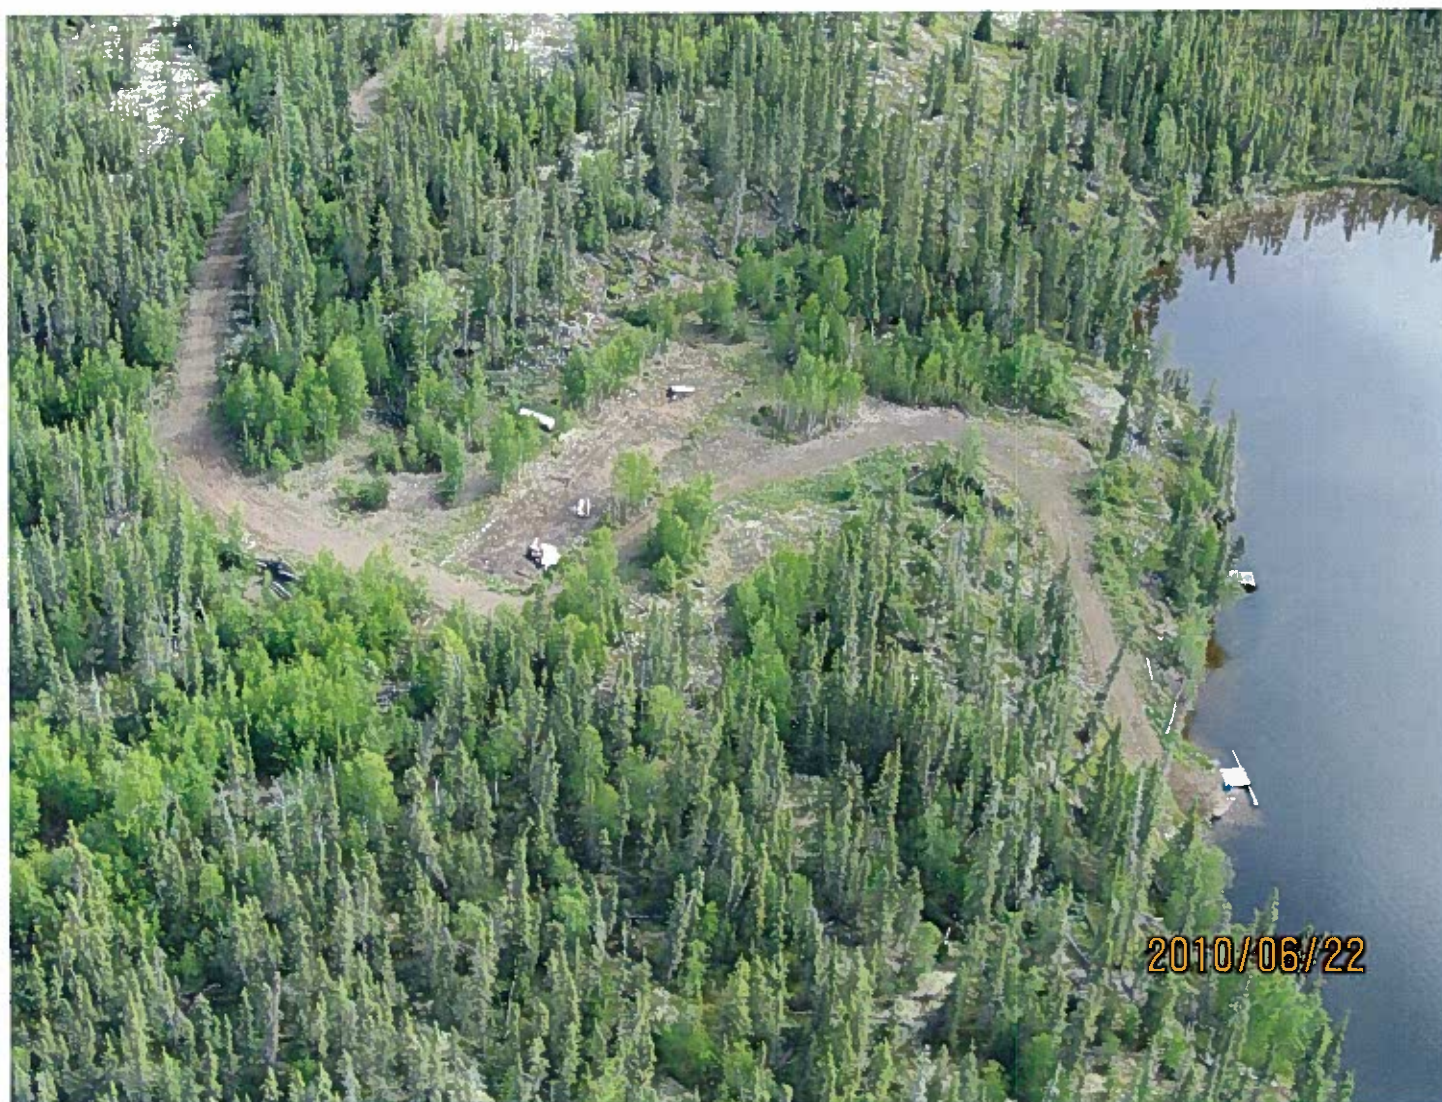
MV2010G0001 - Avalon Rare Metals Inc. - Thor Lake
Further cleanup will be conducted at the previous location of the trailer camp.

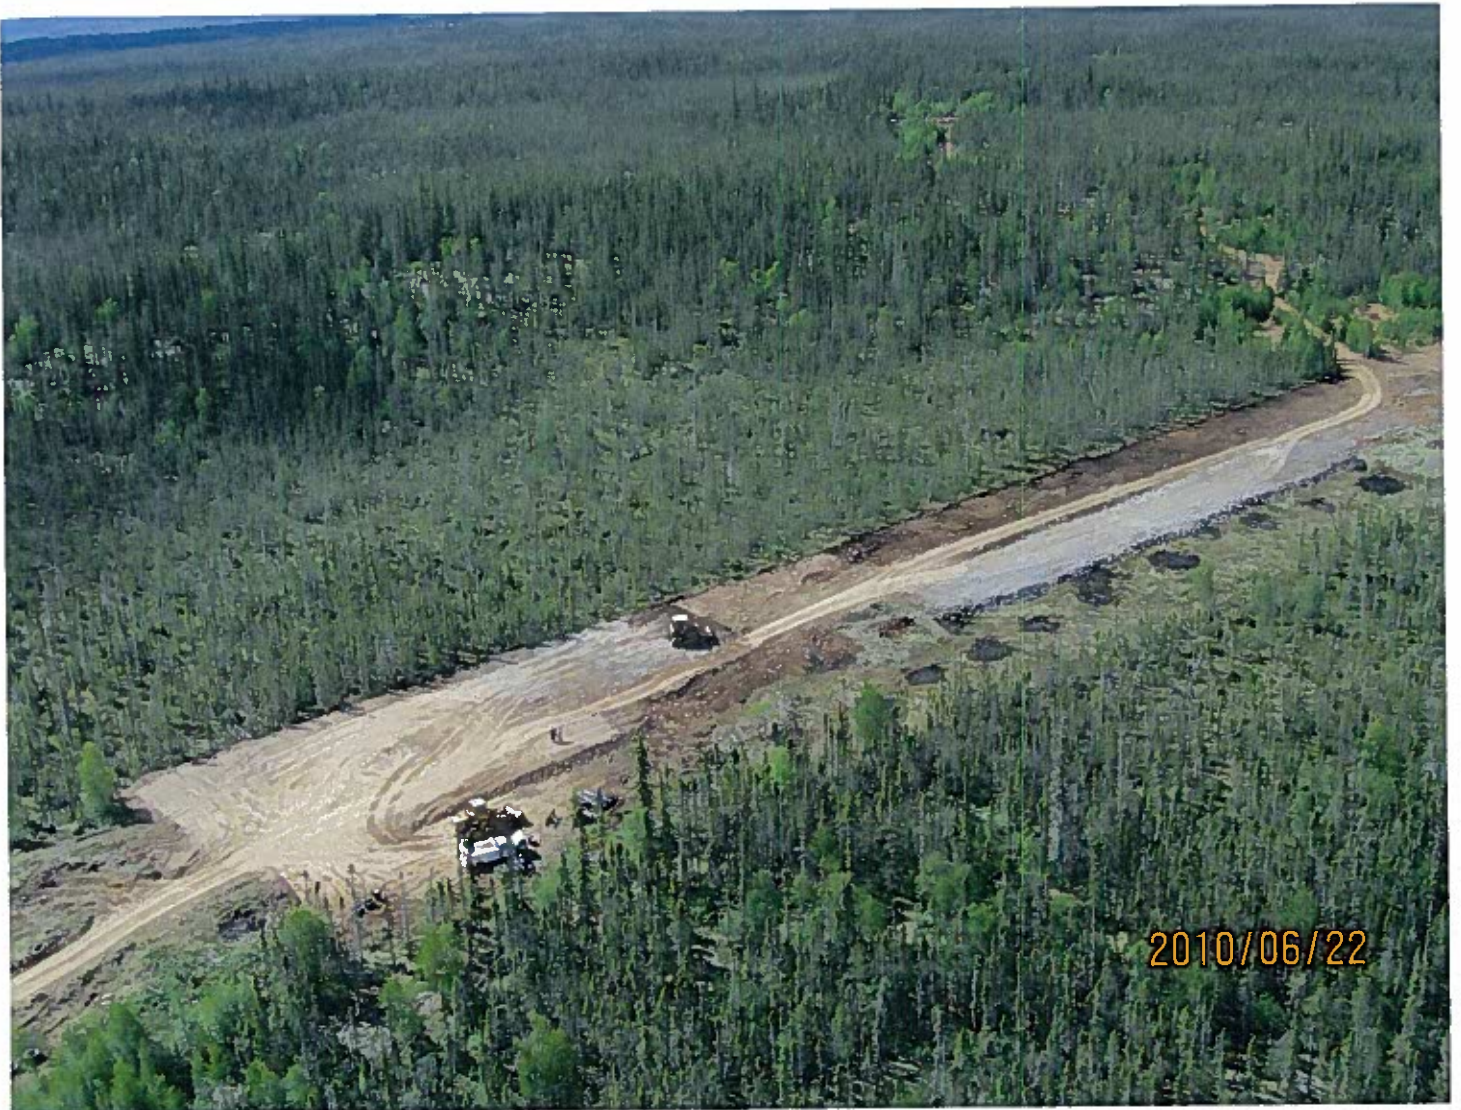
MV2010G0001 - Avalon Rare Metals Inc. - Thor Lake
Looking southwest at the airstrip being constructed West of Thor Lake.

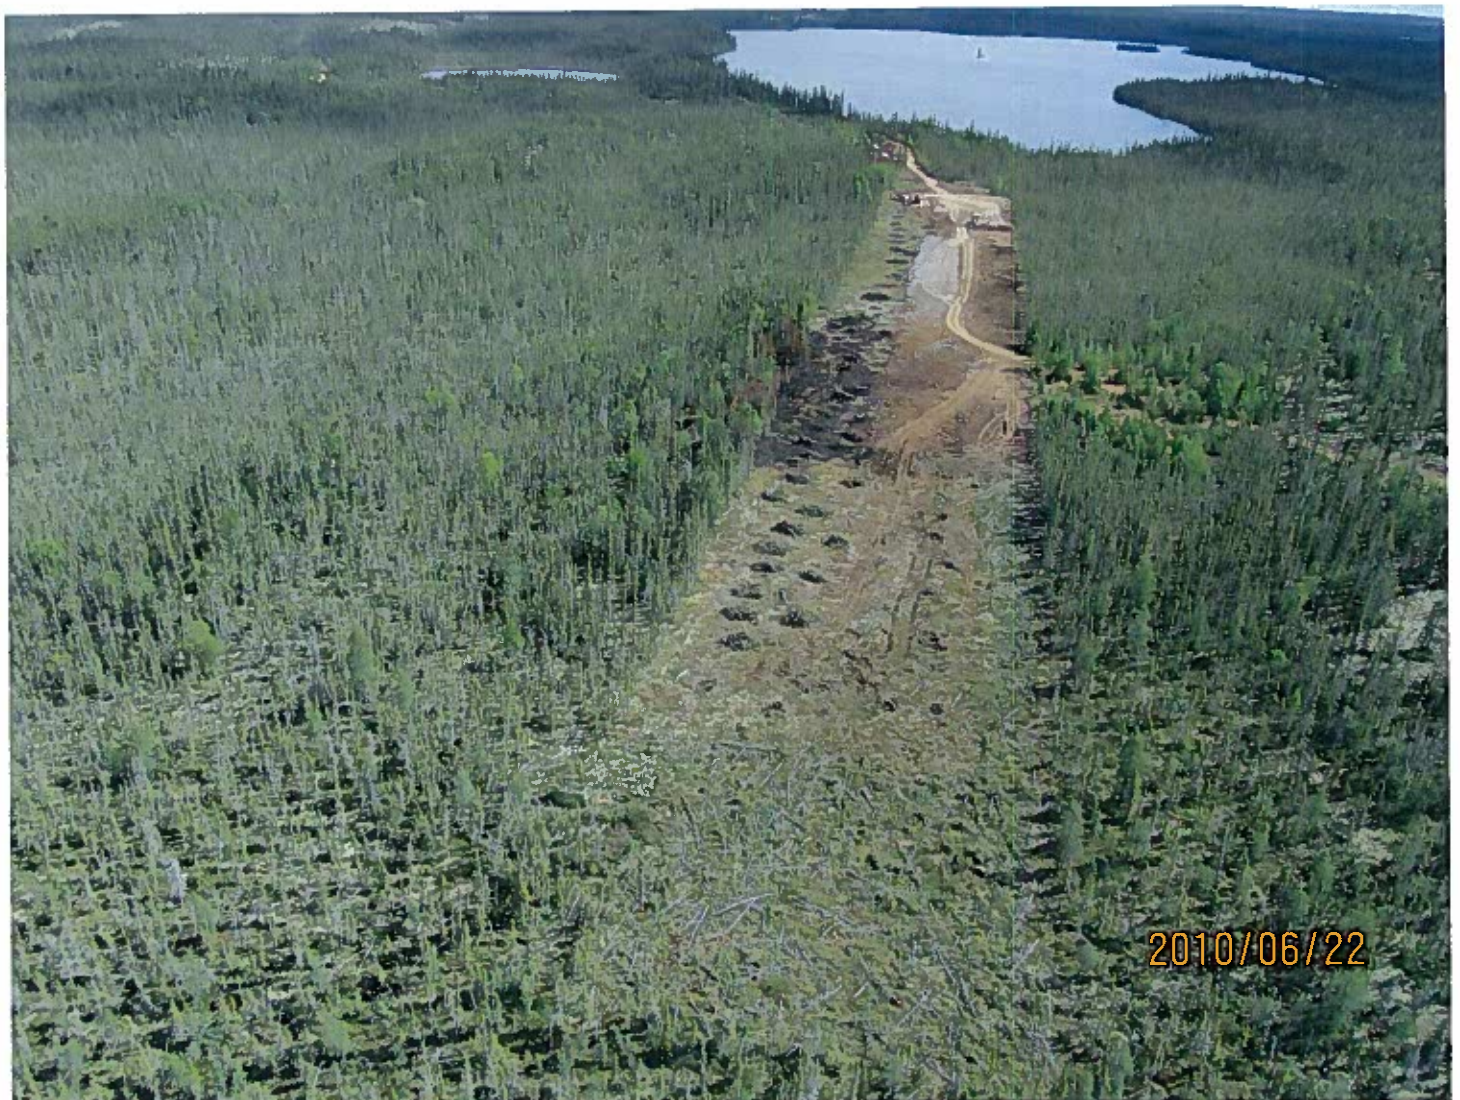
MV2010G0001 - Avalon Rare Metals Inc. - Thor Lake
Looking East along the airstrip right-of-way. Thor lake in the background.

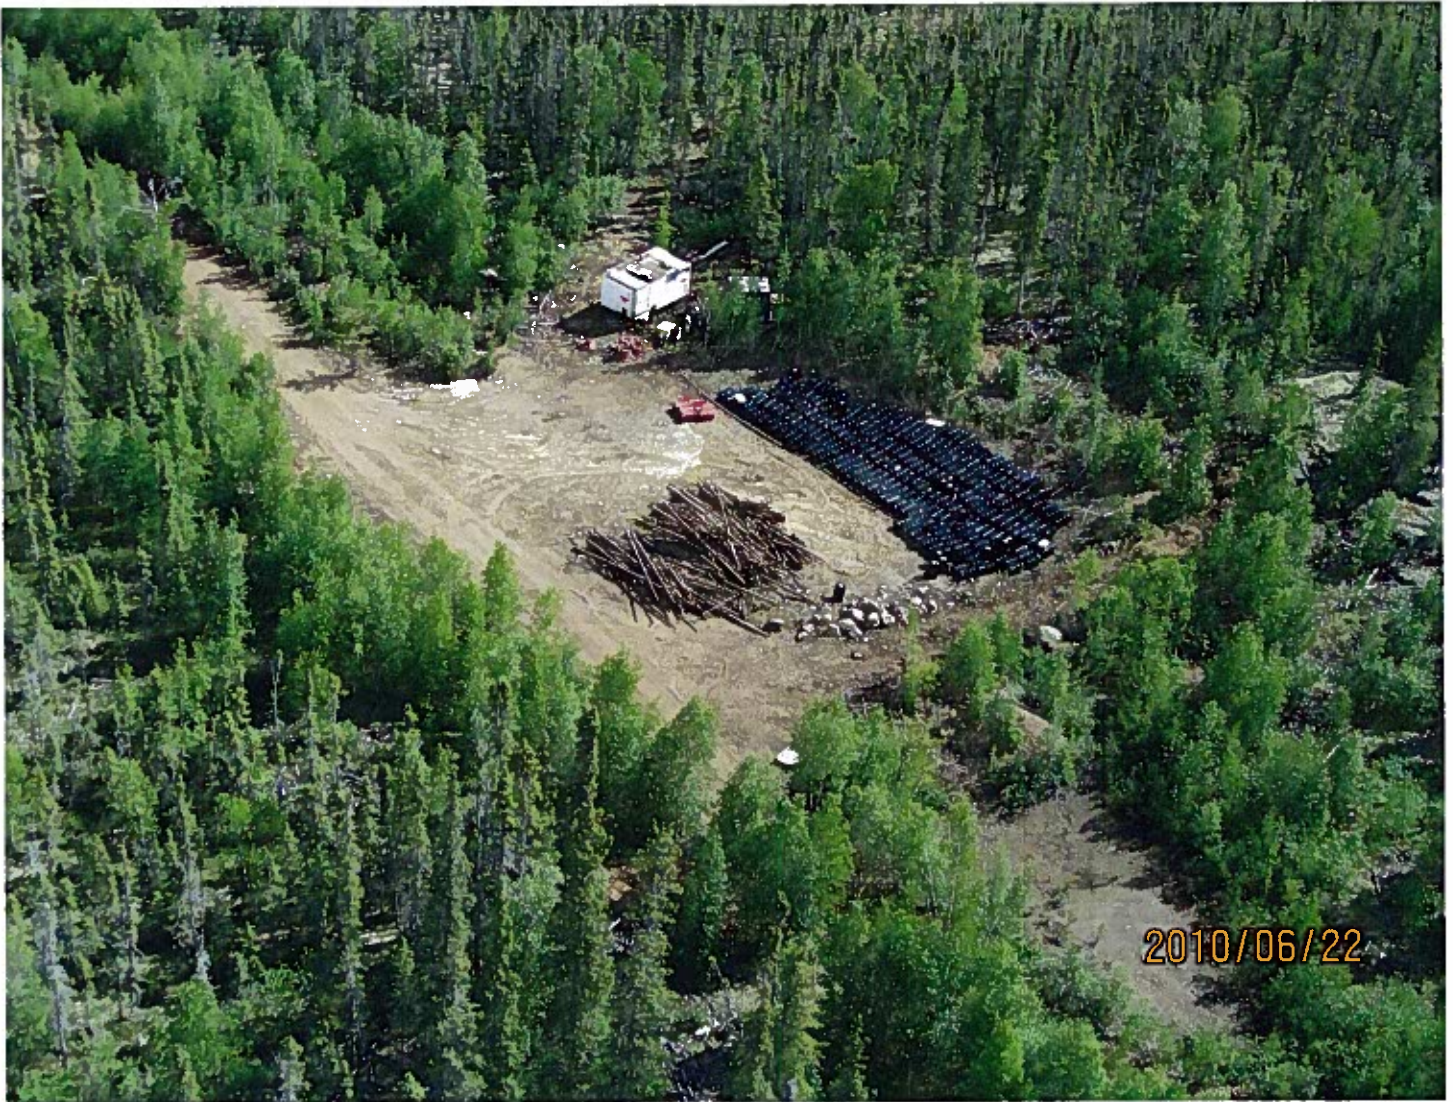
The brushing of the airstrip commenced on May 21st, 2010, and discussions were held with Mr. Randy O'Keefe to ensure trees/brush would be disposed of as per the permit conditions. Mr. O'Keefe was well aware of the requirements of conditions #28 to #30, and adherence was maintained throughout this activity. Most of the brush was piled and burnt, and salvageable trees have been de-limbed and stockpiled for the corduroying of access trails.

MV2010G0001 - Avalon Rare Metals Inc. - Thor Lake
Trees that will be utilized for corduroying, fuel cache and Foraco tracked drill.

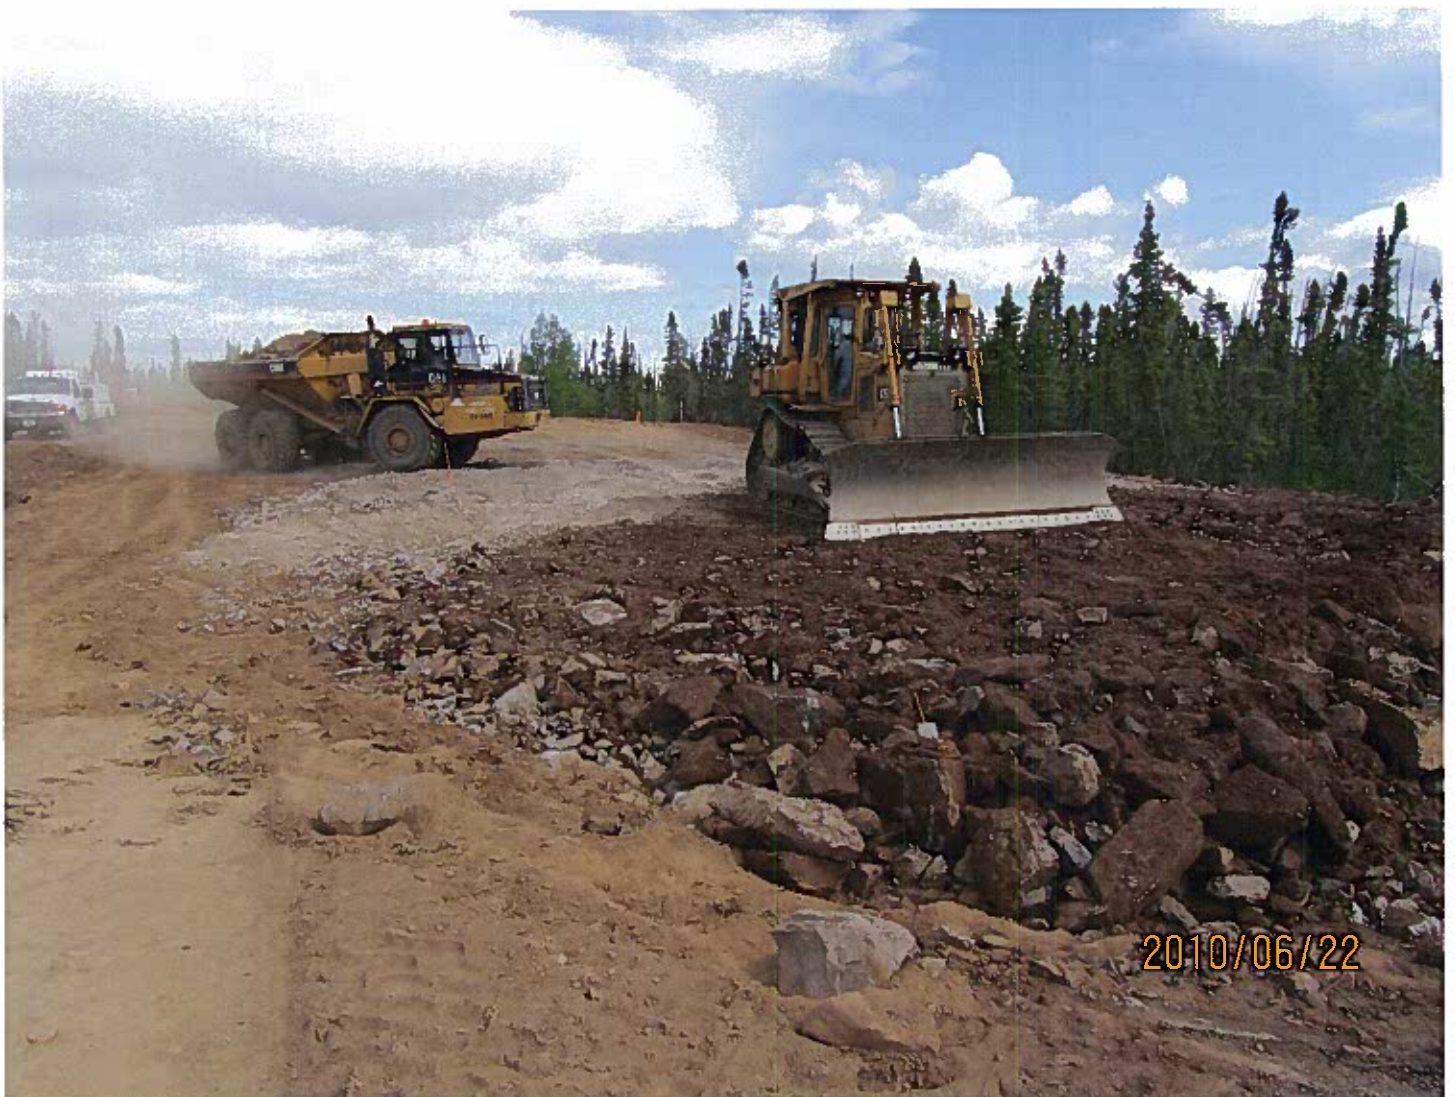
Equipment operating at the time of the inspection was a dozer and two rock trucks at the East end of the airstrip, and an excavator at the T-zone. The establishment of a drainage ditch on the North side of the airstrip was discussed with the Field Supervisors, and this activity will entail cutting this area and filling the airstrip right-of-way. The Inspector has no concerns with this activity as it is within the scope of the permit, protects the integrity of the airstrip and re-establishes drainage.

MV2010G0001 - Avalon Rare Metals Inc. - Thor Lake
Rock truck and dozer working at the East end of the airstrip.

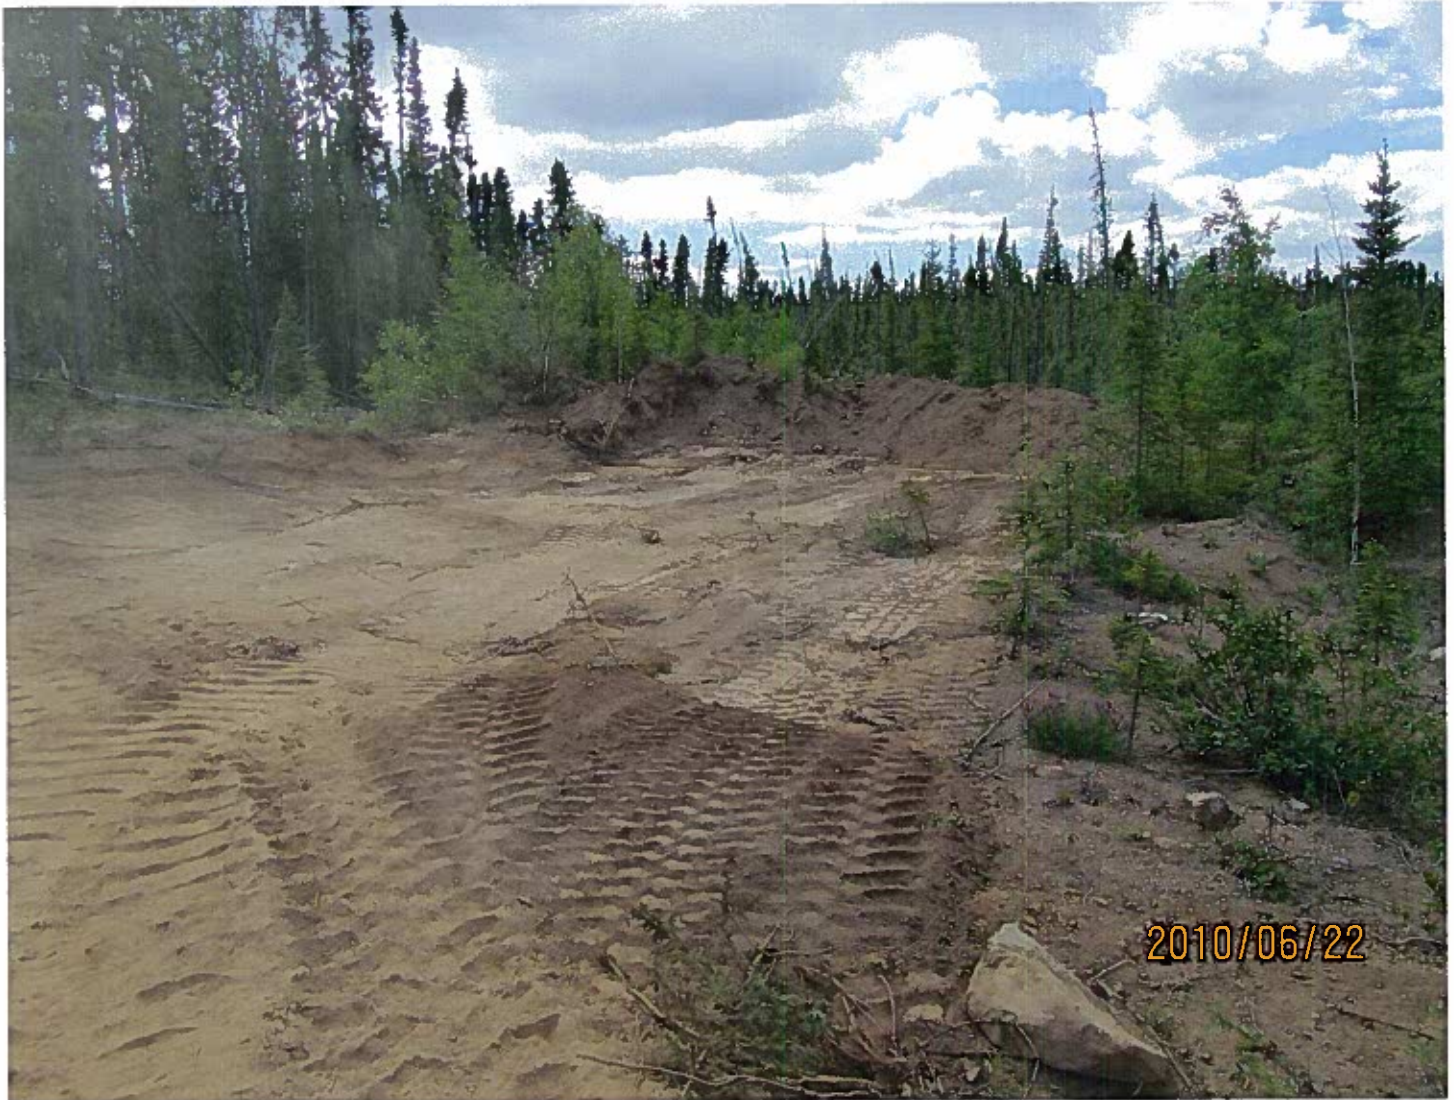
Waste rock to bring the airstrip up to grade is being hauled along the all-weather road from the T-Zone and it was noted that some trees have been displaced along the road that require disposal as per condition #28 of the permit, and pullouts require re-contouring. Prior to the removal of the waste rock at the T-Zone, it was surveyed and marked (for the equipment operators) by professional geologists to ensure that only rock that is highly unlikely to generate acidity would be taken. By removing these rock piles and re-contouring, this will assist in the restoration of the previous operators' land use area.

MV2010G0001 - Avalon Rare Metals Inc. - Thor Lake
Push out along the all weather road that must be pulled back and re-contoured.

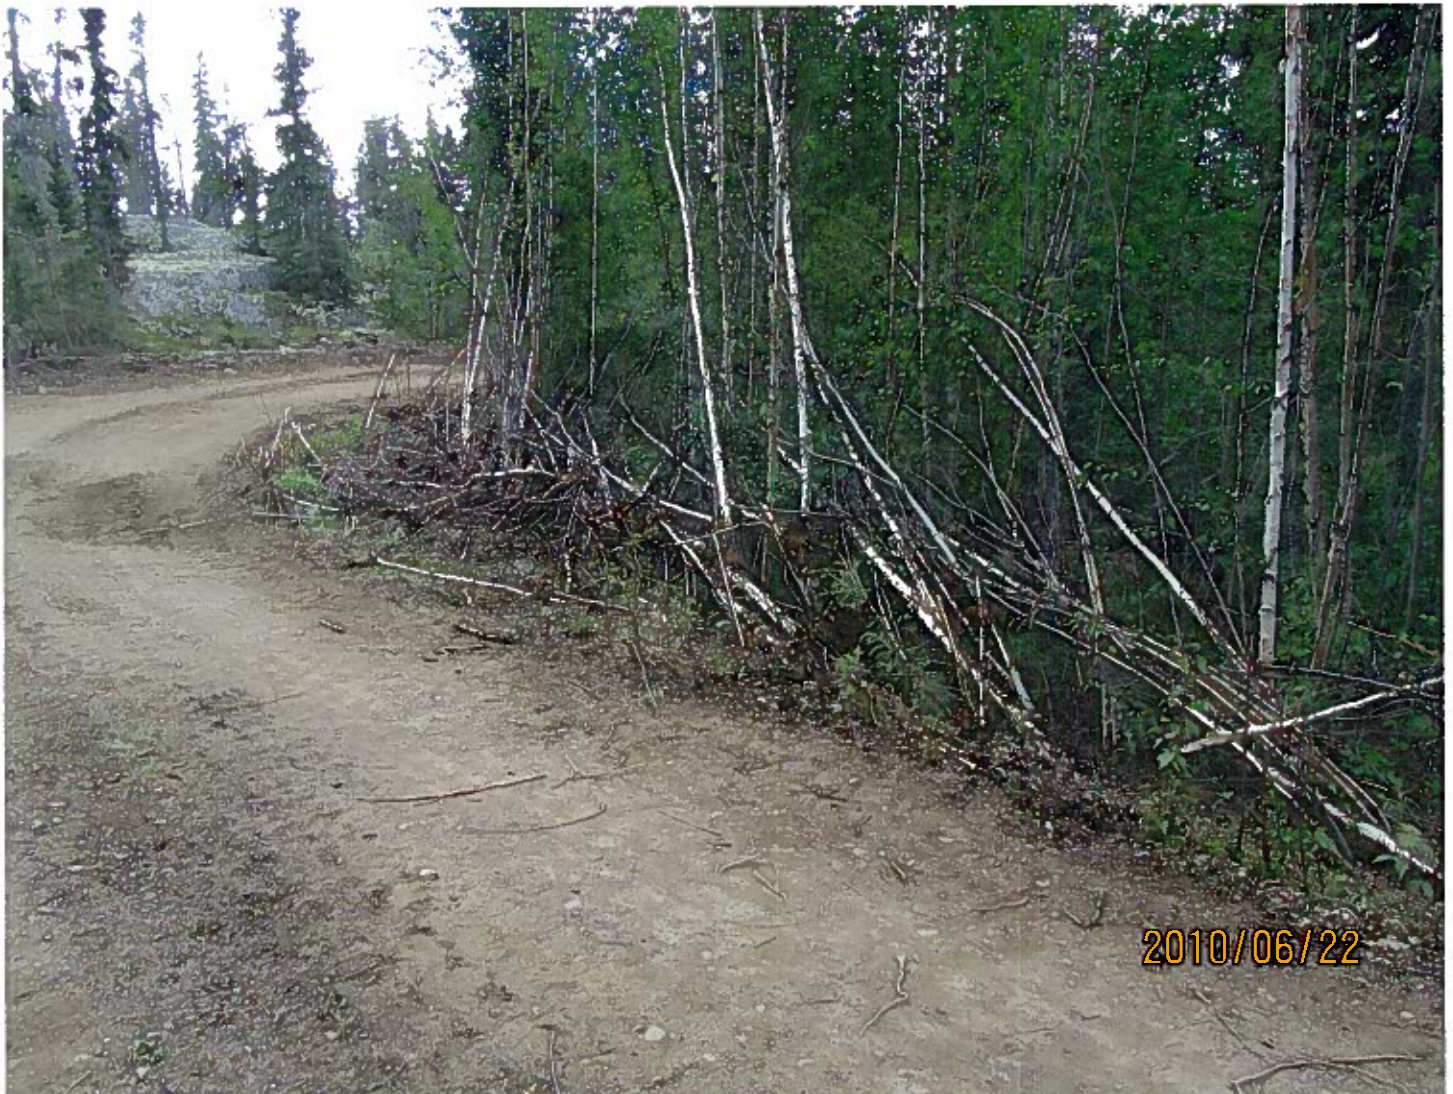
MV2010G0001 - Avalon Rare Metals Inc. - Thor Lake
Vairous areas along the road system that have leaners present that must be disposed of as per the permit operating conditions.

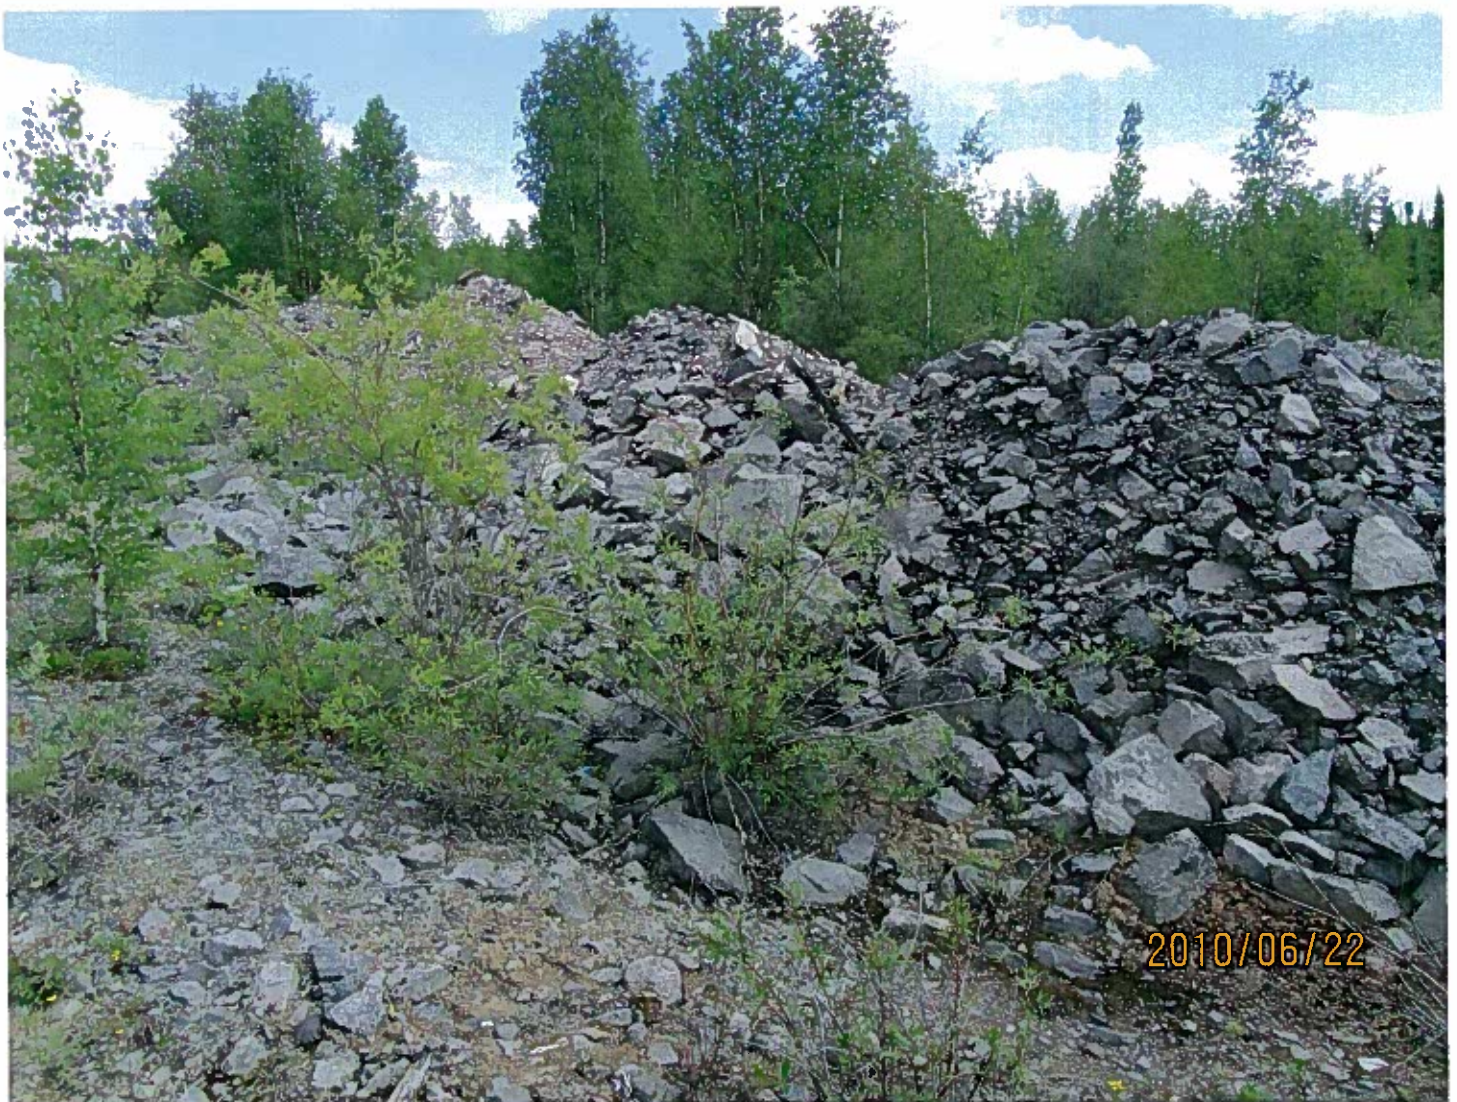
MV2010G0001 - Avalon Rare Metals Inc. - Thor Lake
Piled rock at the T-zone from the decline development that will be used during airstrip construction.

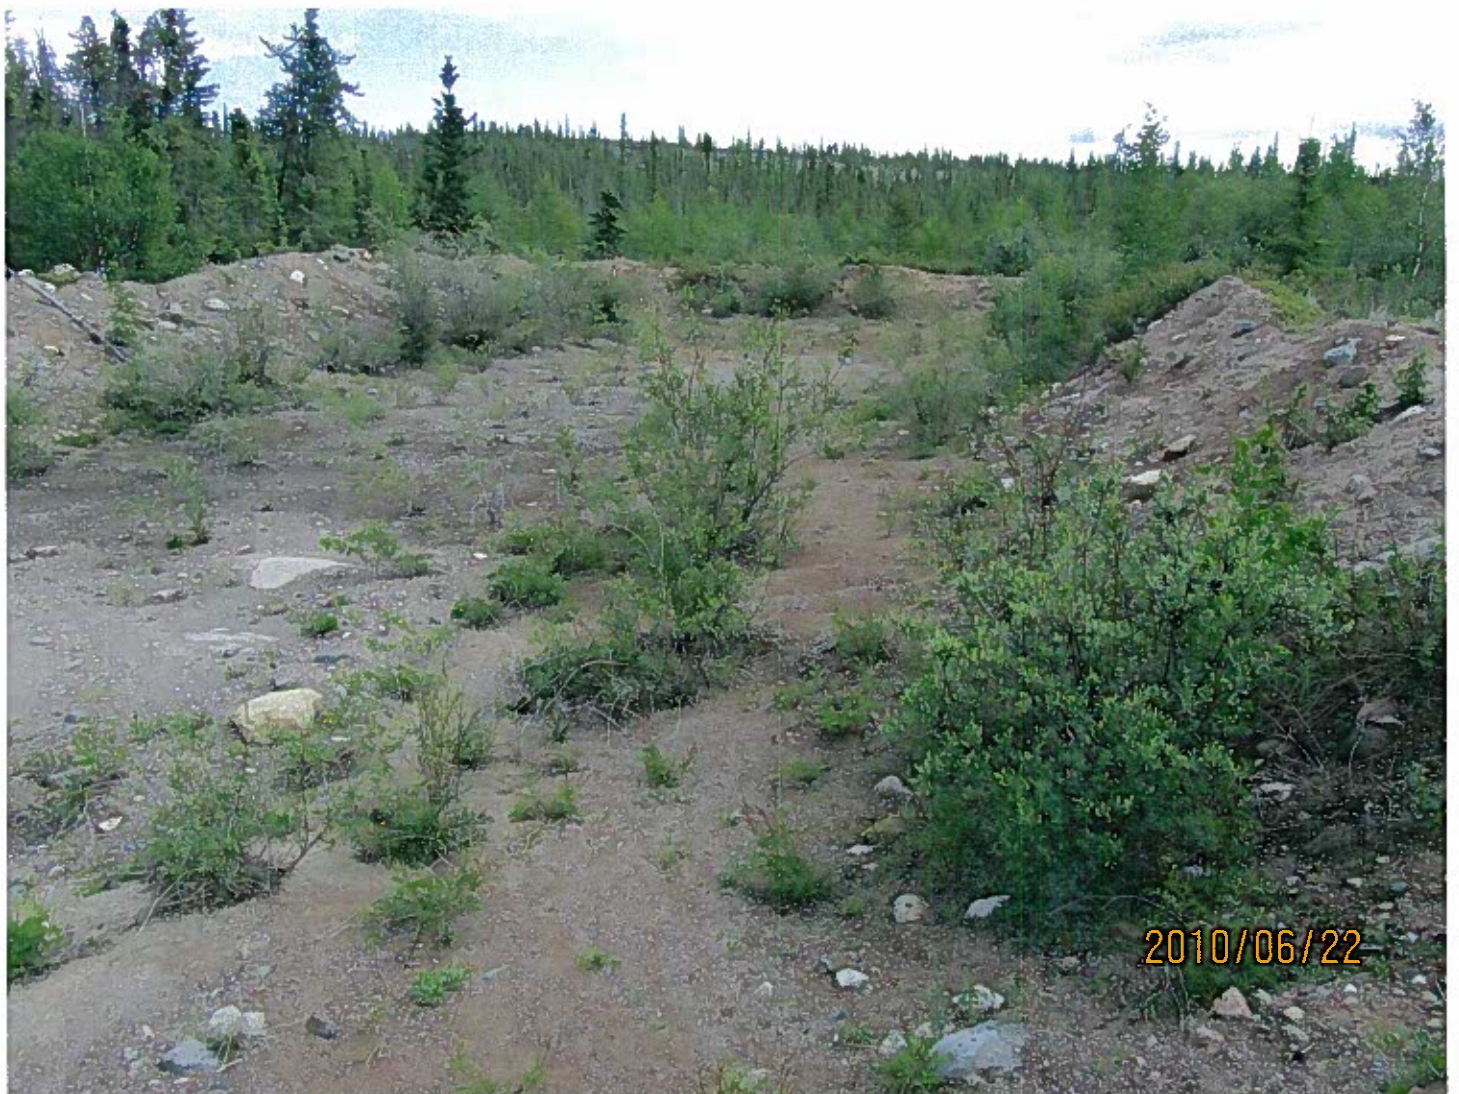
MV2010G0001 - Avalon Rare Metals Inc. - Thor Lake
Sedimentation pond at the T-zone that will be restored while equipment is actively working in the area.
